WEEKLY INCIDENT SUMMARY

Week ending Friday 06 November 2020

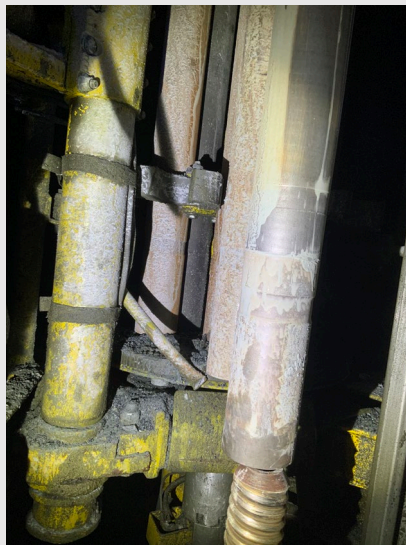
Dangerous incident
IncNot0038584
Underground
metals

An operator was using a scaling bar to attempt to free up a jammed drill rig carousel after a drill steel had become stuck. While pushing on the bar the operator lost his grip. The bar sprung back and hit him in the lower jaw causing a severe laceration.

Operators need to remain situationally aware and avoid trying to apply solutions to problems that have not been risk assessed. Force should not be applied to plant with tools that are not fit-for-purpose.

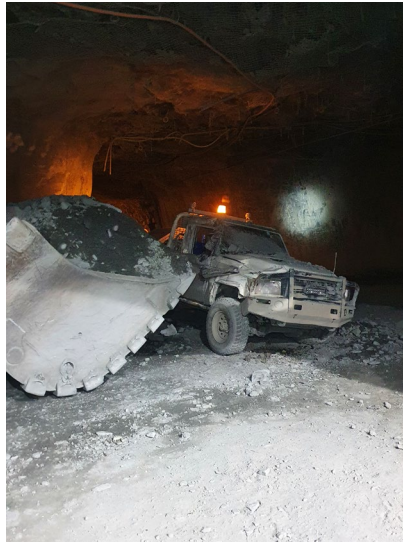
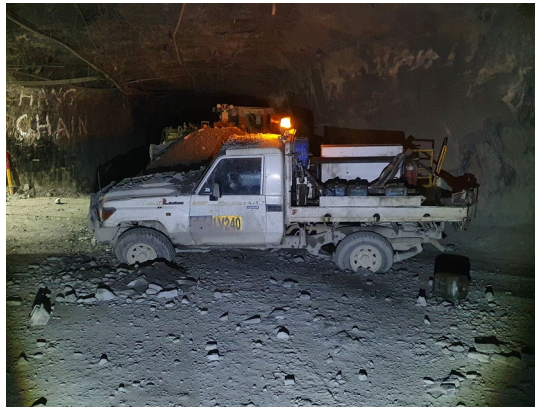
Dangerous incident
IncNot0038570
Underground
metals

While tramping with a loaded bucket from the stockpile to the crusher, a loader collided with the driver's side of a light vehicle. The vehicle was moved sideways with such force that the passenger side tyres were pushed off the wheel rims. The driver and passenger were fortunate to escape injury.

Lack of positive communication has been the root cause of many incidents, including fatalities. Mine operators must consider higher-order controls including proximity detection.

Effective protocols and procedures should be in place to ensure that positive communication between all operators is achieved. Supervisors must monitor the

correct use of these protocols on a continual basis.
