WEEKLY INCIDENT SUMMARY

Week ending Friday 29 January 2021

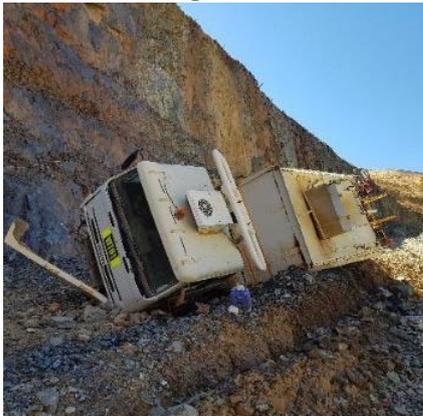
INCIDENT TYPE	SUMMARY	COMMENTS TO INDUSTRY
Dangerous incident IncNot0039090 Underground metal mine

Roads or other vehicle operating areas	<p>A water truck lost control on a ramp and rolled over. The driver sustained minor injuries.</p> <p>Preliminary findings suggest that the brakes failed and the driver, who was not qualified to drive a water truck, was unable to bring the truck to a stop.</p>

<p>Mine operators must have documented life-cycle maintenance strategies for plant and ensure that maintenance is undertaken in accordance with the manufacturer's recommendations.</p> <p>Workers must not operate plant without training and must be assessed as competent to operate that specific plant. Pre-start assessments must be carried out prior to operating mobile plant.</p>

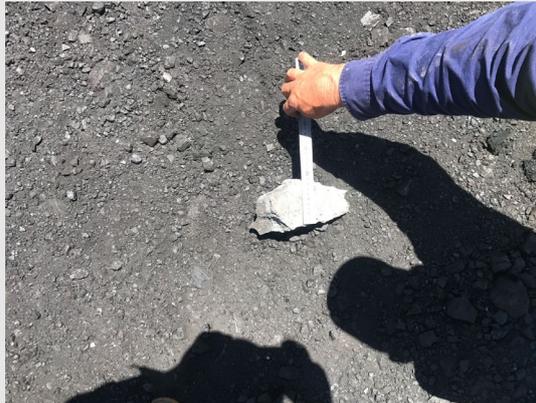
Dangerous incident
IncNot0039098
Open cut coal mine

When blasting overburden, fly rock has been ejected beyond the exclusion zone and into an area where mining plant was operating.
No one was injured.

The Resources Regulator published an investigation report in August 2020 following a dangerous blasting incident. Refer to: [Investigation Report – Dangerous Blasting Incident](#)
Mine operators are reminded that appropriate systems must be in place to review and audit the explosives control plan and blasting work practices, to ensure that exclusion zone requirements are adequate.
Persons conducting a business or undertaking (PCBU) should be aware of clauses 26 and 31 and Schedule 2 of the Work Health and Safety (Mines and Petroleum Sites) Regulation 2014.

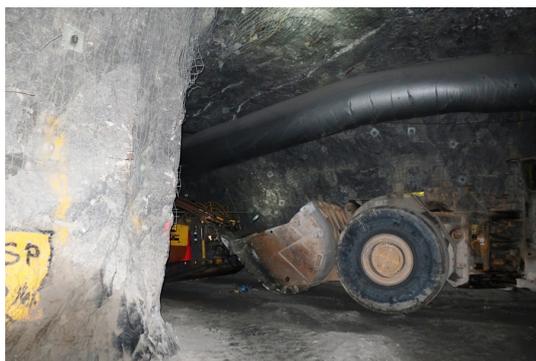
Dangerous incident
IncNot0039102
Underground
metal mine

A jumbo that was parked on the start of a decline has been hit in the rear by a loader bucket. The operator of the jumbo was at the front of the machine at the time of the collision. No one was injured.

A safety alert will be published for this incident.
Operators should ensure that all safety devices, such as beacons, are present and operating when undertaking a pre-start assessment and take the necessary action to remedy any faults.
Operators should also assess risks that may arise from their actions. When parking a vehicle, the operator should maintain situational awareness. If it is necessary to park in a position that increases the risk of a collision, positive communications and/or other risk controls, such as signs, should be used to minimise the risk.

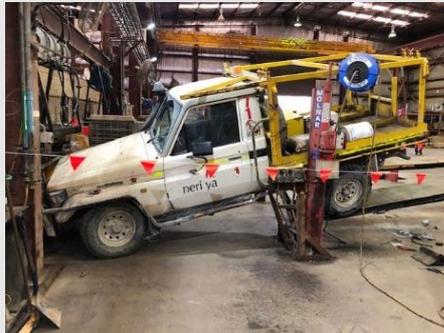
Dangerous incident
IncNot0039117
Underground
metal mine

A maintenance hoist that was loaded with a light vehicle had a rope failure that caused the hoist to drop on one side.
No one was injured.

Mine operators are reminded that hoist ropes should be regularly inspected and the triggers for rope replacement should be determined according to the task, the rating of the ropes and the risk associated with rope failure.

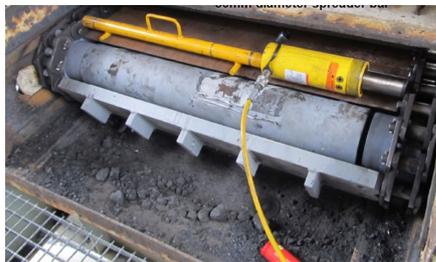
Dangerous incident
IncNot0039120
Open cut coal mine

A worker was struck in the face by a metal spreader bar while in the process of reconnecting the chain on a feeder breaker. Another worker applied a small amount of pressure to a 30T ram, applying a compressive force to the spreader bar before the injured worker had moved to a safe standing zone.

Workers should ensure they use fit-for-purpose equipment when undertaking tasks. Safe standing zones should be determined where hydraulic pressure is being applied to objects and there is a potential for unintended movement or equipment failure. Workers should communicate their intentions clearly and ensure that their actions don't put others in a position of danger.
