WEEKLY INCIDENT SUMMARY

Week ending Friday 29 January 2021

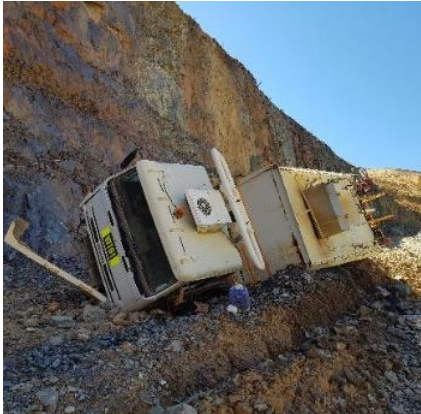
INCIDENT TYPE	SUMMARY	COMMENTS TO INDUSTRY
Dangerous incident IncNot0039090 Underground metal mine

Roads or other vehicle operating areas	<p>A water truck lost control on a ramp and rolled over. The driver sustained minor injuries.</p> <p>Preliminary findings suggest that the brakes failed and the driver, who was not qualified to drive a water truck, was unable to bring the truck to a stop.</p>

<p>Mine operators must have documented life-cycle maintenance strategies for plant and ensure that maintenance is undertaken in accordance with the manufacturer's recommendations.</p> <p>Workers must not operate plant without training and must be assessed as competent to operate that specific plant. Pre-start assessments must be carried out prior to operating mobile plant.</p>

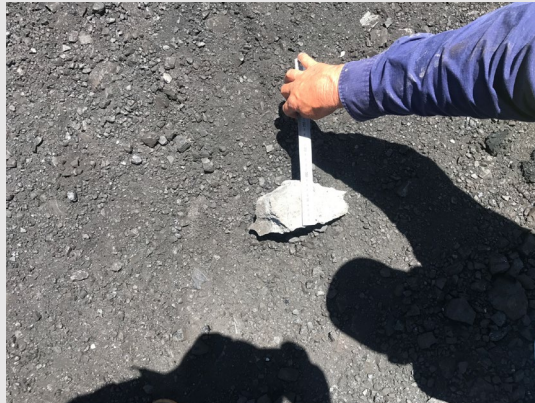
Dangerous incident
IncNot0039098
Open cut coal mine

When blasting overburden, fly rock has been ejected beyond the exclusion zone and into an area where mining plant was operating.
No one was injured.

Mine operators are reminded that appropriate systems must be in place to review and audit the explosives control plan and blasting work practices, to ensure that exclusion zone requirements are adequate.

Persons conducting a business or undertaking (PCBU) should be aware of clauses 26 and 31 and Schedule 2 of the Work Health and Safety (Mines and Petroleum Sites) Regulation 2014.

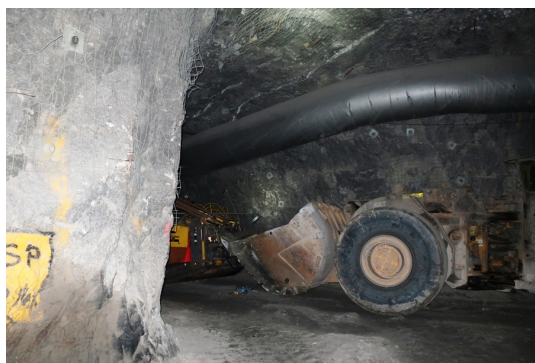
Dangerous incident
IncNot0039102
Underground
metal mine

A jumbo that was parked on the start of a decline has been hit in the rear by a loader bucket. The operator of the jumbo was at the front of the machine at the time of the collision. No one was injured.

Operators should ensure that all safety devices, such as beacons, are present and operating when undertaking a pre-start assessment and take the necessary action to remedy any faults.

Operators should also assess risks that may arise from their actions. When parking a vehicle, the operator should maintain situational awareness. If it is necessary to park in a position that increases the risk of a collision, positive communications and/or other risk controls, such as signs, should be used to minimise the risk.

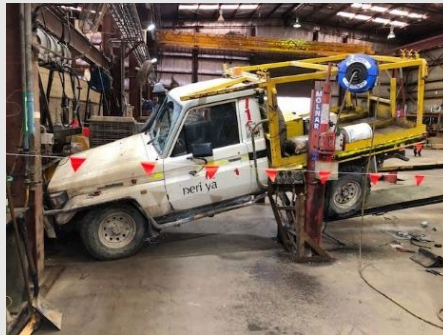
Dangerous incident
IncNot0039117
Underground
metal mine

A maintenance hoist that was loaded with a light vehicle had a rope failure that caused the hoist to drop on one side.
No one was injured.

Mine operators are reminded that hoist ropes should be regularly inspected and the triggers for rope replacement should be determined according to the task, the rating of the ropes and the risk associated with rope failure.

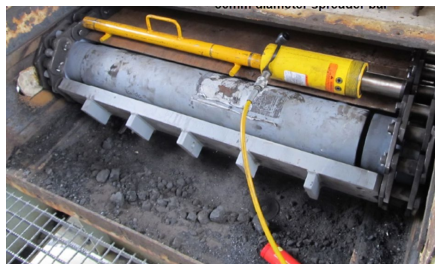
Dangerous incident
IncNot0039120
Open cut coal mine

A worker was struck in the face by a metal spreader bar while in the process of reconnecting the chain on a feeder breaker. Another worker applied a small amount of pressure to a 30T ram, applying a compressive force to the spreader bar before the injured worker had moved to a safe standing zone.

Workers should ensure they use fit-for-purpose equipment when undertaking tasks. Safe standing zones should be determined where hydraulic pressure is being applied to objects and there is a potential for unintended movement or equipment failure. Workers should communicate their intentions clearly and ensure that their actions don't put others in a position of danger.
