WEEKLY INCIDENT SUMMARY

Week ending Friday 05 February 2021

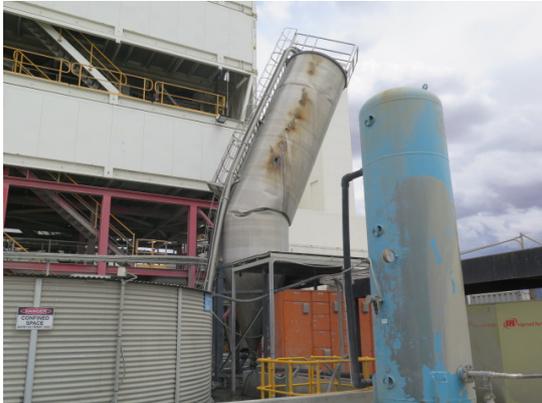
INCIDENT TYPE	SUMMARY	COMMENTS TO INDUSTRY
Dangerous incident IncNot0039128 Underground metal mine	A 10-metre high, four-metre diameter water clarifier tank at a paste fill plant buckled.

The cause of this incident is yet to be determined. Further information may be published at a later date. Mine operators need to operate and maintain tanks to meet OEM recommendations. Mine operators should also be aware of the dangers associated with excessive build-up of solids in tanks.
Dangerous incident IncNot0039131	A worker was blasted in the face by compressed air while attempting to extend a two-inch air line. The worker	Unfixed pressurised hoses should not be worked on without isolating the energy source and

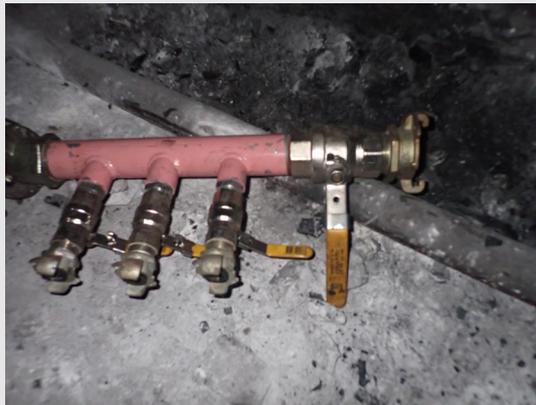
Underground coal mine

was connecting a pipe to a manifold that was being held by a second worker. The second worker unintentionally hit the ball valve, which allowed the compressed air to escape. The injured worker was hospitalised with facial injuries.

dissipating any stored energy. Operators should consider using gate valves in place of ball valves to isolate air flow.

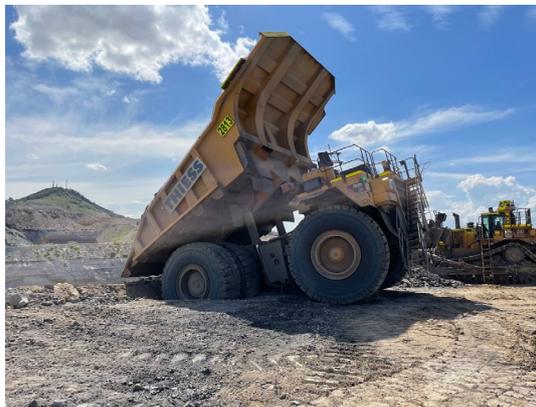
Dangerous incident
IncNot0039161
Open cut coal mine

A dump truck has dropped about one to two metres when the dump wall failed as the operator was tipping a load.

Mine operators must have safe systems of work in place to inspect dumps. These inspections must consider weathering effects, ground water and conditions that affect the dump wall stability. Refer to: [Safety Bulletin SB20-01 Failure of highwalls, low walls and dumps.](#)
