WEEKLY INCIDENT SUMMARY

Week ending Friday 26 February 2021

INCIDENT TYPE	SUMMARY	COMMENTS TO INDUSTRY
Dangerous incident IncNot0039277 Open cut coal mine

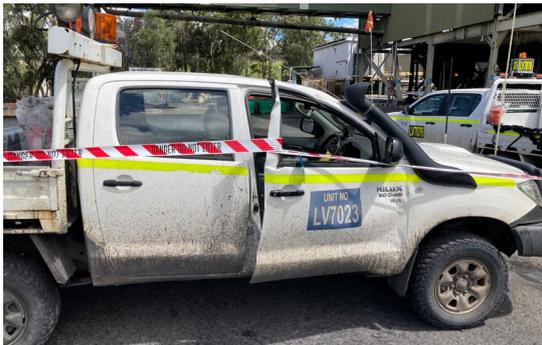
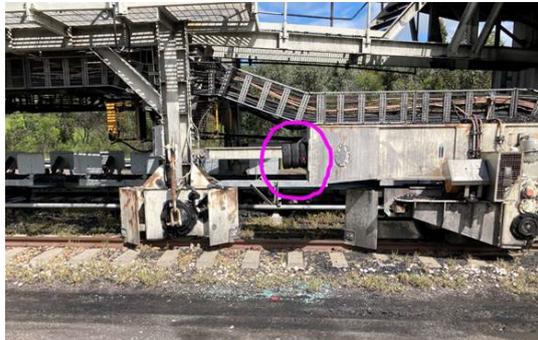
<p>Roads or other vehicle operating areas</p>	An operator was sitting in his light vehicle with the door open, after clearing a fault on a stacker. An unplanned movement of the stacker caused the front buffer of the stacker to hit the open door of the vehicle causing the door frame to buckle and the glass to shatter. The operator was uninjured.

Operators need to remain situationally aware around moving plant particularly when there is no clearly identified delineation zone. Drivers should ensure that no part of their vehicle encroaches into the danger zone. Where there is moving components on fixed infrastructure, exclusion zones need to be determined and appropriate delineation installed.

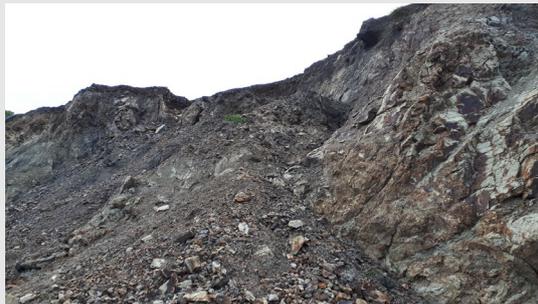
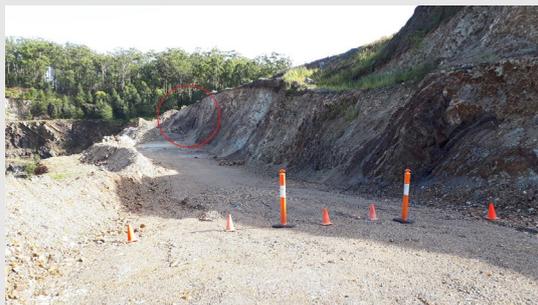
Following heavy rain, approximately 60 tonnes of loose material slipped onto a ramp. The ramp was not in use and had been bunded off at the top. Nobody was injured.

Mine operators are reminded that when developing the control measures to manage the risks of ground or strata failure consideration must be given to:

- the means by which water may enter the mine
- the procedures for removing water from the mine and how those procedures influence rock stability over time
- the geotechnical characteristics of the rocks and soil, including the effects of water on rock support and stability.
