# WEEKLY INCIDENT SUMMARY

Week ending Friday 12 March 2021

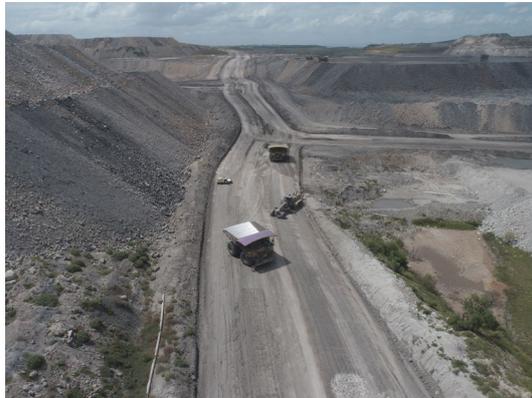
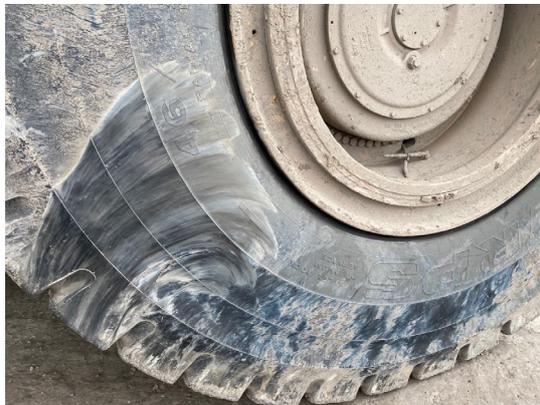
INCIDENT TYPE	SUMMARY	COMMENTS TO INDUSTRY
Dangerous incident IncNot0039385 Open cut coal mine

Roads or other vehicle operating areas	While working on a haul road, a grader operator performed a u-turn. The position 2 tyre of the grader contacted the position 3 tyre of a haul truck that was overtaking the grader at the time. The grader operator did not look to see if the road was clear before initiating the u-turn. The haul truck operator had followed the correct procedure for overtaking.	Mines should develop, review and update procedures that manage the interaction of all mobile plant operating on site, including requirements for proximity detection and positive communication. Mines should consider including protocols for graders to conduct U-turns in their traffic rules. The installation of passing indicators on graders could facilitate positive communications allowing trucks to safely pass. Refer to <a href="#">Safety Bulletin 18-06 Lack of positive communications</a>

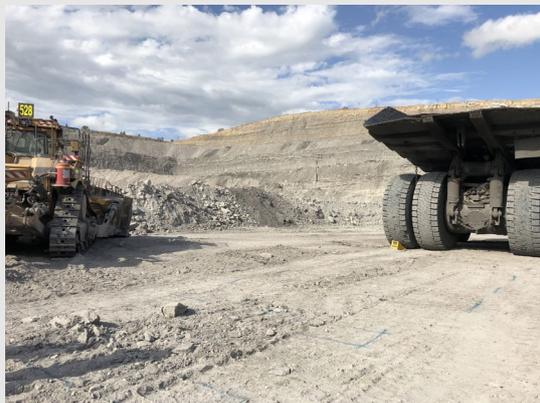
Dangerous incident  
IncNot0039419  
Open cut coal mine

A dozer and a haul truck collided at a tip head. Both vehicles were reversing at the time of the incident. A preliminary investigation suggests that the truck operator did not follow the site requirement for positive communications with the dozer operator.

Machine operators should not rely on experience or previous movements of other operators as a substitute for positive communications. Lack of positive communication has been the root cause of many incidents and mine operators must consider higher-order controls including proximity detection. Mines should consider periodic refreshers in positive communications protocols for operators using mobile equipment.

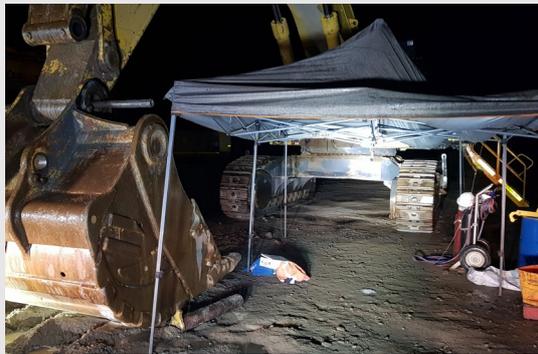
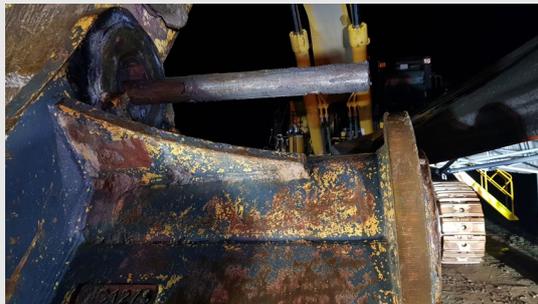
Severe incident  
IncNot0039423  
Open-cut  
construction  
materials

A worker sustained a compound fracture to his leg during the removal of a bucket from an excavator. The bucket holding-pin was being pushed from one side of the bucket by a pin pusher attached to a loader. The pin was almost free of its housing when the operator moved to the other side of the bucket, the pin came free, bounced off the bucket and hit the operator on the leg.

The risk of an unsecured pin falling and hitting a person is an easily identifiable risk for which controls need to be put in place prior to work commencing. Documented risk assessments and/or procedures for such a task should be available and supervisors should ensure that controls, such as no-go zones and safe standing zones, are in place and communicated to all workers involved in the task.
