WEEKLY INCIDENT SUMMARY

Week ending Friday 28 May 2021

Mine safety reference ISR21-21

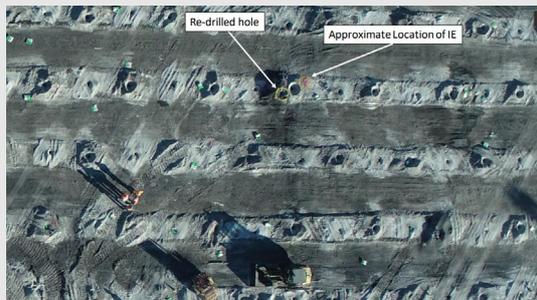
Dangerous incident
IncNot0039957
Open cut coal mine

A drill rig trammed to a demarcated shot hole to re-drill it. The drill operator accessed the loaded shot without authorisation of the nominated shotfirer and without the guidance of a spotter. The operator was unaware that he was drilling inside the demarcated area. A booster and detonator were on the cuttings of the original drill hole about two to three metres from the operating drill. The mine has a procedure in place for re-drilling, but the rig operator failed to follow the procedure.

Section 28 of the Work Health and Safety Act 2011 prescribes the duties of workers. Workers must:

- care for their own health and safety and that of others
- cooperate with any reasonable policy or procedure.

Where a procedure exists for a particular task, workers should follow the procedure.

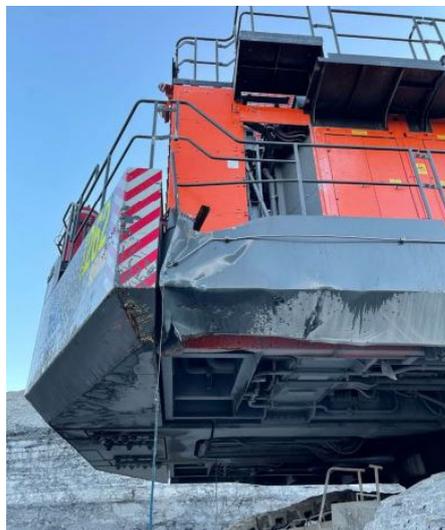
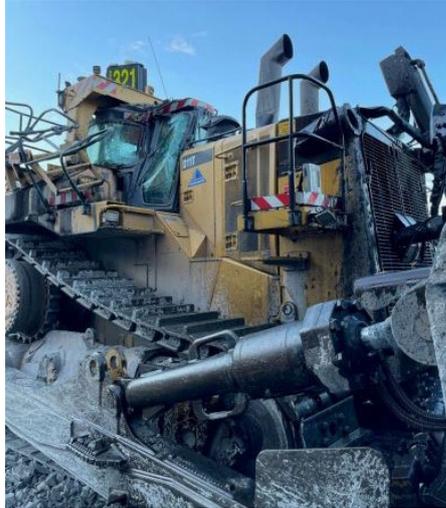
An excavator collided with a dozer causing significant damage to the cabin. The operators had established positive communications to allow the dozer to enter the excavator's swing radius. However, the excavator operator restarted operation without confirming that the dozer was clear of the swing radius.

To control the risk of collision excavators should cease operation while dozers are operating within the swing radius. Mines should not rely on procedural controls for managing the risk of collisions. Collision avoidance technology should be integrated into mobile equipment.

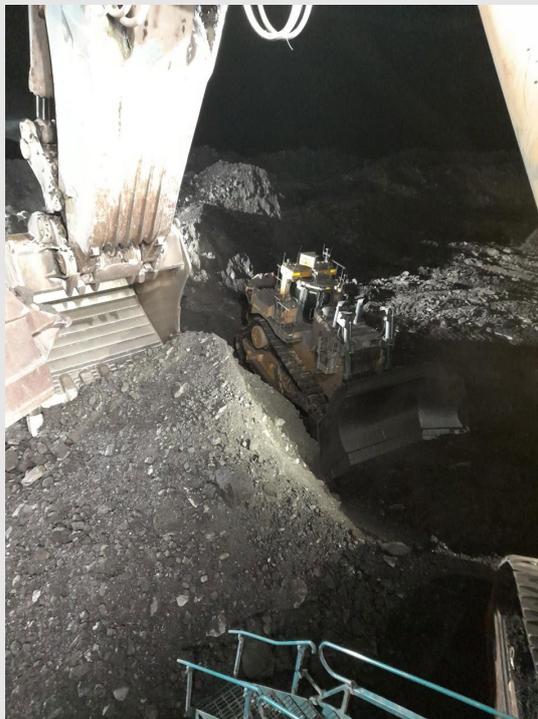
Dangerous incident
IncNot0039972
Open cut coal mine

An excavator collided with a dozer that was working inside the swing radius of the excavator. The excavator bucket has hit the exhaust stack and blade lift cylinder at the front of the dozer. There were no injuries.

Dozer operators must maintain a safe distance when operating in close proximity to excavators (must remain outside of the excavator swing radius). Machine operators should not rely on experience or previous movements of other operators as a substitute for positive communications. Refer to [Safety Bulletin 18-06 Lack of positive communications](#) which addressed similar incidents.
