WEEKLY INCIDENT SUMMARY

Week ending Friday 10 September 2021

Summarised incidents

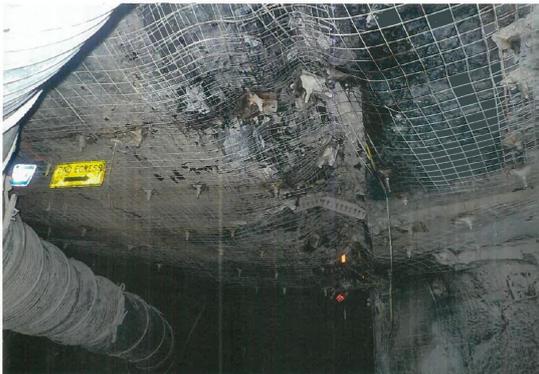
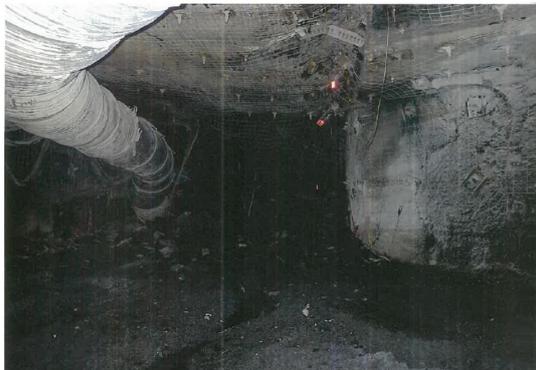
| INCIDENT TYPE | SUMMARY | COMMENTS TO INDUSTRY |
|---|--|---|
| Dangerous incident IncNot0040643 Underground coal mine Ground or strata | <p>A roof fall occurred in an underground coal mine. The fall was the full width of the roadway and extended 15 to 20 metres. The fall occurred as workers were in the crib room preparing to start work in the area where the fall occurred. Monitoring in the intersection showed 31 millimetres total displacement leading up to the fall. Initial investigations suggest it is a stress related roof fall.</p> | <p>This incident is under investigation and further information may be published later. Underground mine operators should review the adequacy of their strata monitoring arrangements and associated trigger action response plans (TARPs) to ensure that workers are not exposed to unacceptable risks associated with strata failure. Mine operators should ensure that any abnormal changes in the strata behaviour are considered as potential indicators of geological change and respond appropriately. Mine operators should ensure that the strata monitoring plan includes the</p> |

timing for installation of strata monitoring devices and required installation of the devices in all high-risk areas including intersections.

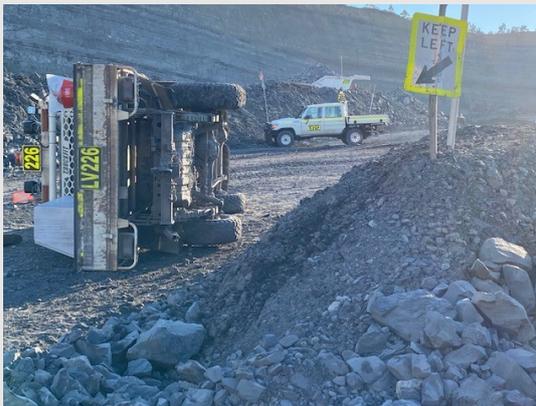
Dangerous incidents
IncNot0040675
Open cut coal mine

A contractor was driving a light vehicle up a ramp when the sun affected their vision. The vehicle mounted a windrow and tipped onto the passenger side. The driver was wearing a seatbelt and was uninjured.

Drivers must maintain focus on the task at hand. When visibility is affected, drivers should find a safe place to stop and address the issue, rather than continuing to drive on. Roadway and intersection designs must consider all environmental factors that could affect visibility, including sunlight and the location of fixed lighting.
