WEEKLY INCIDENT SUMMARY

Week ending Friday 17 September 2021

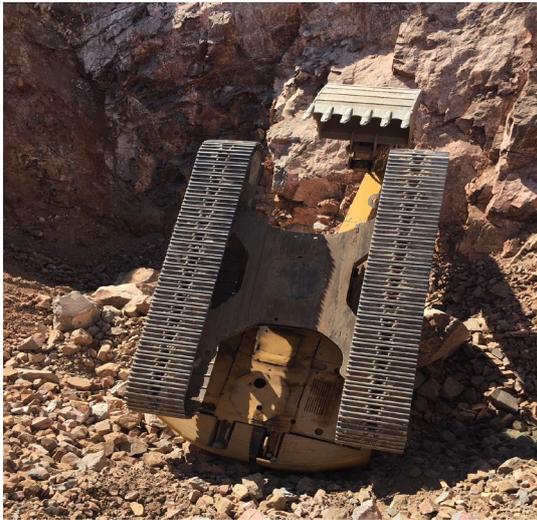
<p>A 50-tonne excavator was operating on a pad of material that was being fed into a mobile crusher when the air conditioner</p>	<p>Equipment operators must maintain situational awareness and remain vigilant to the inherent risks when working at height.</p> <p>When equipment is changed out, the operator and supervisor should review the hazards and controls for the task.</p>

failed. Consequently, the operator swapped to a 20-tonne excavator. While setting up to cut down the pad, the operator reversed off the edge of the pad, rolling backwards down the 3.5 metres face. The operator was uninjured.

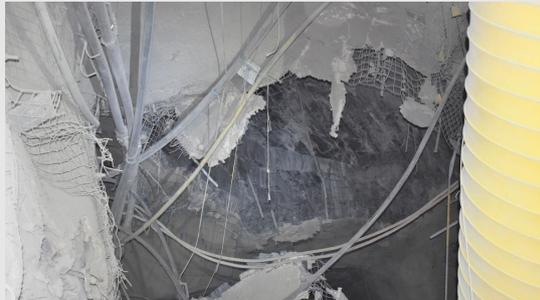
A fall of ground occurred in a metalliferous mine. The roof of a four-way intersection fell across the fullwidth of the intersection. No one was in the area at the time of the fall.

Underground mine operators should review the adequacy of their strata monitoring arrangements and associated trigger action response plans (TARPs) to ensure that workers are not exposed to unacceptable risks associated with strata failure. Strata monitoring should be increased in areas of geological structures or where other mining operations may influence strata.

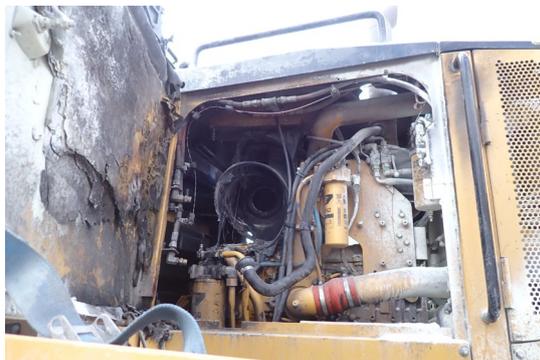
A grader caught on fire while being refuelled. Diesel fuel escaped from a crack in the weld between the tank and the inlet pipe. The fuel ignited when it contacted a hot surface within the engine compartment. The operator was using a non-approved device to hold the fuel nozzle handle open. There were no injuries.

Under no circumstances should operators override safety controls on refuelling systems. Operators must always maintain control of the fuel flow. Investigations are ongoing and further information may be released in future. The videos linked below are from Resources Safety and Health, Queensland. They highlight the dangers of failing to use OEM recommended procedures when refuelling mobile plant.
