MINE SAFETY INVESTIGATION UNIT

INFORMATION RELEASE

Event Fatality in a residence

Location Cudal Limestone Quarry, Cudal (near Orange), NSW

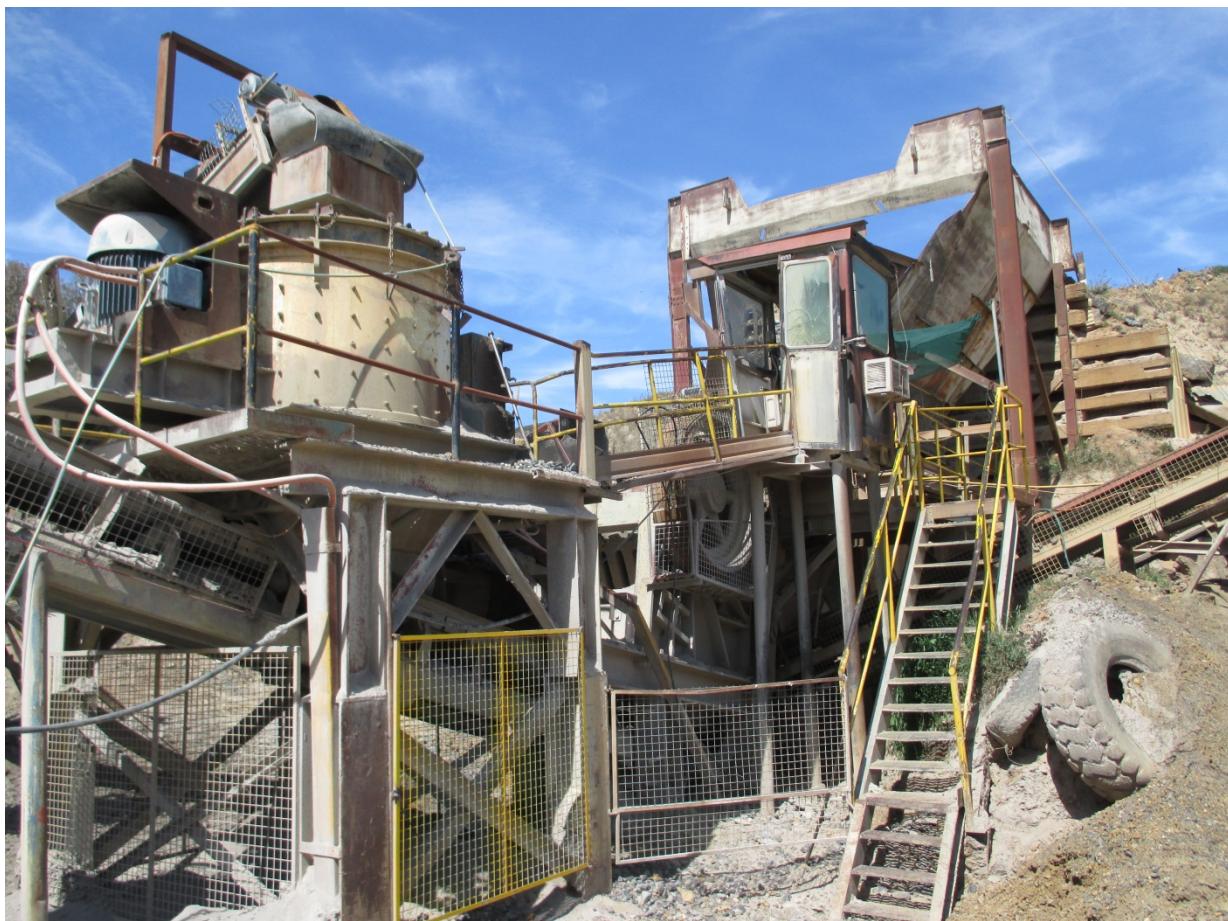
Image 1: Photograph of the quarry crushing plant taken by an investigator on 15 September 2014.

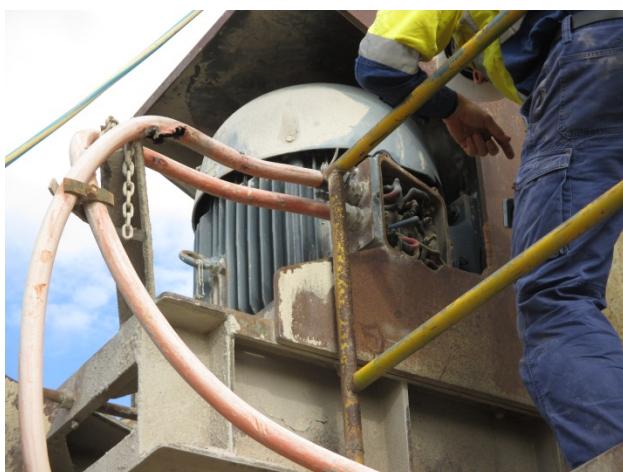
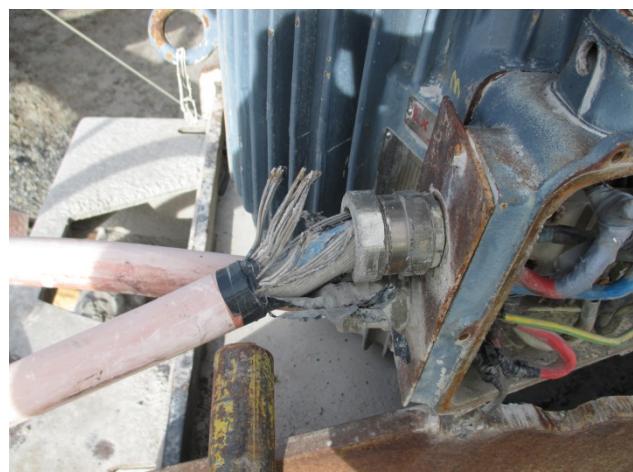
A phase to earth fault was identified on a motor supply cable. The protective insulation was damaged inside the motor terminal box and there was evidence of arcing and high temperature damage to a motor supply cable at a metal support arm near the terminal box.

Image 2 & 3: Photographs of the crushing plant motor power supply taken by an investigator on 15 September 2014.

The method of support for the motor cables, including a cable clamping bracket, had not adequately supported the weight of the cable. This resulted in damage to the cable where the cable passed over a metal bracket.

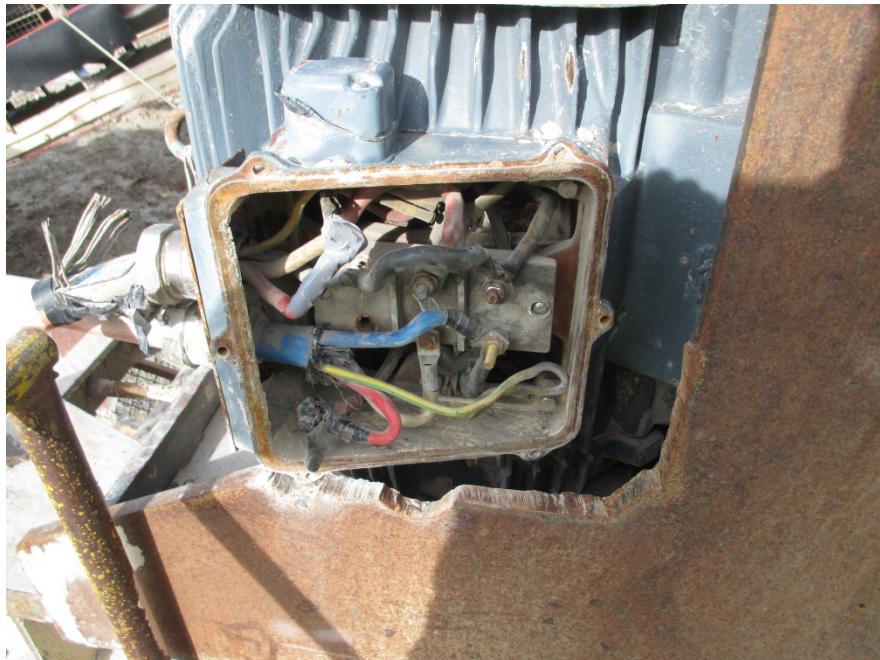
Image 4: Photograph of the crushing plant motor terminal box wiring taken by an investigator on 15 September 2014.

One of the cables to the crusher motor was not terminated correctly into the cable gland, allowing movement of the cable and resulting in damage to the insulation inside the motor termination box.

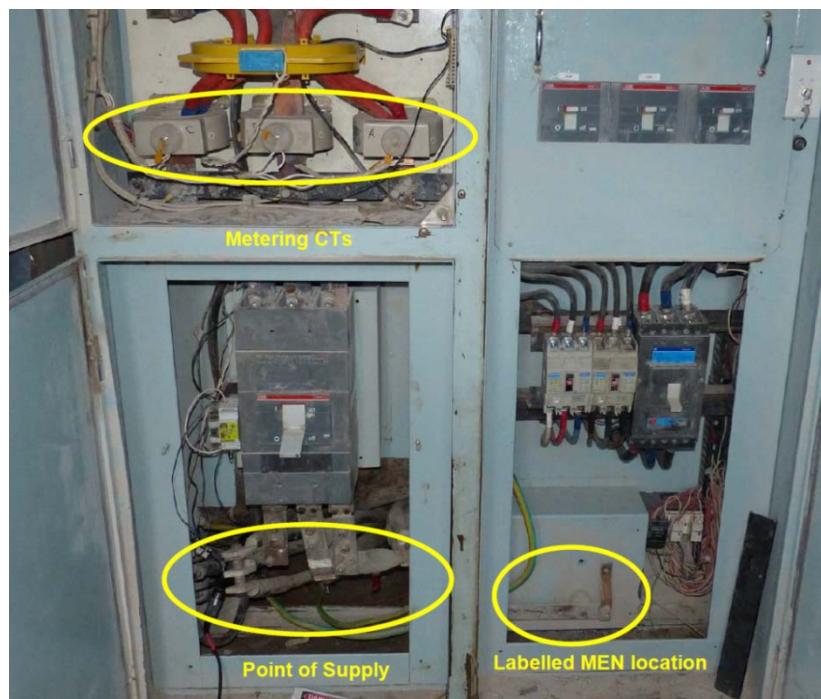
At the main switchboard, it was observed that no earth to neutral link (E-N link) was fitted. The absence of the E-N link at the main switchboard resulted in an increase in the earth fault loop impedance from the motor of the crushing plant to the supply transformer. This increased fault loop impedance resulted in a voltage rise on the neutral conductors throughout the quarry supply system during an electrical fault condition.

The earth leakage relay did not activate during the fault event.

Image 5: Photograph of the quarry main switchboard taken by investigating consultants.

Electrical installations at the surface of a mine are required to comply with AS/NZS 3000 (the wiring rules). The absence of the earth to neutral link at the quarry switchboard does not meet the requirements of the wiring rules for a MEN earthing system.
