# Investigation report

**Report into the death of Lee Peters at the Ridgeway Mine, Cadia, NSW on 6 September 2015**

Published by NSW Department of Industry, Skills and Regional Development, NSW Resources Regulator

**First published:** March 2017

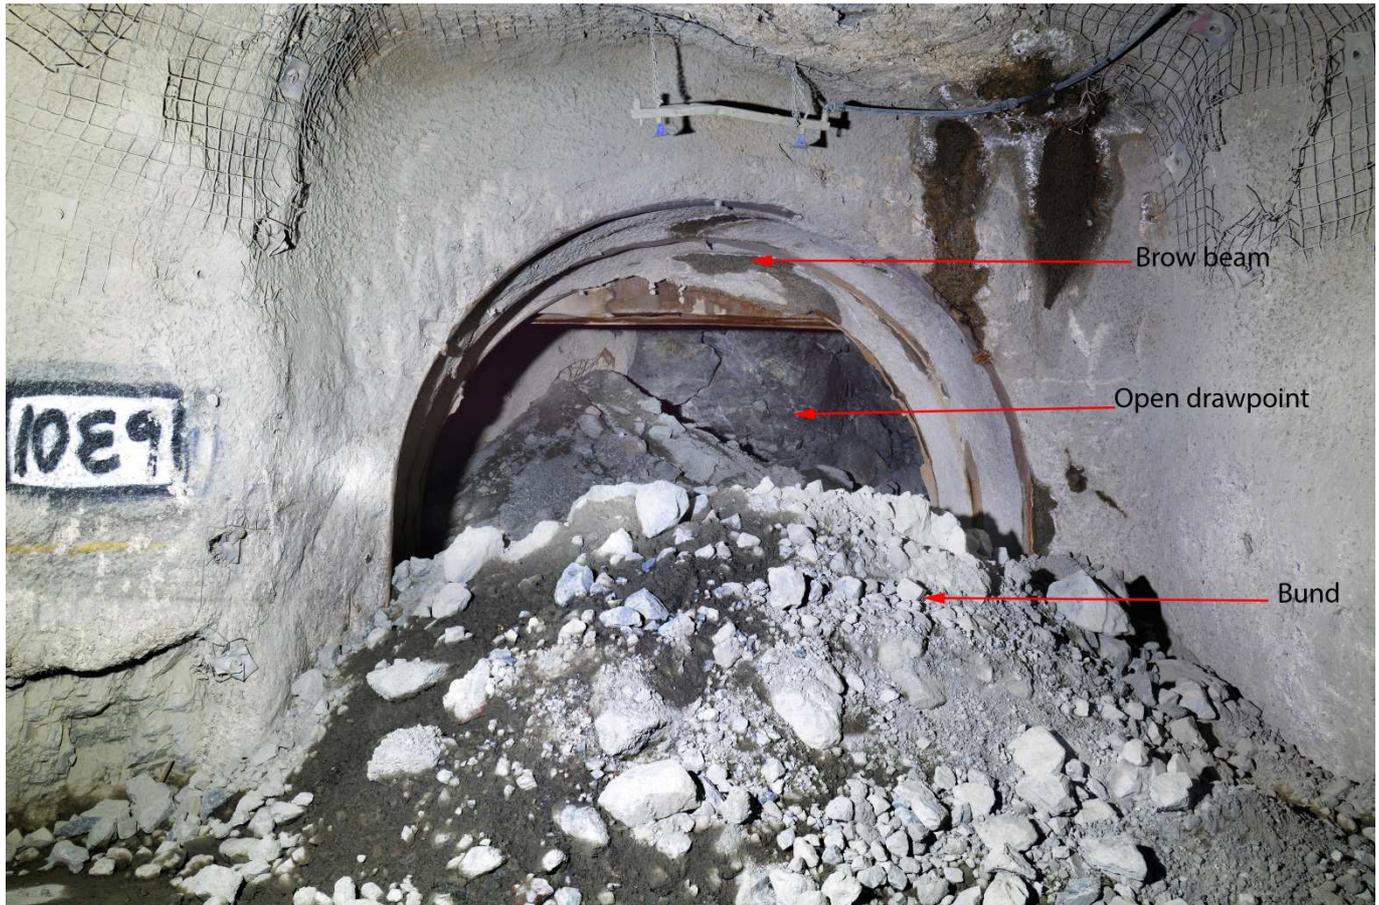
Figure 7 Photograph of 10E9 open, hung up draw point and bund.

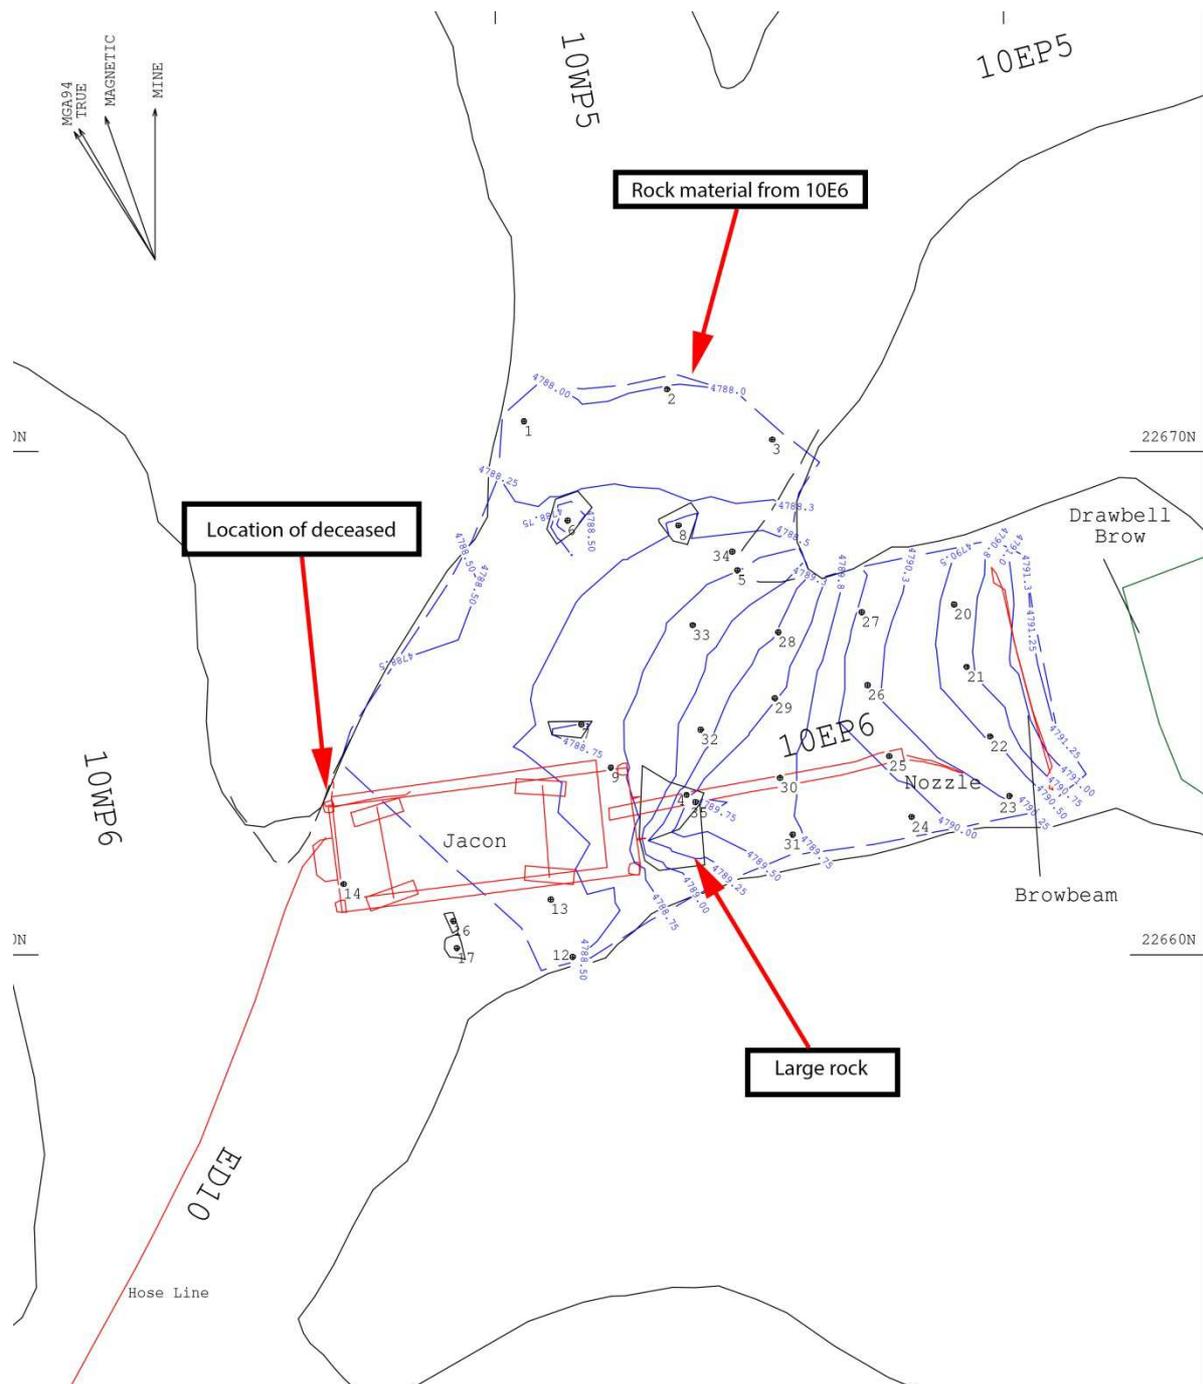
The incident scene is depicted in Figures 11 and 12. NML workers found Mr Peters trapped between the western sidewall of extraction drive 10 and the left hand rear corner of the water cannon. The water cannon was pushed out of the access drive to draw point 10E6 and into the sidewall of extraction drive 10 by a considerable volume of dry rock material (note, water present in photos is believed to have come from the water cannon operation). At the front of the water cannon lay a large rock (about 8 tonnes) which had made contact with the front of the water cannon. Broken rock materials had flowed out of the draw point and across the extraction drive (refer to Figures 11 and 12). Particle size distribution analysis revealed that approximately 50% of the material was less than 10 mm in diameter. Some larger rocks (approximately 500 mm – 1000 mm in diameter) were interspersed with this fine material. The total volume of material that flowed from the draw point was surveyed and calculated to be 95 cubic metres or approximately 260 tonnes. This calculation did not take into account rock material that may have been present in the form of a bund. If a bund was present at the time of the incident then the calculated volume would be less.

Figure 11 Incident location plan showing the locations of the deceased and the water cannon and the floor contours (at 0.25m intervals) after the inflow event. The blue contours indicate the depth of the material that has flowed from 10E6 draw point.

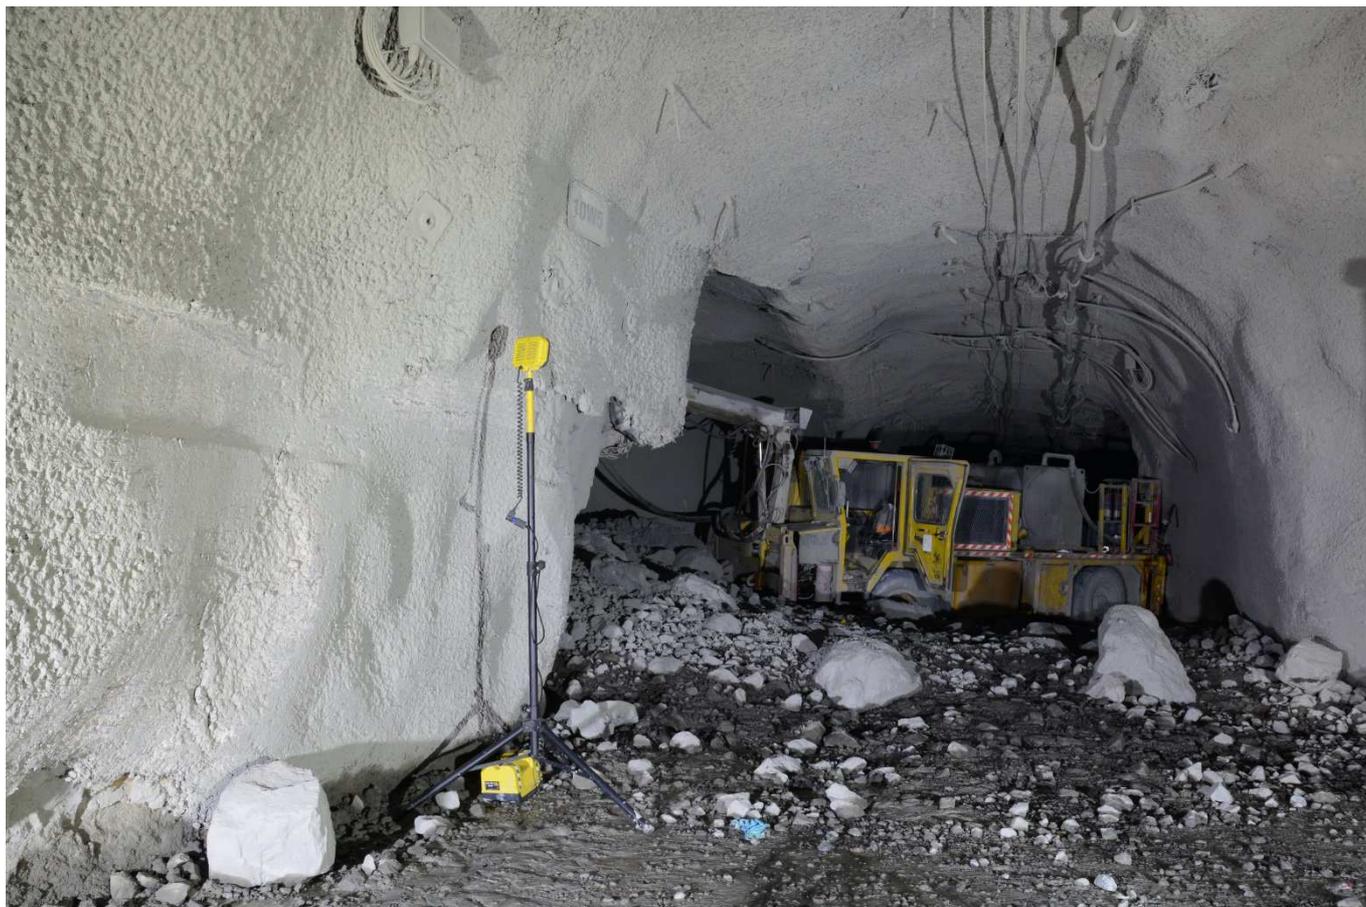
Figure 12 A photograph of the incident scene taken from the north side of draw point 6 in extraction drive 10, looking south (photograph by Department of Industry).

The water cannon will not function in water jetting mode unless the park brake is activated and the doors closed. Investigators noted that skid marks were visible on one rubber tyre and track marks were visible on the mine floor. This has led investigators to believe that the park brake was activated at the time of the incident. Investigators have also established that contrary to the safe working procedure for operating the machine (UGP-233), the front stabiliser jacks on the water cannon were not lowered at the time of the incident. Testing after the incident was unable to establish definitively if the machine would have had more resistance or less resistance to sliding when hit by the broken rock in the given conditions if the stabiliser legs were set. It is worth noting that the theoretical value for the coefficient of friction between metal and concrete is significantly less than between rubber and concrete. Functional testing of the water cannon confirmed that the park brake was operating as designed.

The other worker found Mr Peters fatally injured and trapped behind the water cannon at extraction drive 10E6 draw point. The incident scene depicted in Figure 12 shows the water cannon still in position; however Mr Peters has been recovered. Figure 11 identifies a plan of the scene and locates where Mr Peters was trapped.

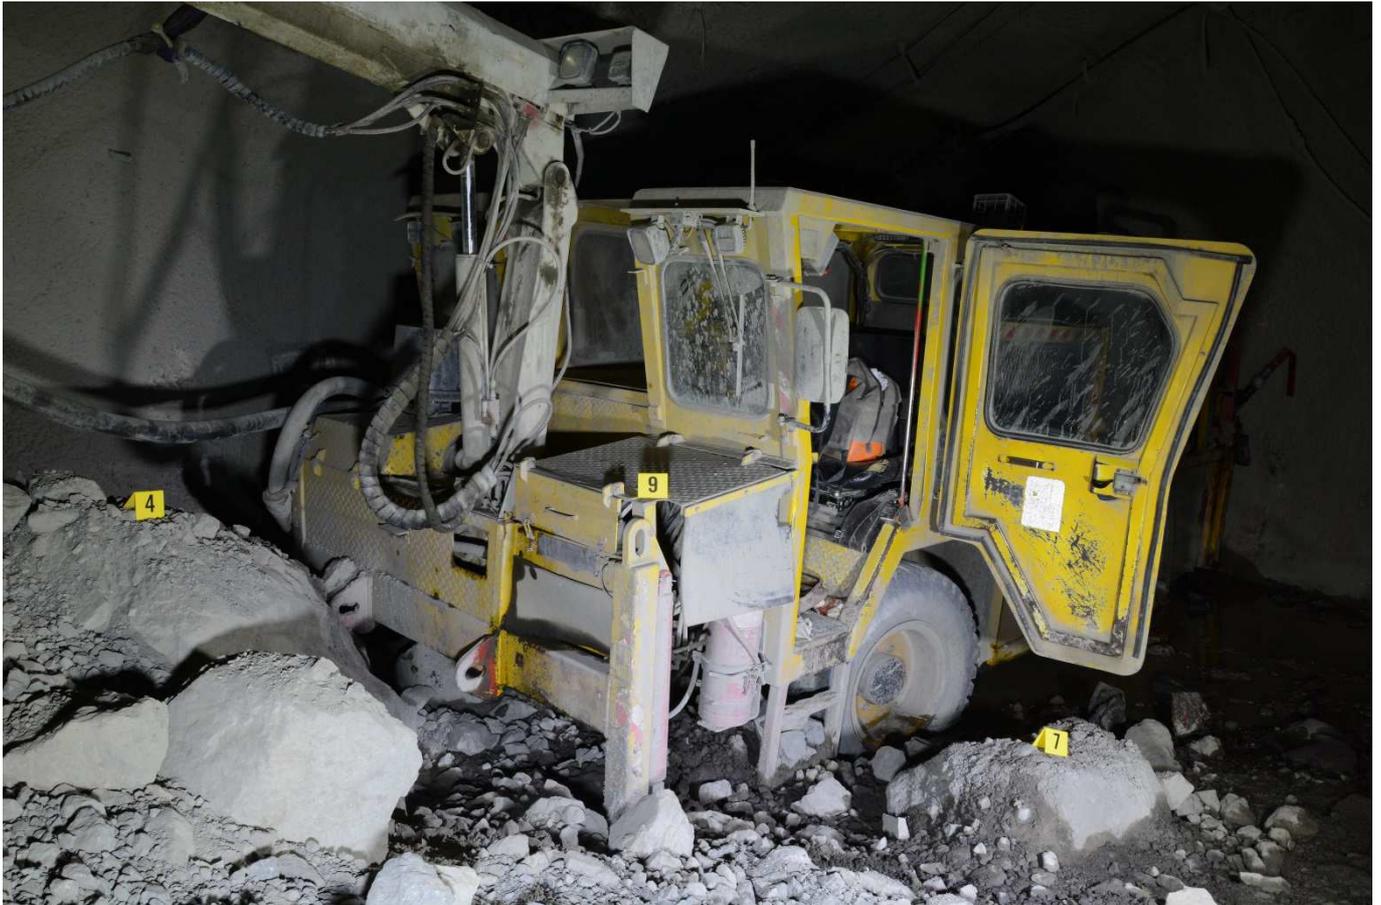
Figures 12, 13 and 14 depict photographs of the incident scene. The significant distance that the material flowed into the extraction drive roadway and down the drive beyond the corner of the pillar is noteworthy. It is also worth noting in figures 13 and 14 the large boulder that has made contact with the front of the water cannon (under place marker 4). This boulder weighed approximately 8 tonnes and was identified as resting on the concrete floor. Interspersed with the fine rill material were larger rocks that encroached on the operators working zone (visible in figure 11) and travelled the entire way to the western (opposite) sidewall.

Figure 13 The water cannon with a large boulder contacting the front of the machine (under place marker 4).

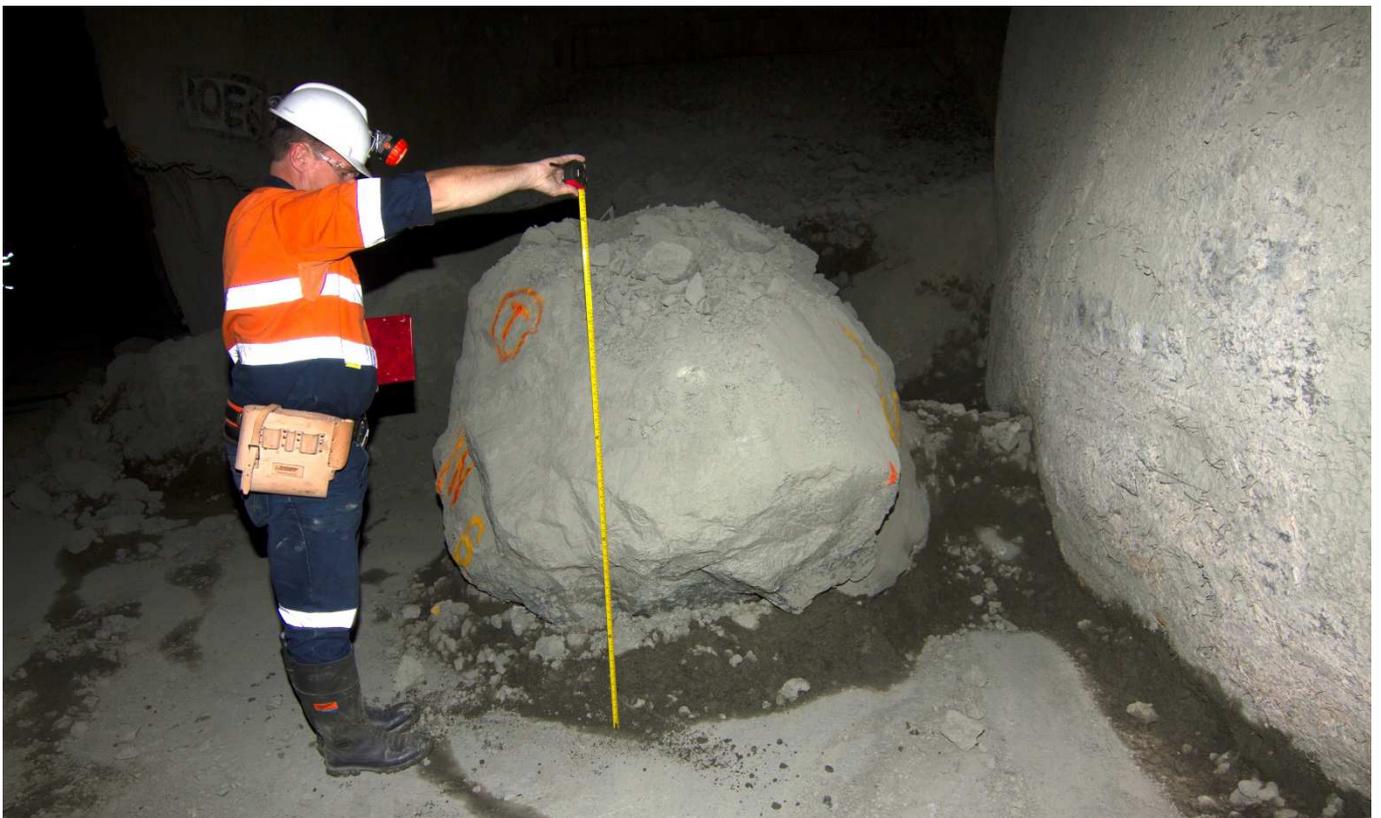
Figure 14 Photograph of a large rock that was contacting the front of the water cannon after excavating around it.

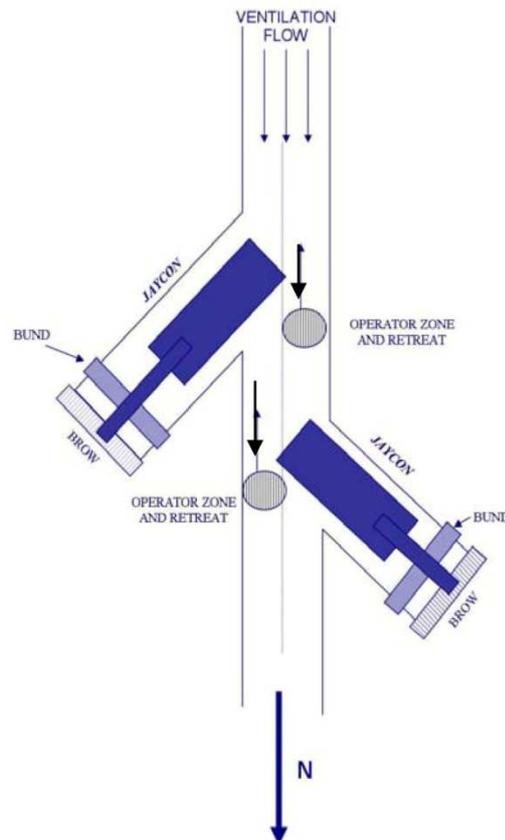
Figure 16: Diagram from *Safe Work Procedure UGP-233 Operate Jacon Maxijet Water Cannon* illustrating where the water cannon operator was to stand and retreat when a hang up was being washed.

Reference to Figure 16 shows that the designated operating position is not consistent with that described in the text of the safe work procedure. Rather, the operating position is shown on the opposite side of the extraction drive, immediately adjacent to the rear end of the water cannon that was closest to the sidewall of the extraction drive. This corresponds to the location in which Mr Peters was crushed.

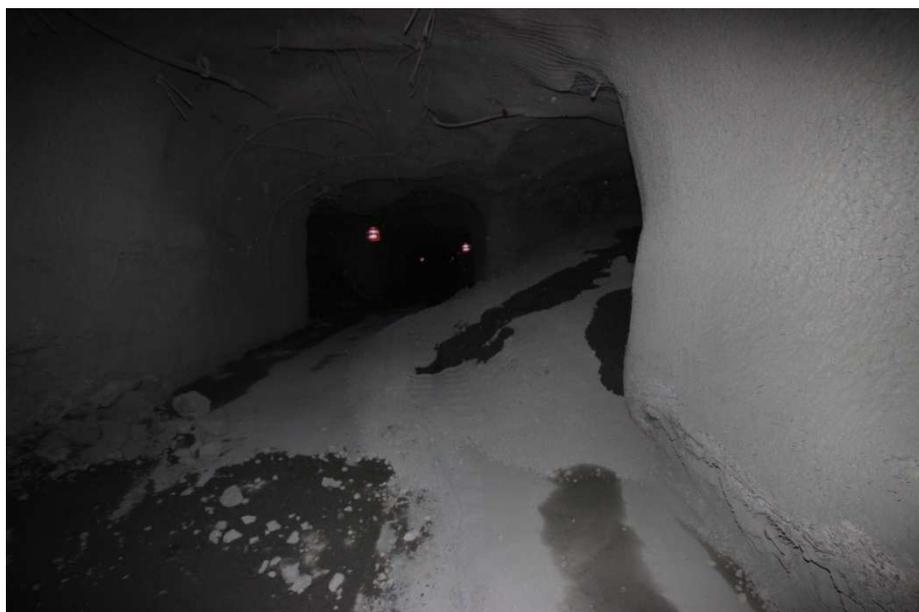
Figure 17 and 18 show examples of uncontrolled inflows of material from draw points at Ridgeway Mine. Dry material was associated with the inflow shown in Figure 17 and wet material with that shown in Figure 18.

Figure 17 An uncontrolled inflow of dry material at draw point in extraction drive 11 (note water visible in rill pile is from dust suppression sprays).

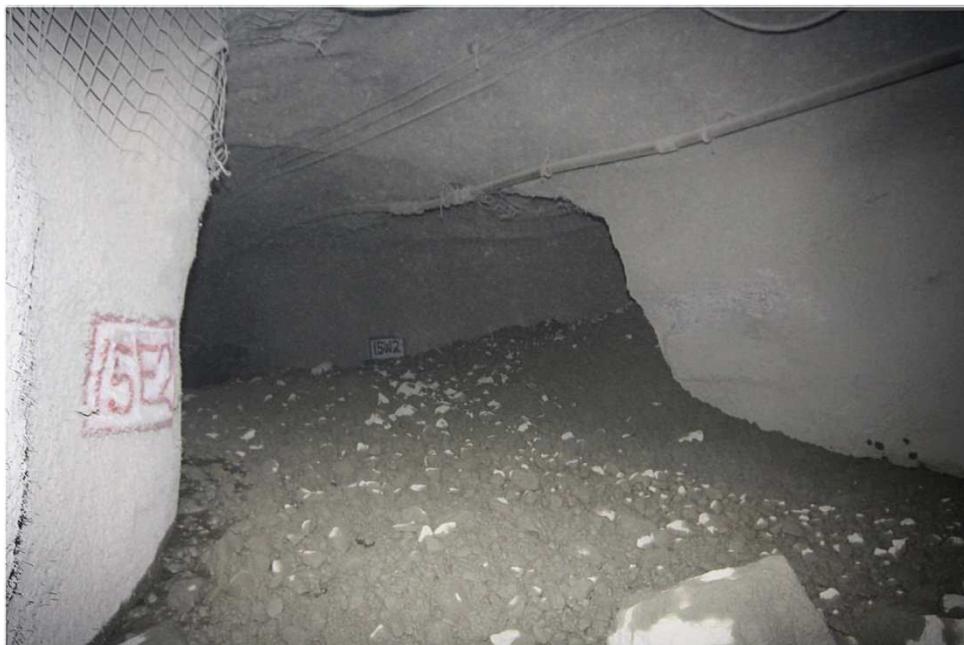
Figure 18 An uncontrolled inflow of wet material at a draw point in extraction drive 15 in August 2015.

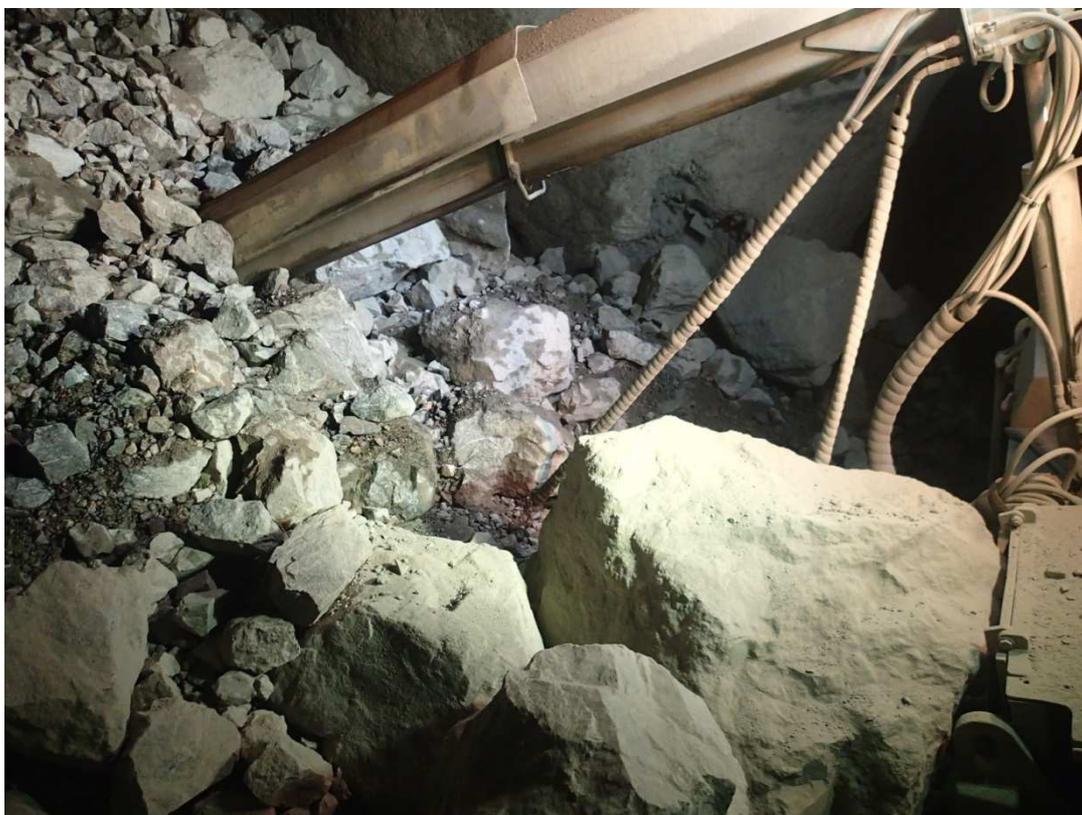
Figure 19 A photograph of another incident involving the water cannon XT008 on 22 August 2015. Note the large rock making contact with the front of the water cannon

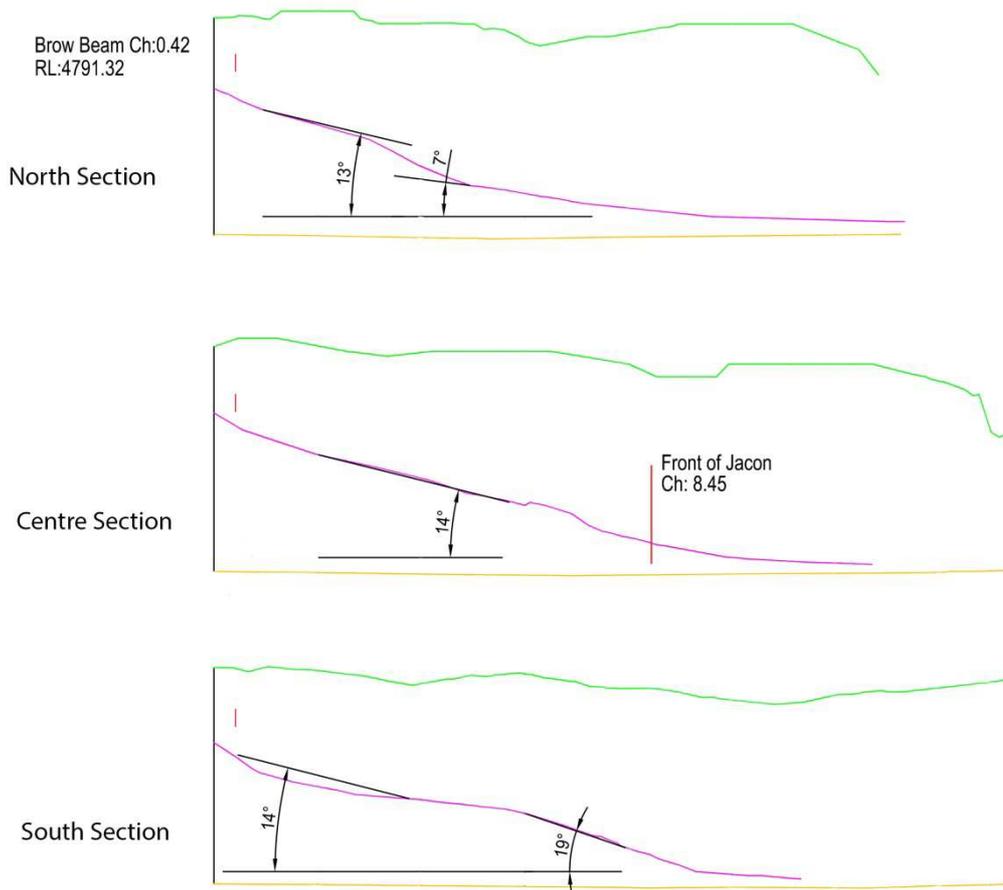
Figure 11 shows the floor contours at 10E6 as measured by CVO staff after the incident. This figure forms the basis for Figure 21, which shows vertical profiles through the rill (muck pile), down the centreline and between the mine walls.

Figure 21: Vertical section showing angle of rill at 10E6 after the incident.

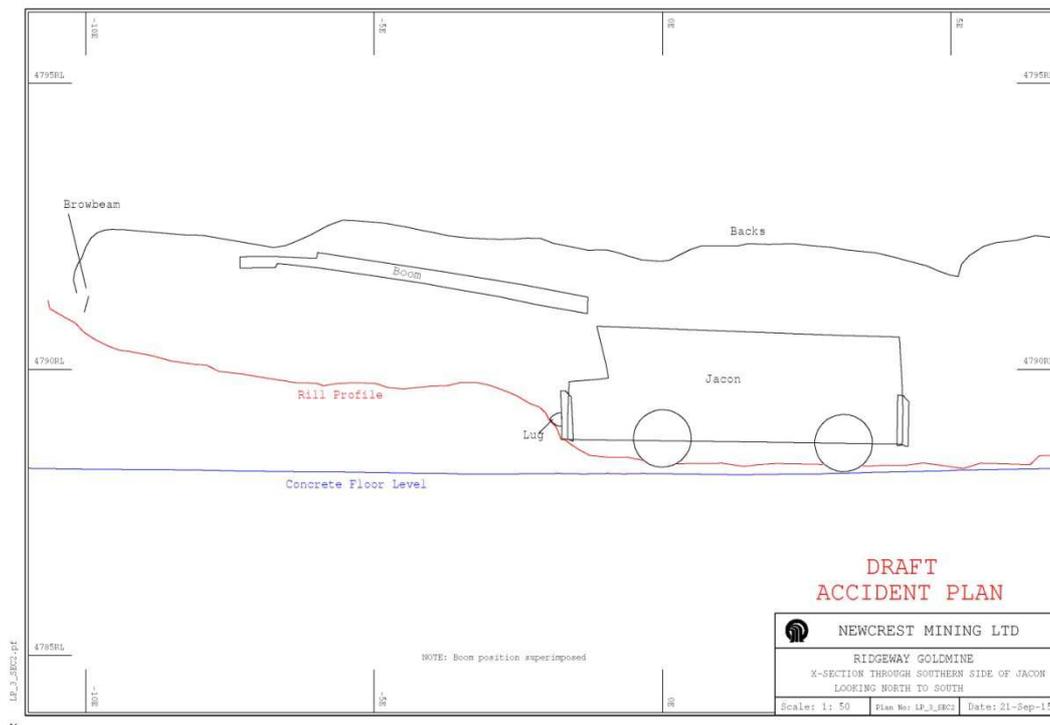
Survey data shows that the overall angle of repose of the inflow material ranged from between 7° and 19°. However, the rill towards and along the southern mine wall was characterised by an extended and relatively flat section, as particularly apparent in Figure 22. These angles of repose compare to that of 30° recorded in the pre incident chronology for draw point 5E1 and 37° used in the numerical modelling conducted in 2011 to determine bund size and location.

Figure 22: Cross-section through southern side of Jacon, looking north to south.

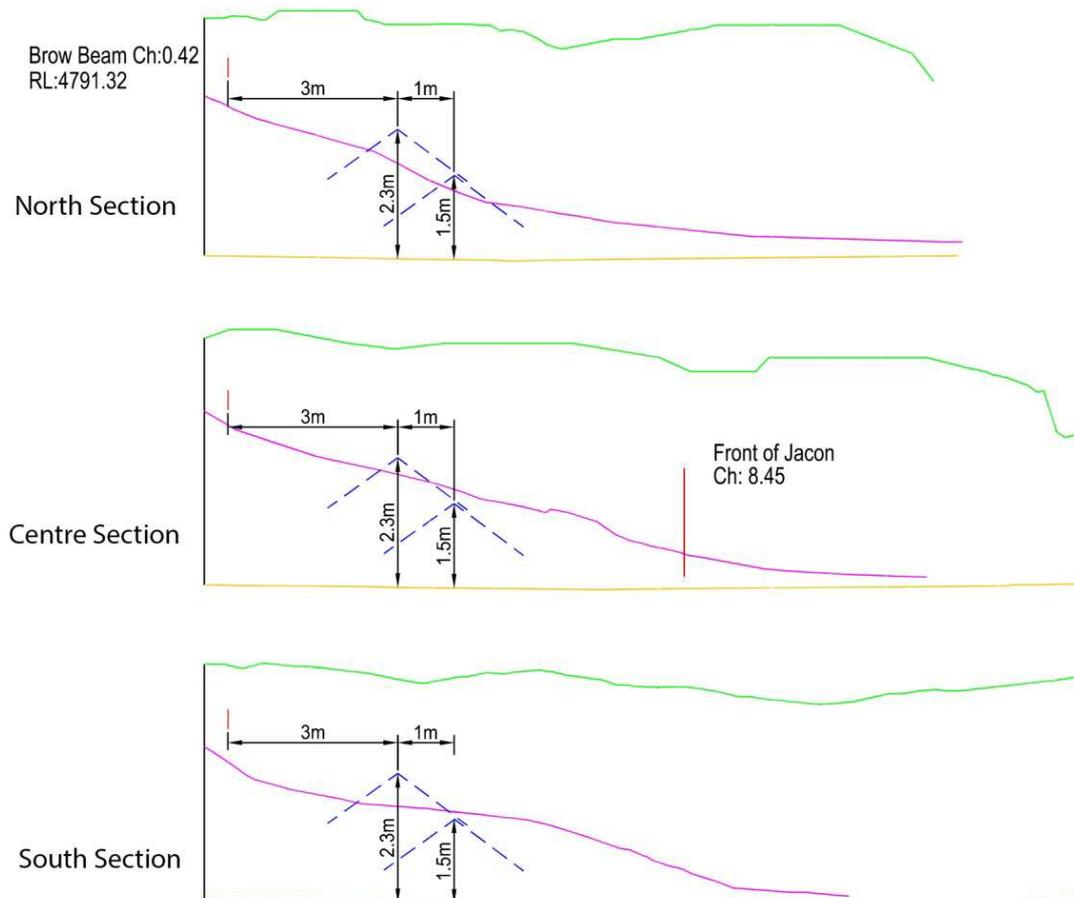
Figure 23: Vertical sections showing the locations and sizes of bunds if bunds had been constructed to the specifications given in Figure 15.
