## Week ending 24 January 2018

This incident summary provides information on reportable incidents and safety advice for the NSW mining industry. To report an incident to the NSW Resources Regulator: phone 1300 814 609 24 hours a day, 7 days a week.

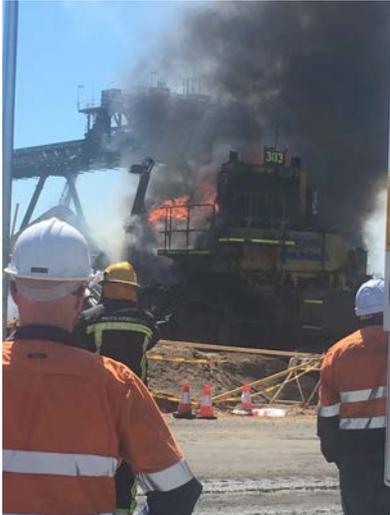
Incident type	Summary	Recommendations to industry
Dangerous incident SinNot-2018/00100	<p>A fire occurred on a dozer. The operator saw smoke coming from in front of the radiator. The operator stopped the machine, called emergency, initiated the fire suppression system and exited the machine. The fire was extinguished about an hour later with help from a water cart.</p>

This incident is currently being investigated by the Resources Regulator.
