INVESTIGATION INFORMATION RELEASE

Worker injured releasing jammed conveyor chain

Incident date: 5 February 2019

Location: Springvale Colliery, Lithgow, NSW

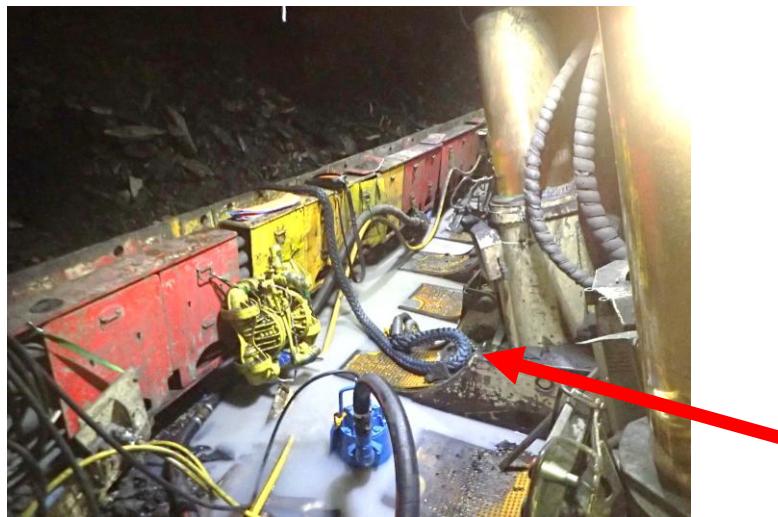
A shearer operator was injured in the process of releasing a jammed armoured face conveyor (AFC) chain using the shearer on a longwall. The injury occurred when an eight-tonne working load limit (WLL) Rud link, located on the shearer ranging arm, failed due to overload. The shearer operator was hit on the leg by recoiling components of the tow rope assembly when the Rud link failed. The worker was in the roof support walkway at the maingate end of the longwall, approximately 22 metres (15 roof supports) from the failed connection point on the shearer.

Figure 1: Location of worker struck by the recoiling shackle and blue Amsteel® rope

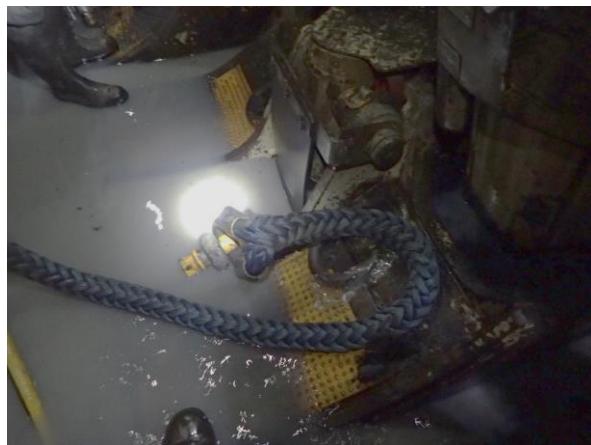
Shortly after the load was applied to the towing assembly by the shearer, the Rud link failed, the bow shackle and rope recoiled back towards the three workers located at the maingate. The bow shackle struck the shearer operator on the lower right leg. The connection point on the shearer was located approximately 22metres (15 roof supports) from where the injured shearer operator was located.

Figure 2: The 35t WLL bow shackle and blue Amsteel® rope on the roof support pontoon

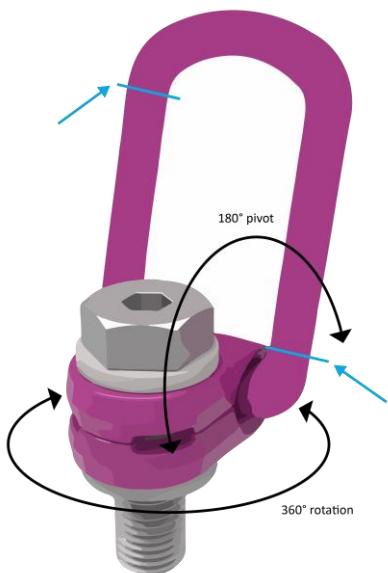
- The Rud link was as Rud VLBG, 8t lifting capacity with an M36 Property class 10.9 bolt.
- The Rud link had fractured transversely at two diagonally opposite corners. (refer figures 3 & 4)

Figure 3: Similar Rud bolt on lifting point. Location of fracture indicated by blue arrows

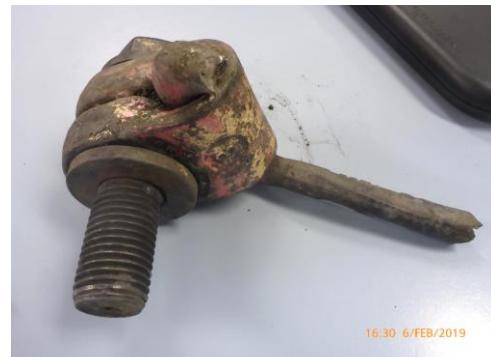
- Both fractures exhibited overload fracture over the entire fracture surface. There was no evidence of fatigue or other pre-existing cracks on either fracture surface.

Figure 4: The failed incident 8t Rud link (source NSW Resources Regulator)

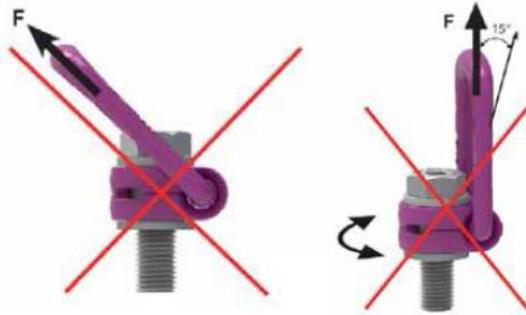
- The bolt on lifting point assembly was designed to rotate about the bolt as well as the lug to pivot through 180°. However, the OEM recommends that the lifting lug not be pivoted back over the bolt and clamp assembly or that the assembly not be rotated while loading in a direction parallel to the bolt axis. (refer figure 6)

Figure 6: Lifting configurations not recommended by Rud
 (source Rud website)
