**COMPLIANCE AUDIT PROGRAM**

# **GLENELLA QUARRY**

Glenella Quarry Pty Ltd

Title: Compliance Audit Program: Glenella Quarry, Glenella Quarry Pty Ltd

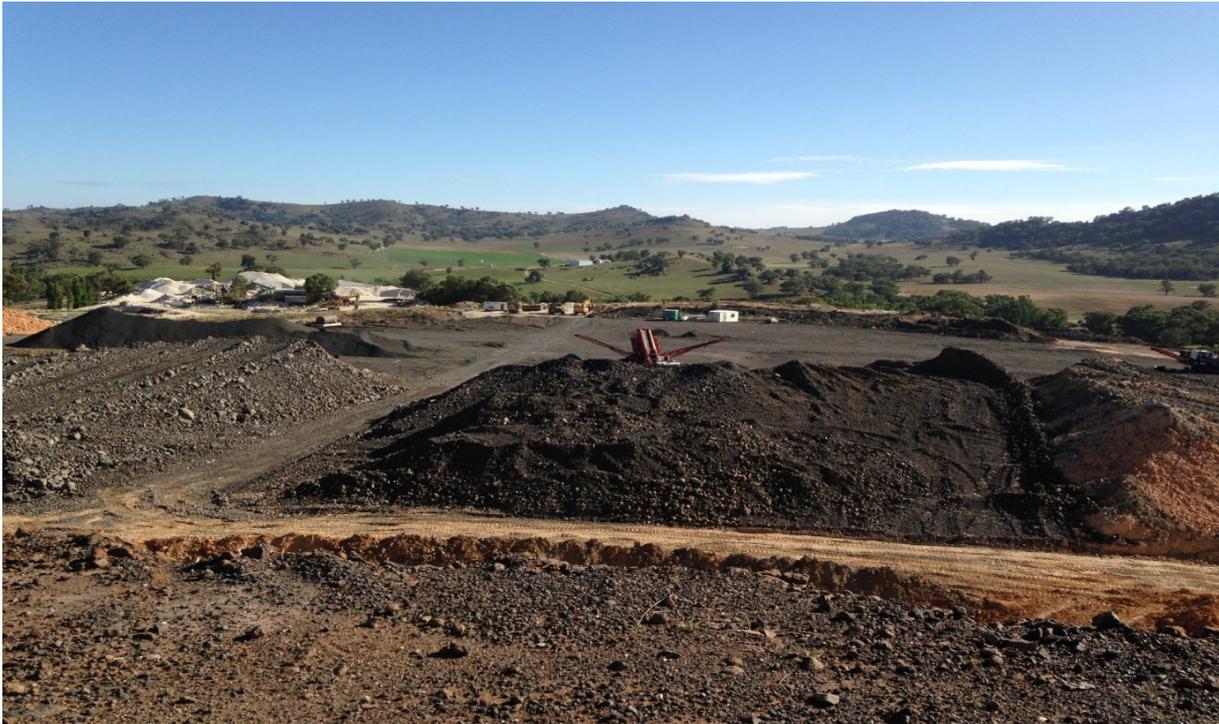
*Figure 1 View across the operation (facing north)*

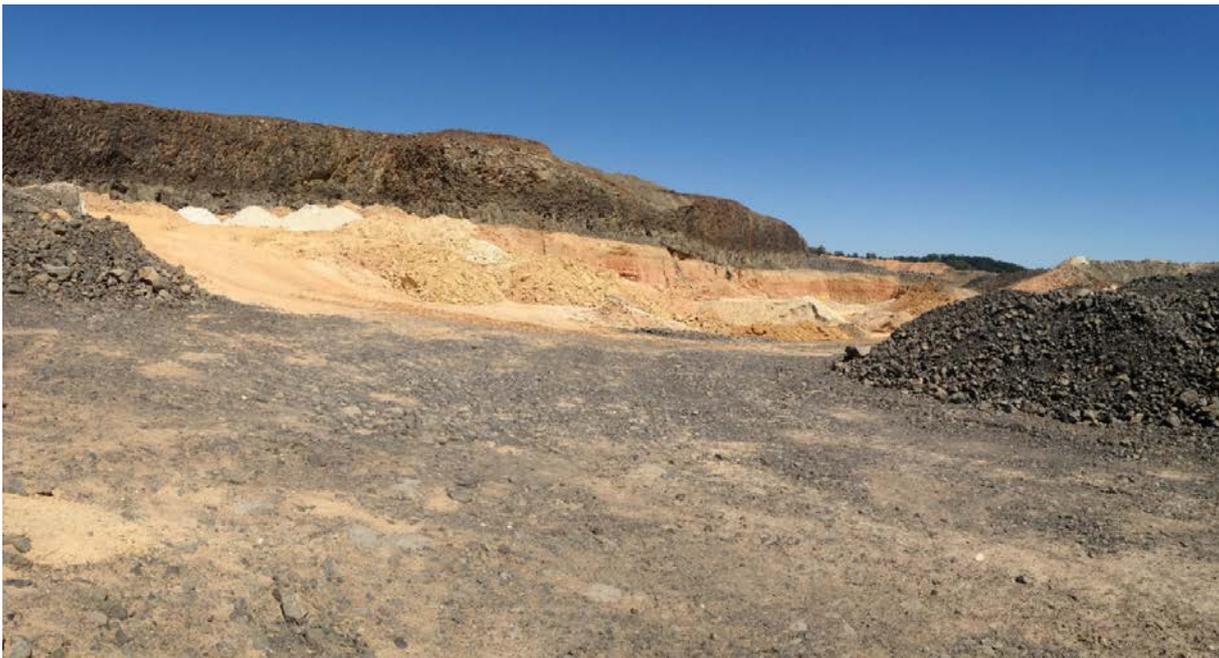
*Figure 2 Quarry pit floor (facing south)*

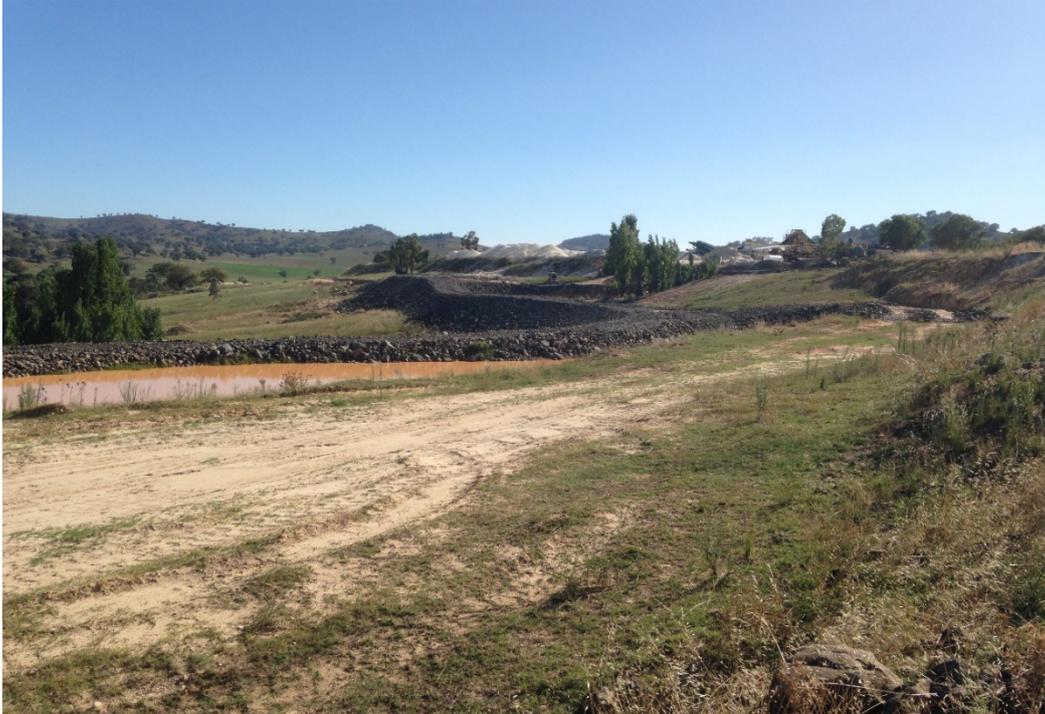
*Figure 3 Example 1 of water management structures (western edge facing north)*

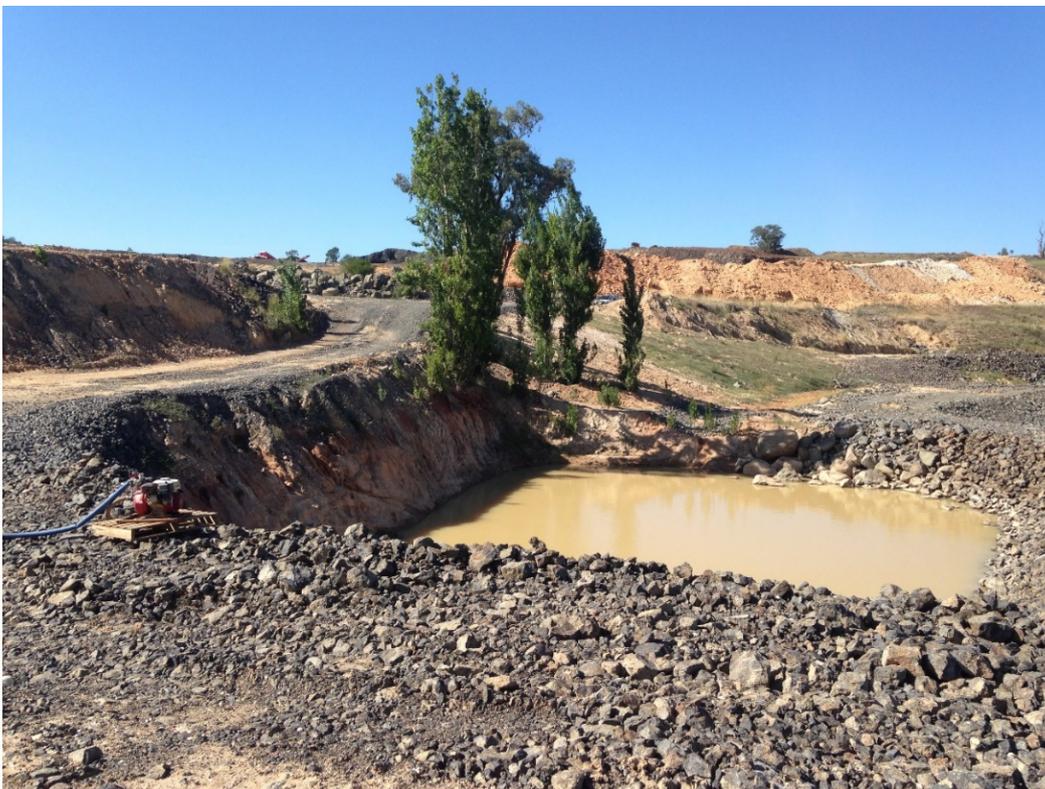
While water/run-off and erosion and sedimentation are generally well managed across the site (refer to figures 4 and 5), there is an exception. At the northern end of the site, there is evidence of erosion

*Figure 4 Example 2 of water management structures (western edge facing south)*

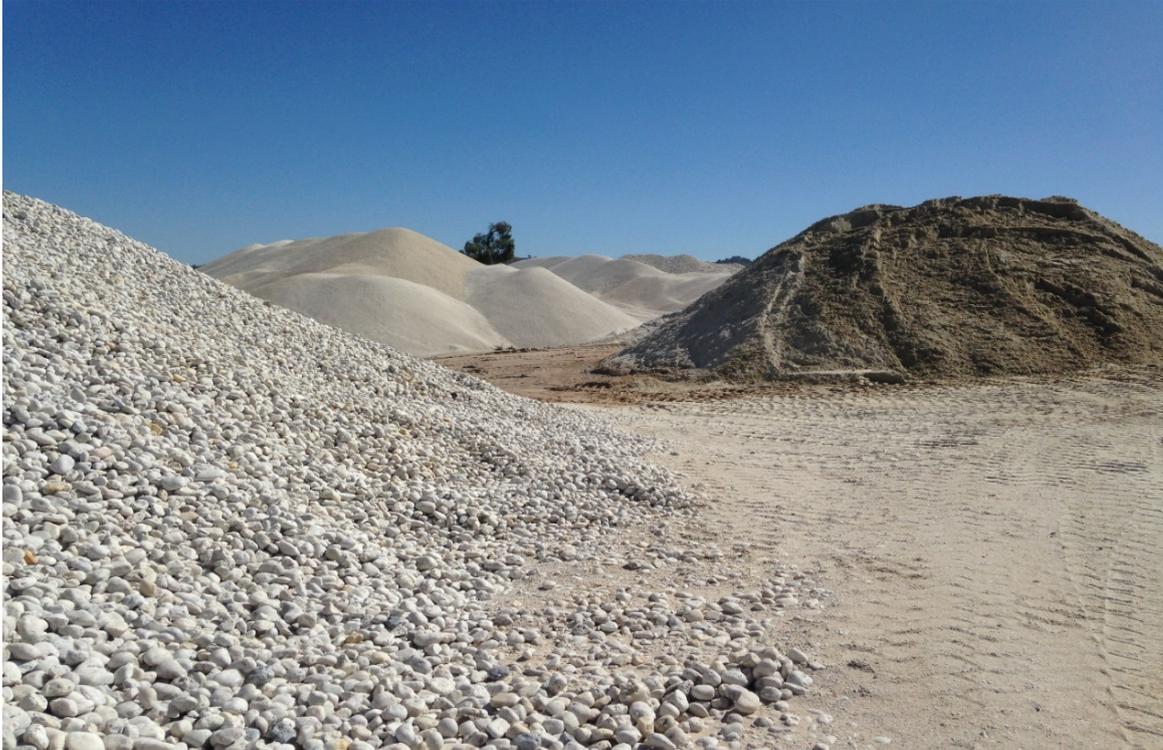
*Figure 5 Stockpile management*

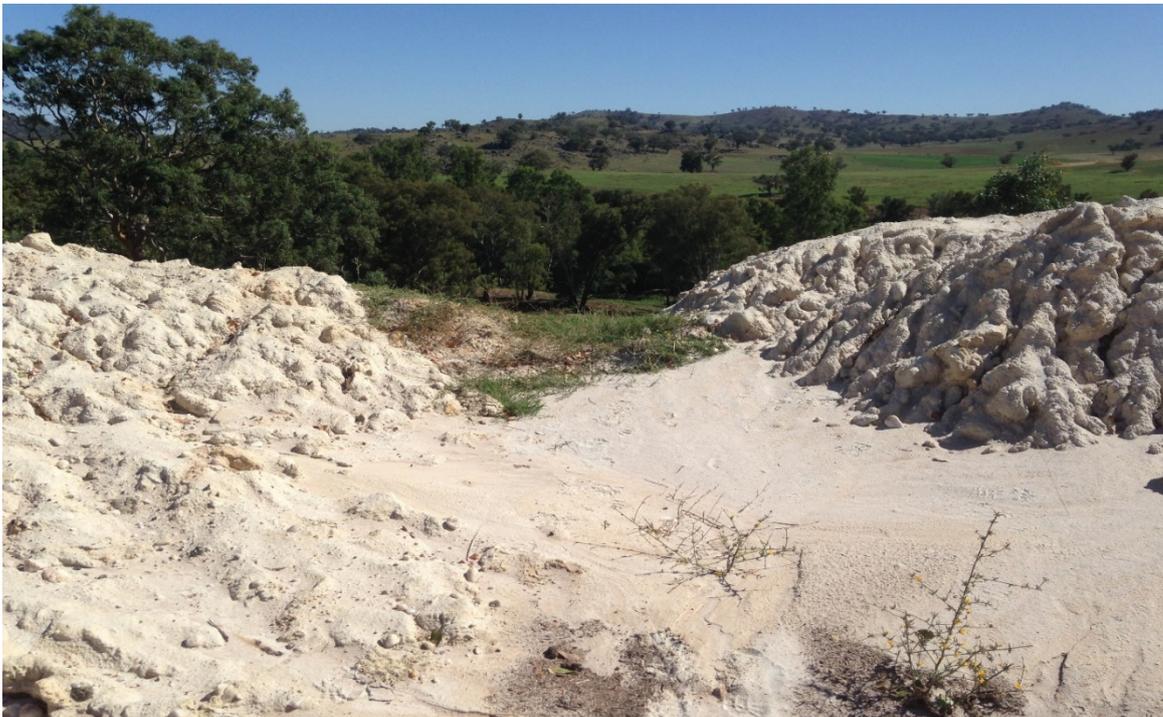
having occurred because of poor management. This was raised as **non-compliance No. 1** ranked **NC2**. It is noted that while erosion has occurred in this area (refer to figures 6, 7 and 8), and there is evidence of some movement of sedimentation downhill from the northern edge of the disturbed area of the site, sedimentation has not travelled far and there is little to no risk of movement outside of ML1692.

*Figure 6 Erosion on northern edge of disturbed area (facing north)*

It is noted that this was previously identified by the Regulator, which in turn reported the matter to the Environmental Protection Authority (EPA). The company is working with both the Regulator and the EPA, including the development of a pollution reduction program for the EPA, and a MOP amendment to include relevant measures for more effective erosion and sedimentation management.

NON- CONFORMANCE NO.	DESCRIPTION OF ISSUE	RECOMMENDATION
<b>ML1692</b>		
<b>1 (NC2)</b>	<p>Obligation</p> <p>Condition 2 of ML1692 requires that the titleholder must implement all practicable measures to prevent and/or minimise any harm to the environment that may result from the construction, operation or rehabilitation activities under the ML.</p> <p>For the purposes of this condition: environment means ‘components of the earth, including: land, air and water’</p> <p>Finding</p> <p>There is evidence of erosion in various locations on the site, but there is no evidence of any issues off title because of erosion. The issue has previously been identified and reported to the EPA. This has resulted in the requiring a pollution reduction program (PRP) to be developed by the company.</p> <p>The PRP and the erosion issues are being progressively managed by the company in conjunction with the Regulator and the EPA.</p> <p>The company has committed to a modified MOP to incorporate pollution management measures resulting from erosion.</p>	<p>Continue to work with the Regulator and the EPA to achieve the best measures to prevent and/or minimise any harm to the environment.</p> <p>Ensure that the modified MOP captures relevant aspects of these measures and the PRP.</p>

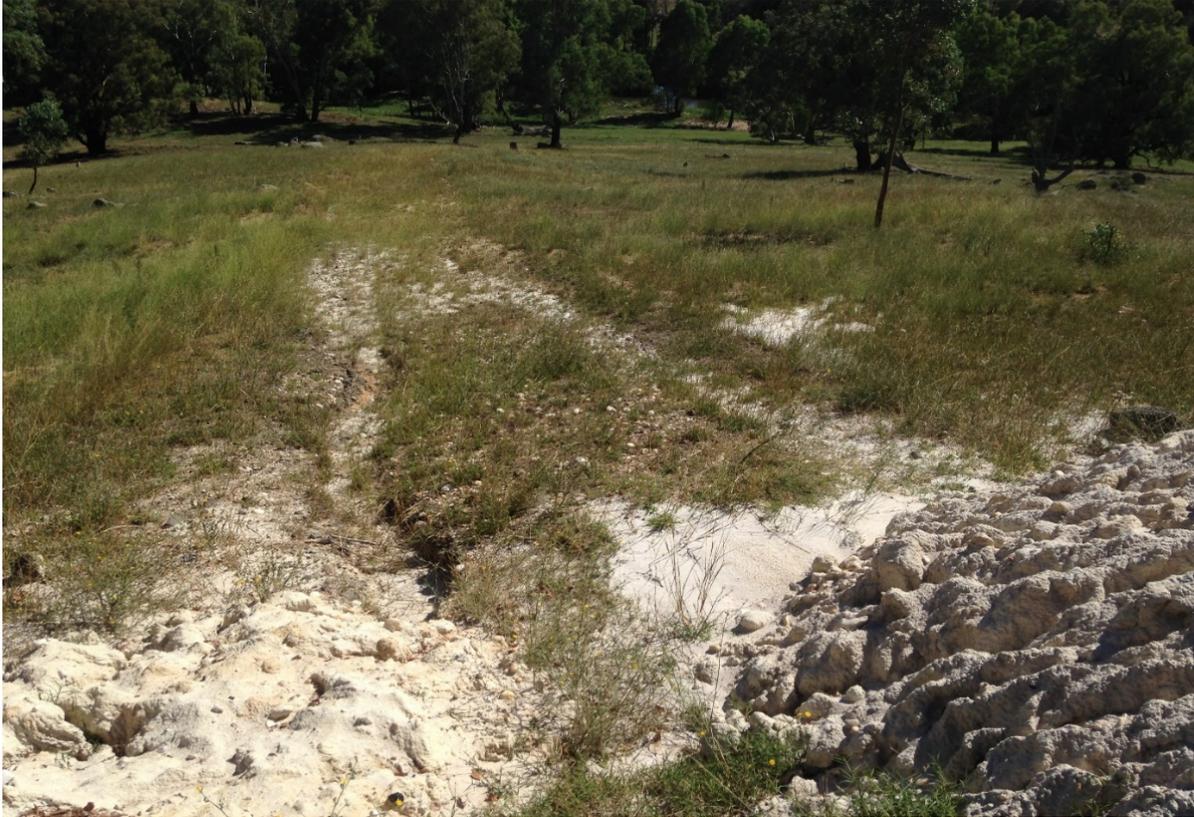
*Figure 7 Erosion – no evidence of pollution off site (facing north)*

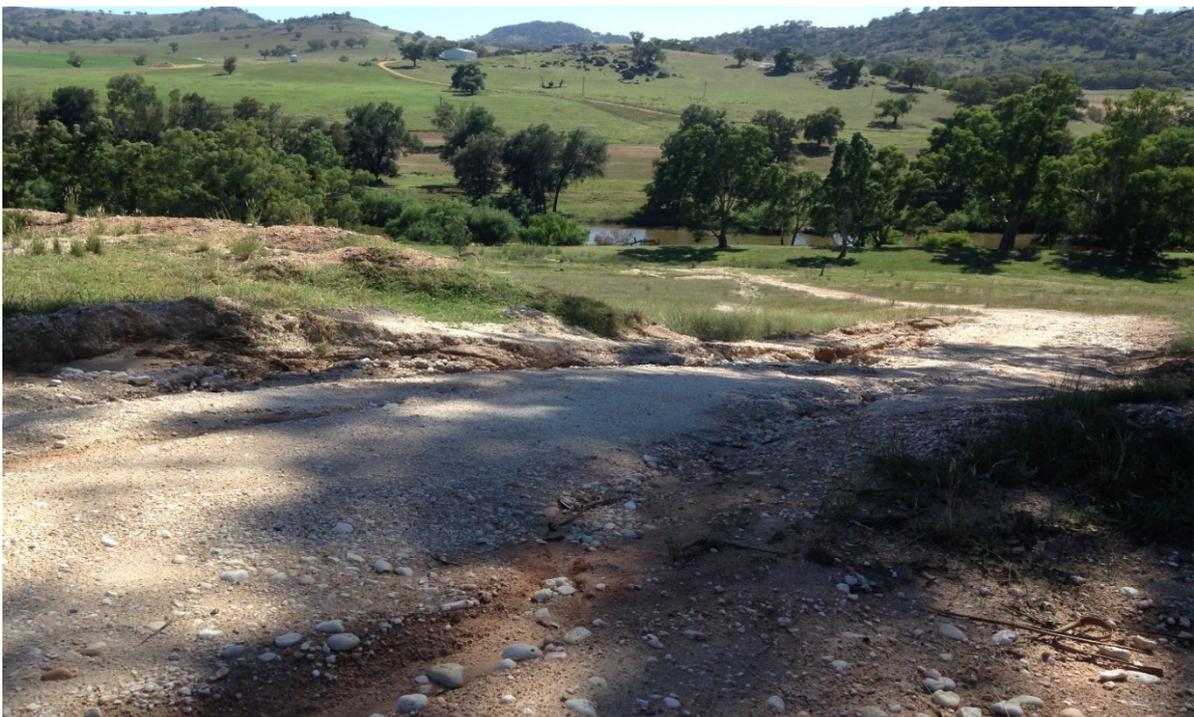
*Figure 8 Erosion on road on northern edge of disturbed area (facing north)*

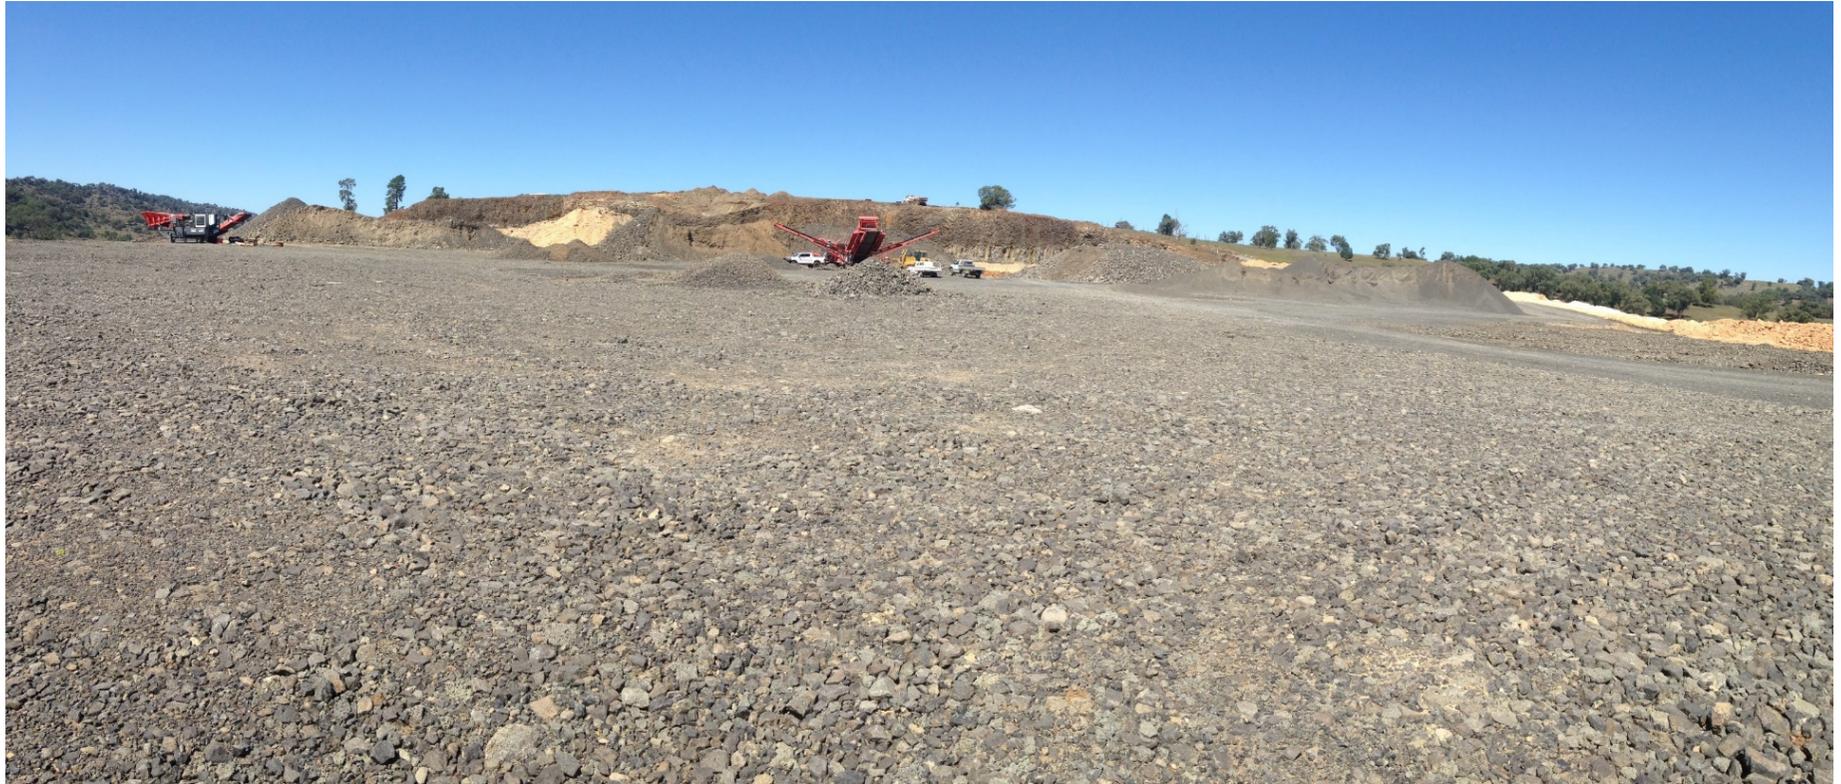
The quarry is operational with most areas still in use, so there has been limited rehabilitation on site. As extraction across the quarry progresses, so does the backfilling of voids and the levelling and compacting of areas to progress towards the proposed rehabilitation in the MOP (refer to figure 9).

*Figure 9 Progressive backfill on quarry floor*

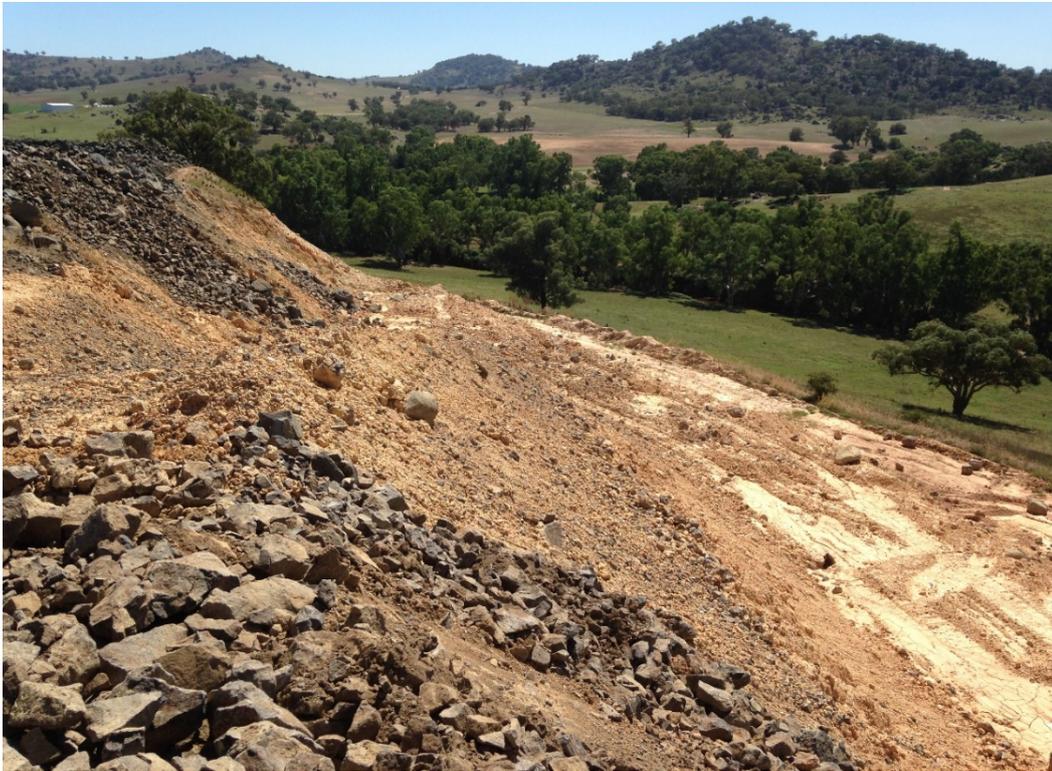
During the site inspection, it was noted that an area of 2 hectares, on the eastern side of the disturbed area of the quarry, is expected to reach final stabilisation as part of rehabilitation by the end of February 2019 (dependent on weather). Establishment of vegetation in this area will begin as soon as possible following earthworks. Rehabilitation works in this area is ahead of the timeframe for rehabilitation in this area according to the MOP. This area of rehabilitation is not being required for completion until the completion of the MOP in 2022 (refer to photographs 10 and 11).

*Figure 10 Rehabilitation on eastern side of operation (facing north)*

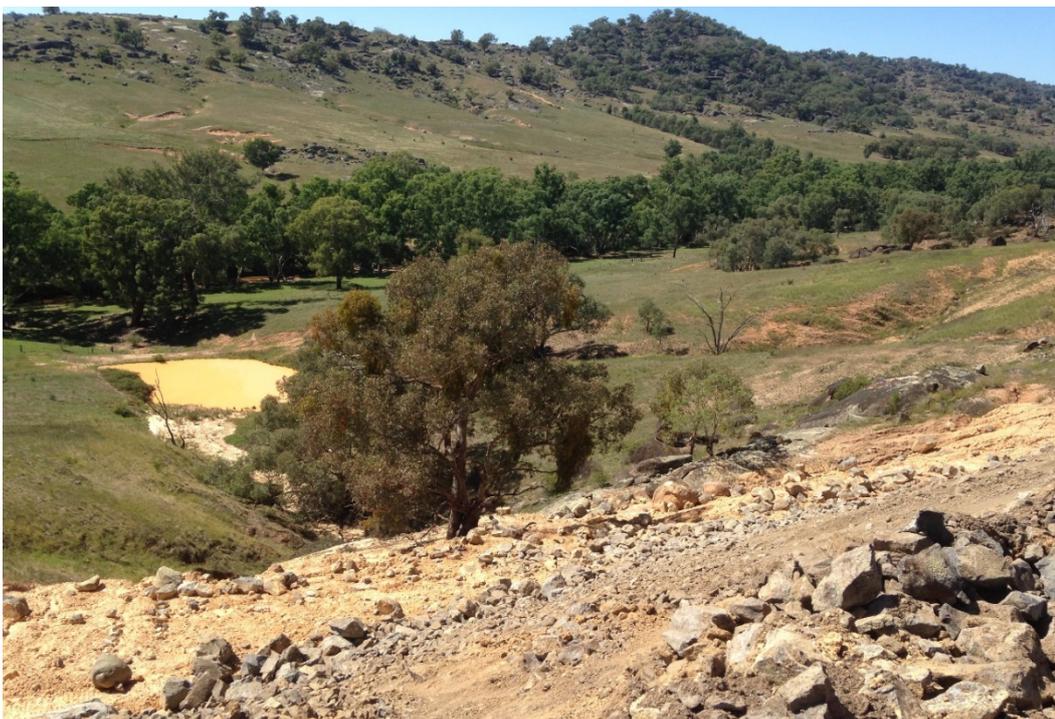
*Figure 11 Rehabilitation on eastern side of operation (facing east)*

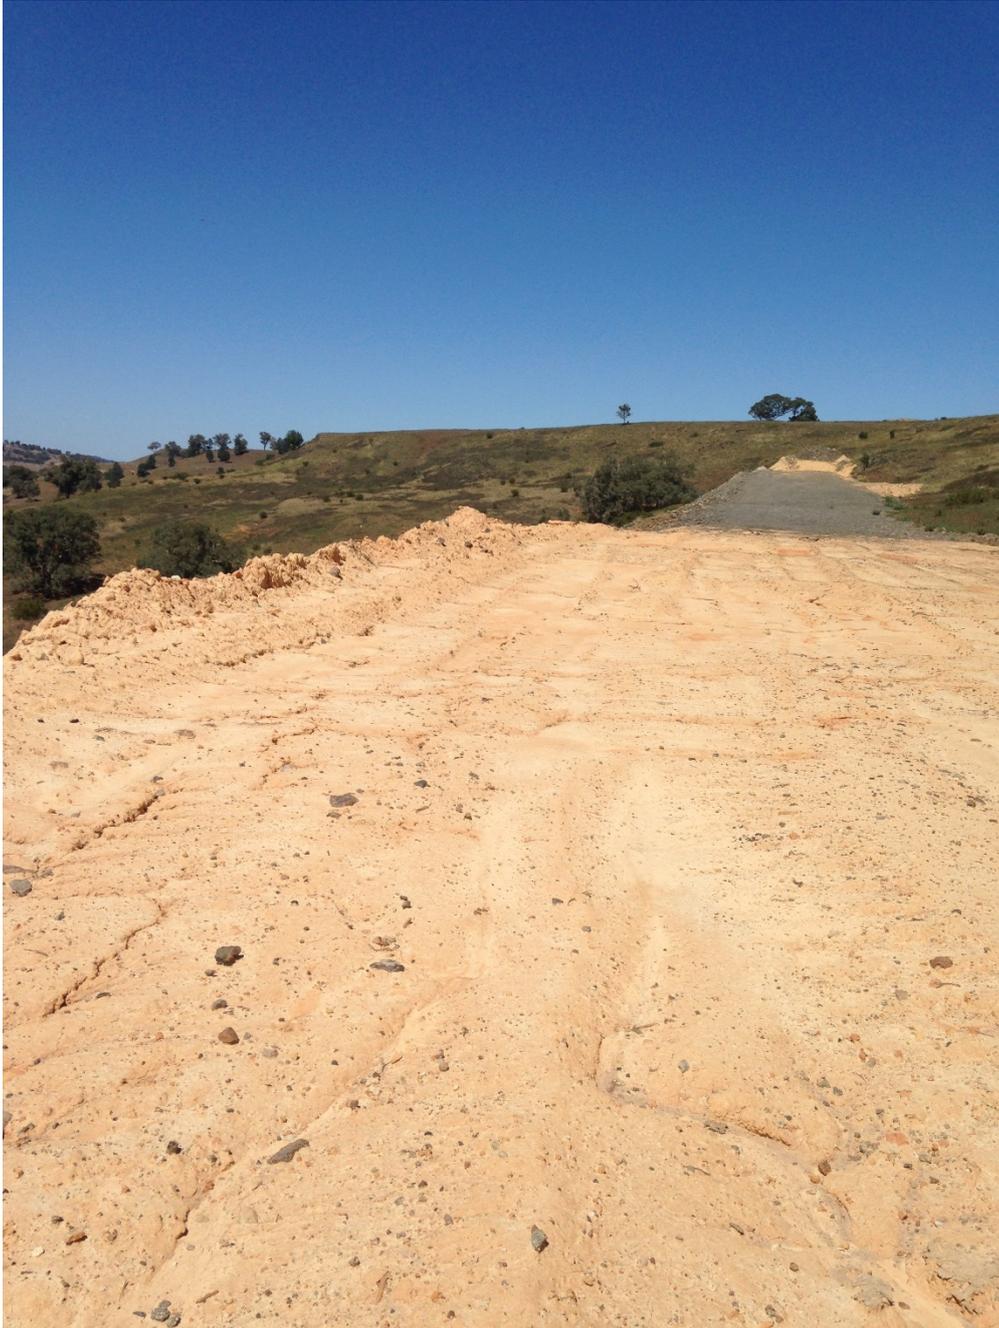
*Figure 12 New exit road on eastern side of operation (facing south)*
