WEEKLY INCIDENT SUMMARY

Week ending 12 April 2019

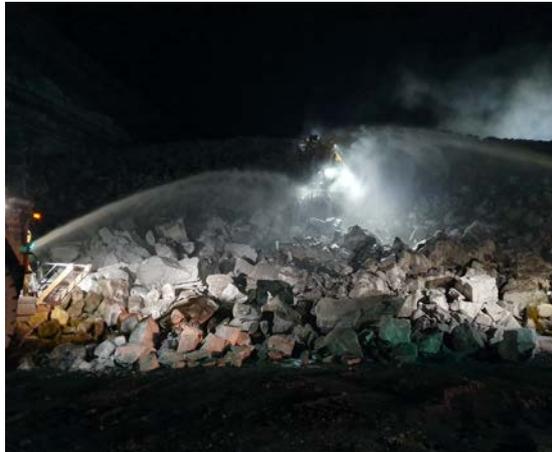
INCIDENT TYPE	SUMMARY	RECOMMENDATIONS TO INDUSTRY
Dangerous incident IncNot0034360	<p>A fire occurred on a dozer in an open cut coal mine. The dozer was capping blasted ground when the operator noticed a fire. The operator decided to relocate the dozer to a lower level to get better access to a water cart when the dozer became bogged on the slope of the blast heap.</p> <p>The dozer's fire suppression system was manually operated, which appeared to extinguish the fire. A short time later, the fire reignited. Several workers attempted to put out the fire with hand-held extinguishers. A water cart arrived and</p>	<p>Within the site's emergency procedures, mine operators should consider access to work areas for emergency vehicles when designing work areas.</p> <p>Operators should follow emergency procedures without causing further risk to themselves and others from environmental hazards such as poor lighting, unstable ground conditions and toxic fumes.</p>

extinguished the fire. The operator slipped and suffered a hand injury.

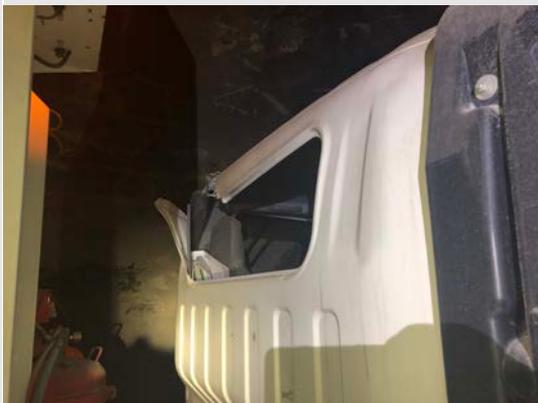
A light vehicle hit a drill steel protruding from a jumbo drilling rig that was parked in the main decline.

The drill steel caught on the passenger side wing mirror and went through the rear window, narrowly missing the passenger. As the vehicle travelled forward, the drill steel started to bend before springing out of the cab and landing 13 metres down the decline. No workers were injured.

Mine operators should ensure that machine loads and items that are stored for transport do not protrude and pose any risk to other passing vehicles.

A S195 notice was issued to the mine preventing drill steels being transported on jumbo's while the machines are tramming between production areas.

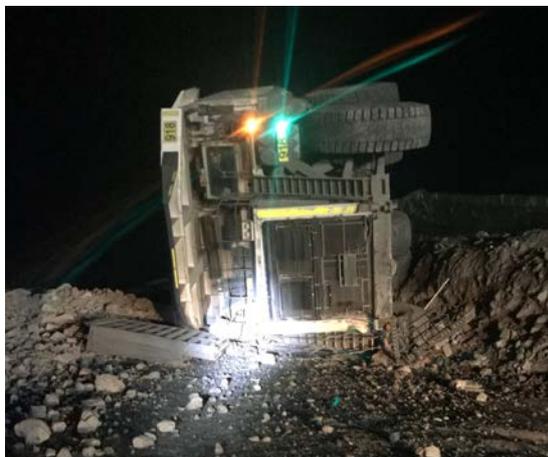
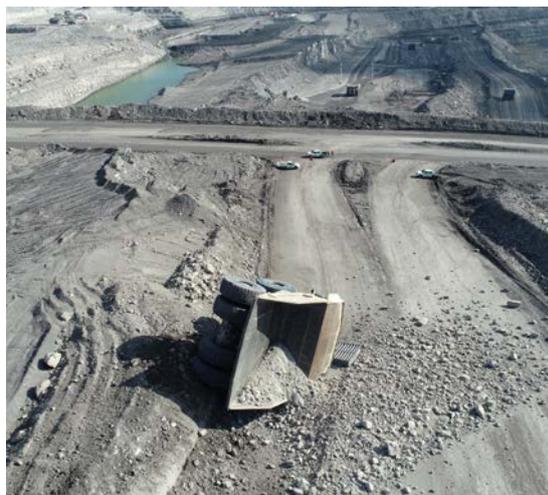
A haul truck rolled onto its side at an open cut coal mine. The truck had travelled over the crest and was descending a ramp.

The operator tried unsuccessfully to slow the truck. The truck contacted a windrow and rolled onto its side. There were no other vehicles in the vicinity at the time. The operator was not injured.

The photographs of the incident site (below) graphically illustrate the potential severity of this incident as the out of control truck was approaching an intersection and a vertical drop at the time.

Mine operators should review whether ramp and cresting speed limits are appropriate for the retarder and braking systems fitted to haul trucks.

Mine operators should review the training provided to operators regarding the safe application of retarders and service brakes on haul trucks.

Mine operators should routinely download and review operating data from haul truck logging systems to verify trucks are being operated in a safe manner.
