**NSW  
Resources  
Regulator**

CAUSAL INVESTIGATION REPORT

# **PIN EJECTION INCIDENT**

Ravensthorpe Open Cut Mine

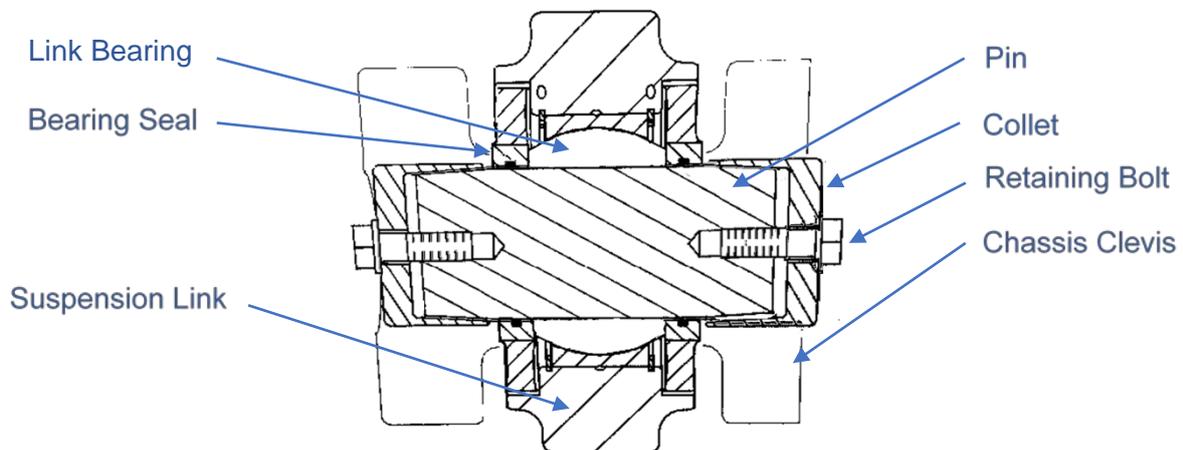
Figure 2 Rear suspension link pin and bearing cross section

Four days into the work schedule, fitters tried to remove the lower left-hand side rear suspension link by first removing the outer collets. Collets are used to secure the pin on either side. The collets have a taper corresponding to the taper on either end of the pin and act as a wedge to secure the pin and prevent it from rotating during service. To remove the collets, three jacking screws are used to push the collet away from the pin, but sometimes the 'fingers' break, complicating the removal process. The standard Caterpillar link removal procedure does not provide advice on what the fitters should do if they break.

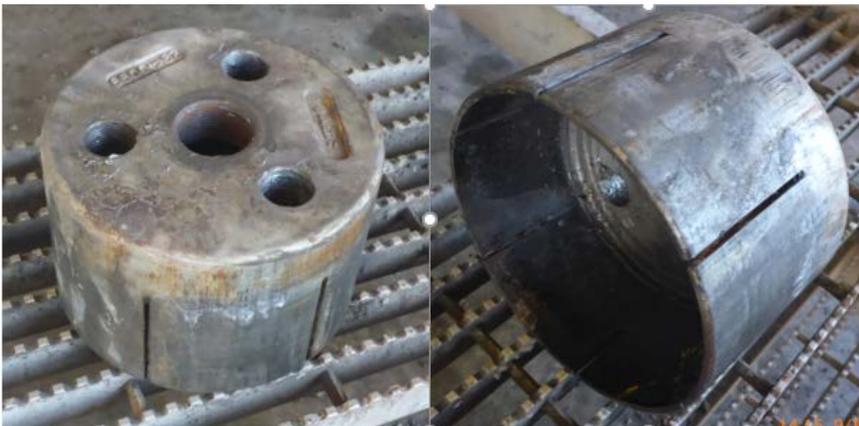
Figure 3 Pin collets

The fitters successfully removed the rear pin outer collet but had difficulty with the front outer collet. They asked that a boilermaker remove the collet by gouging it with an oxy-acetylene torch. A boilermaker performed this task between 7.30am and 10.20am. The fitters tried to extract the pins at 3.20pm, using a hydraulic porta-power and sleeve. Both pins were withdrawn about 70 millimetres, which was the limit of travel for this set of tooling.

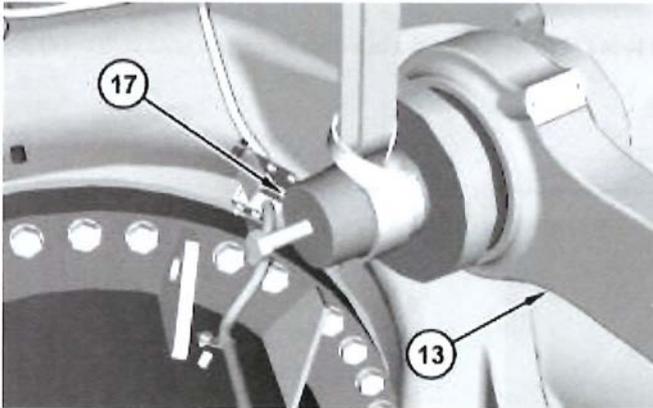
Figure 4 OEM bolt and sleeve pin removal tooling

Day shift handed over to night shift at 6.30pm to continue removing the pins. The night shift workers managed to fully remove the rear pin using the original equipment manufacturer (OEM) bolt and sleeve method. In this method, a sleeve is placed over the pin and a bolt inserted into the end of the pin. Torque is applied to the bolt via a pneumatic torque wrench turning the bolt and withdrawing the pin.
