# WEEKLY INCIDENT SUMMARY

Week ending Friday 31 January 2020

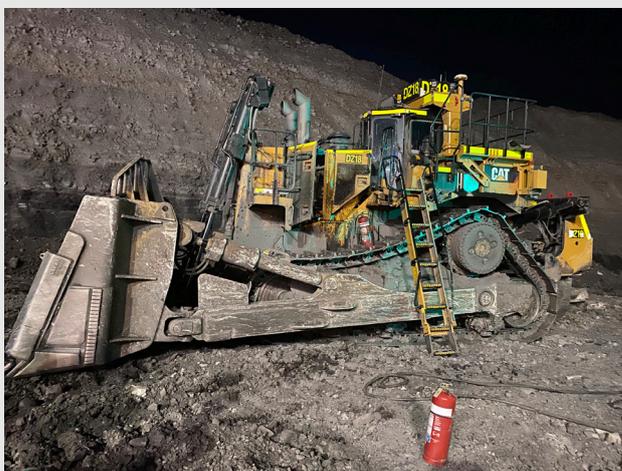
Dangerous incident  
IncNot0036586  
Surface coal mine

A dozer was working next to the dragline when the driver smelled fumes. The operator pulled the dozer back and saw smoke coming from the engine compartment. The fire was extinguished using a hand-held fire extinguisher.

The mine's initial observation identified that the hydraulic pilot filter came loose, which allowed oil mist to be drawn into the engine compartment and made contact with hot surfaces.

Mine operators must ensure that stringent monitoring and quality control of maintenance and repair activities are undertaken to prevent fires on mobile plant.

Enough time and resourcing must also be allocated for maintenance and repair tasks.

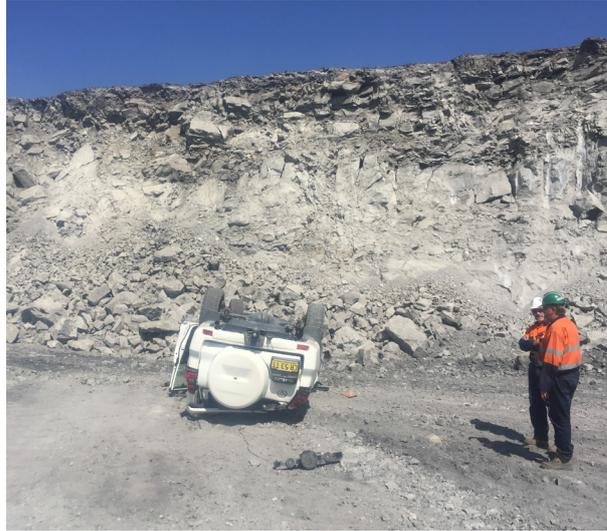
Dangerous incident  
IncNot0036629  
Surface coal mine

A light vehicle operator drove off an open edge (inactive shovel face) and the vehicle fell about 14 metres. The driver had been conducting blast sentry clearance. A bund across the road leading to the inactive face had been opened-up to allow two drill rigs to tram from the blast area. The bund was not replaced, and no other barricade was put in place to prevent vehicle access to the area. The area had previously been a roadway before being excavated.

The vehicle landed nose first before coming to rest on its roof. The driver exited the vehicle and called the emergency response crew who stabilised the driver until the ambulance arrived. The driver was taken to hospital and cleared of any injuries.

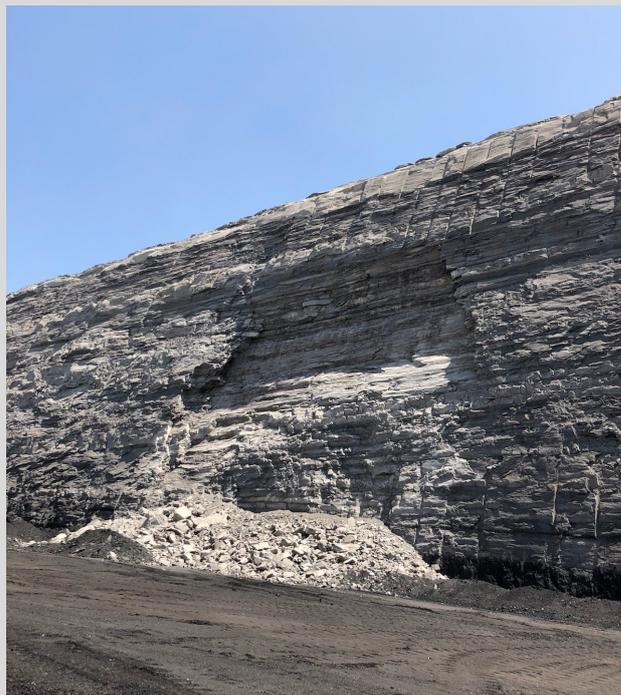
Dangerous incident  
IncNot0036633  
Surface coal mine

A slip in a 60 metre highwall resulted in about 2500 cubic metres (m<sup>3</sup>) of material falling to the ground. The dimensions were about 45 metres high with the maximum extent from the highwall toe of 10-15 metres. A catch windrow was in place under the highwall about 10 metres from the highwall toe. The slip was noticed early enough to remove all workers from the area before the material fell to the ground.

Mine operators must have safe systems of work in place to inspect highwalls. These inspections must consider - weathering effects, ground water and conditions that affect the high wall stability.
