WEEKLY INCIDENT SUMMARY

Week ending Friday 02 October 2020

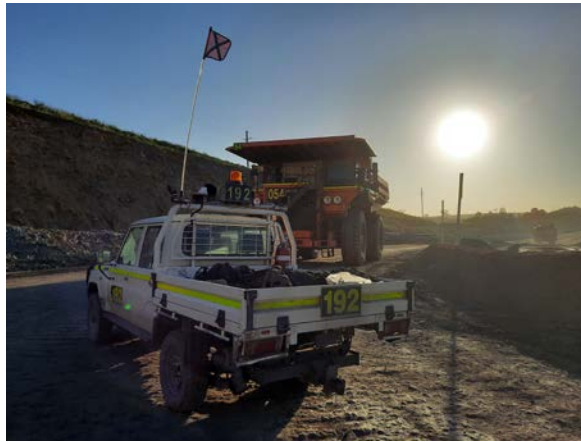
INCIDENT TYPE	SUMMARY	COMMENTS TO INDUSTRY
Dangerous incident IncNot0038360 Open cut coal

<p>A haul truck and a light vehicle had a near miss at an open cut coal mine. The empty haul truck approached a corner where a grader was working on the inside of the curve.</p> <p>The haul truck moved to the wrong side of the road to pass the grader and did not see any approaching vehicles. Both operators saw each other in time to stop their vehicles and avoid a collision.</p>	<p>The risk of collision when vision is restricted is well documented and reasonably foreseeable. Windrows should be constructed and maintained at heights that maximise visibility for all road users and maintain the effective delineation of roadways.</p> <p>Mines should review procedures and warning systems when road maintenance is being undertaken and when part of the road has been closed. When visibility is restricted, vehicle operators should only proceed when they are satisfied the roadway is clear.</p>
