WEEKLY INCIDENT SUMMARY

Week ending Friday 09 October 2020

Summarised incidents

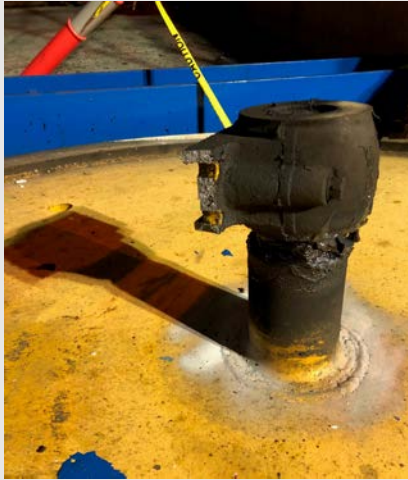
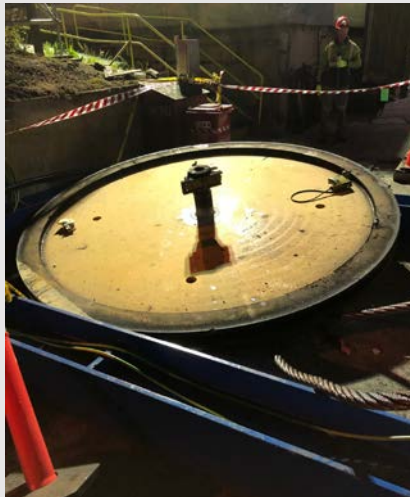
Dangerous incident
IncNot0038413
Underground coal mine

While removing a drift winder rope, the head sheave plumber blocks failed, resulting in the head sheave falling to ground level from its position on the gantry, a vertical distance of approximately 15 metres. The sheave wheel fell into a demarcated no-go zone. A person was positioned in the line of fire when the pulley fell, but was not injured.

Initial investigation indicates that the method of rope removal, using the mobile friction winder, inducted a horizontal load on the plumber blocks. This resulted in the plumber block feet failing and the head sheave working free.

Safe systems of work must be documented and provided by mine operators. Supervisors must ensure that the systems of work are understood and implemented by workers.

Engineering design and expected forces must be calculated for all parts of the task to ensure equipment is designed for the expected duty.

The risk of falling objects and the positioning of workers must be considered in the work methods.

Established no-go zones must be adequately sized to ensure workers are not put at risk from falling objects.
