WEEKLY INCIDENT SUMMARY

Week ending Friday 23 October 2020

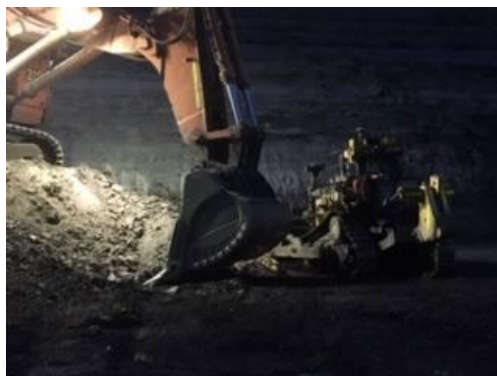
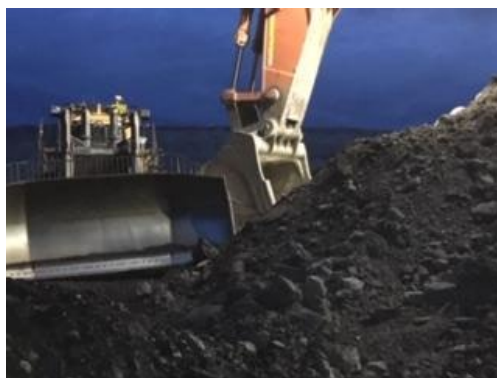
Dangerous incident
IncNot0038475
Open cut coal mine

A dozer driver has connected with the bucket of an excavator as the dozer operator was doing a push across the face. The excavator operator placed the bucket on the bench for the dozer to push across the face. As the dozer pushed past the face, the excavator operator placed the bucket into the dig behind the dozer. The dozer operator reversed the dozer contacting the back of the bucket. No one was injured.

Mine operators should remind all equipment operators of the importance of positive communication across all parts of the mine site. Dozer operators should make positive communications with excavators before entering any excavator swing radius. Mine operators should consider proximity awareness technologies for high interaction areas.

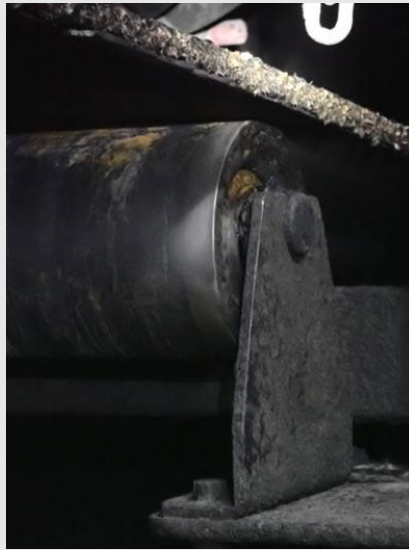
Dangerous incident
IncNot0038503
Underground coal mine

Three mine workers were travelling through an outbye section of the mine when they smelled smoke. They doubled back and discovered a flat return roller emitting smoke and sparks on the outbye side of the drivehead of the belt.

The workers turned off the belt and went to find an extinguisher. When they returned to extinguish the fire, they observed a six to eight inch flame at the end of the roller.

Mine operators must ensure that stringent monitoring and quality control of maintenance and repair activities are undertaken to prevent fires on conveyors. Enough time and resourcing must

be allocated for inspection, maintenance and repair of conveyors considering the length and complexity of the conveyor system.

Maintenance frequency of rollers and pulleys must consider areas of high tension in the conveyor system.

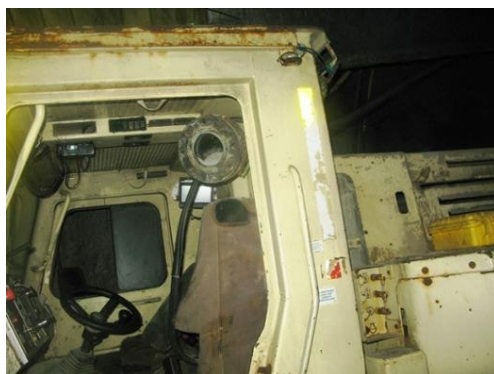
Dangerous incident
IncNot0038460
Underground coal
mine

An agitator truck was reversing up a decline when a four inch polypipe pushed in the back window of the cab. The truck was keeping to one side of the path to avoid a drain on the other side. It appears that the corner of the cab caught the end of a disconnected sandfill poly line which then travelled across the back of the cab and pushed the window in. The glass did not shatter. The operator was uninjured.

Open-ended, low-hanging pipes are an easily identifiable hazard and present an unacceptable risk to vehicle operators. Mine operators should have controls in place to eliminate/mitigate risks that can arise from such a hazard, such as hanging the pipes at a height where they do not align with the travel path of a vehicle.
