WEEKLY INCIDENT SUMMARY

Week ending Friday 23 October 2020

Mine safety reference ISR20-43

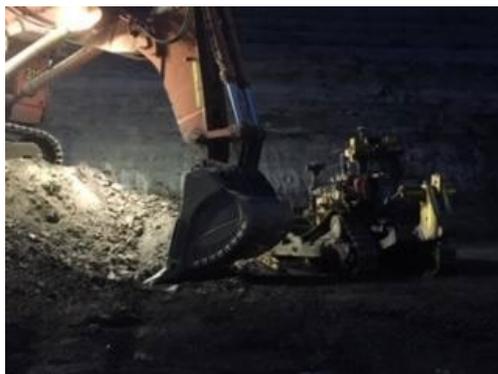
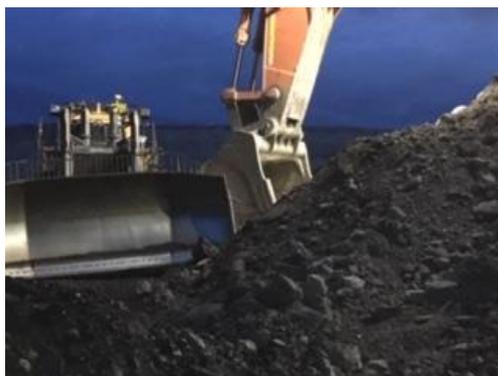
Dangerous incident
IncNot0038475
Open cut coal mine

A dozer driver has connected with the bucket of an excavator as the dozer operator was doing a push across the face. The excavator operator placed the bucket on the bench for the dozer to push across the face. As the dozer pushed past the face, the excavator operator placed the bucket into the dig behind the dozer. The dozer operator reversed the dozer contacting the back of the bucket. No one was injured.

Mine operators should remind all equipment operators of the importance of positive communication across all parts of the mine site. Dozer operators should make positive communications with excavators before entering any excavator swing radius. Mine operators should consider proximity awareness technologies for high interaction areas.

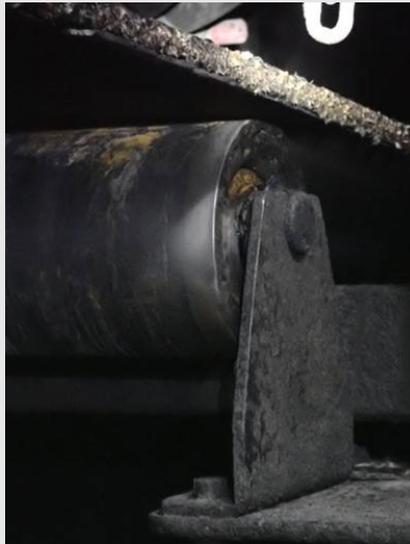
Dangerous incident
IncNot0038503
Underground coal mine

Three mine workers were travelling through an outbye section of the mine when they smelled smoke. They doubled back and discovered a flat return roller emitting smoke and sparks on the outbye side of the drivehead of the belt.

The workers turned off the belt and went to find an extinguisher. When they returned to extinguish the fire, they observed a six to eight inch flame at the end of the roller.

Mine operators must ensure that stringent monitoring and quality control of maintenance and repair activities are undertaken to prevent fires on conveyors. Enough time and resourcing must

be allocated for inspection, maintenance and repair of conveyors considering the length and complexity of the conveyor system.

Maintenance frequency of rollers and pulleys must consider areas of high tension in the conveyor system.

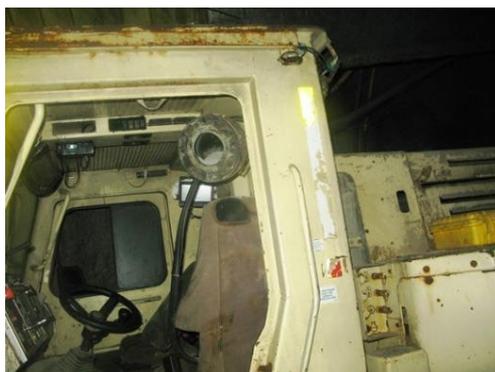
Dangerous incident
IncNot0038460
Underground coal
mine

An agitator truck was reversing up a decline when a four inch polypipe pushed in the back window of the cab. The truck was keeping to one side of the path to avoid a drain on the other side. It appears that the corner of the cab caught the end of a disconnected sandfill poly line which then travelled across the back of the cab and pushed the window in. The glass did not shatter. The operator was uninjured.

Open-ended, low-hanging pipes are an easily identifiable hazard and present an unacceptable risk to vehicle operators. Mine operators should have controls in place to eliminate/mitigate risks that can arise from such a hazard, such as hanging the pipes at a height where they do not align with the travel path of a vehicle.
