INVESTIGATION INFORMATION RELEASE

Collision between dozer and haul truck

Incident date: 5 October 2020

Event: Injury to dozer operator at Mangoola Coal Mine

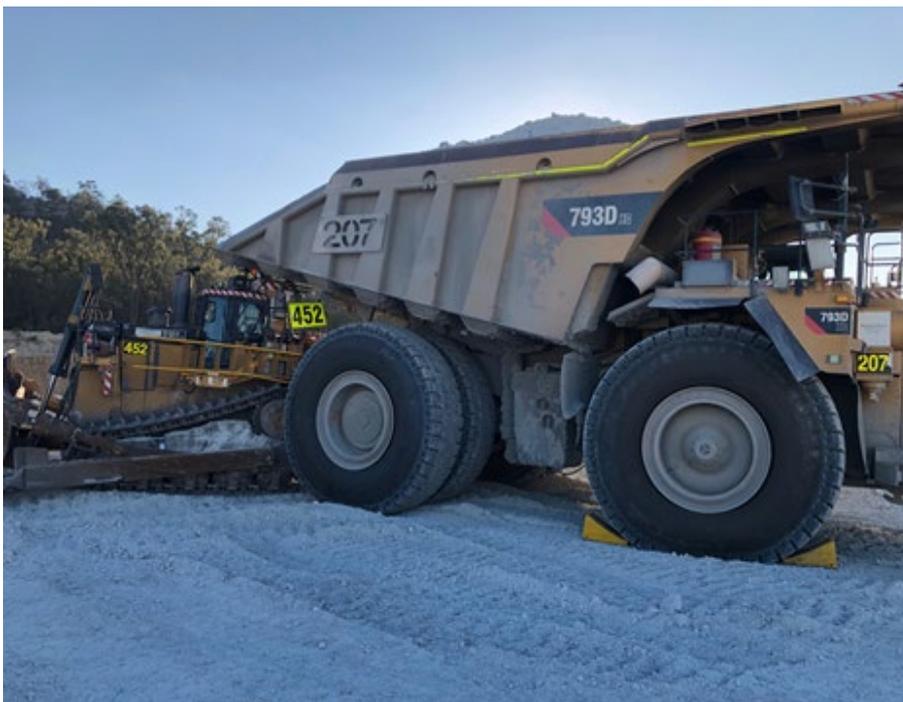
Figure 1 Collision between dozer and haul truck

The incident occurred at about 9am on Monday 5 October 2020. An experienced dozer operator was working on a tip head. A truck operator arrived at the tip head and was unsure where to unload but recalled an earlier instruction from the dozer operator to tip against the wall. The truck operator reversed to dump the load. The truck operator heard a thud and stopped the truck. The haul truck and dozer had collided.

- ensure that positive communications (pos-coms) is effective between operators when haul trucks are approaching dozers working on tip heads

- engineering controls, such as proximity detection, collision avoidance systems and cameras can assist in managing the risks associated with mobile plant interactions
- review the adequacy of surface transport management plans including tip head procedures for effective radio and communications protocols
- ensure the risk controls for mobile plant interaction are being adequately monitored and verified by audit as being effective.
