INVESTIGATION INFORMATION RELEASE

Drift winder head sheave pulley wheel falls from height during winder rope removal

Incident date: 6 October 2020

Location: Appin East Mine, Appin Colliery, Appin NSW

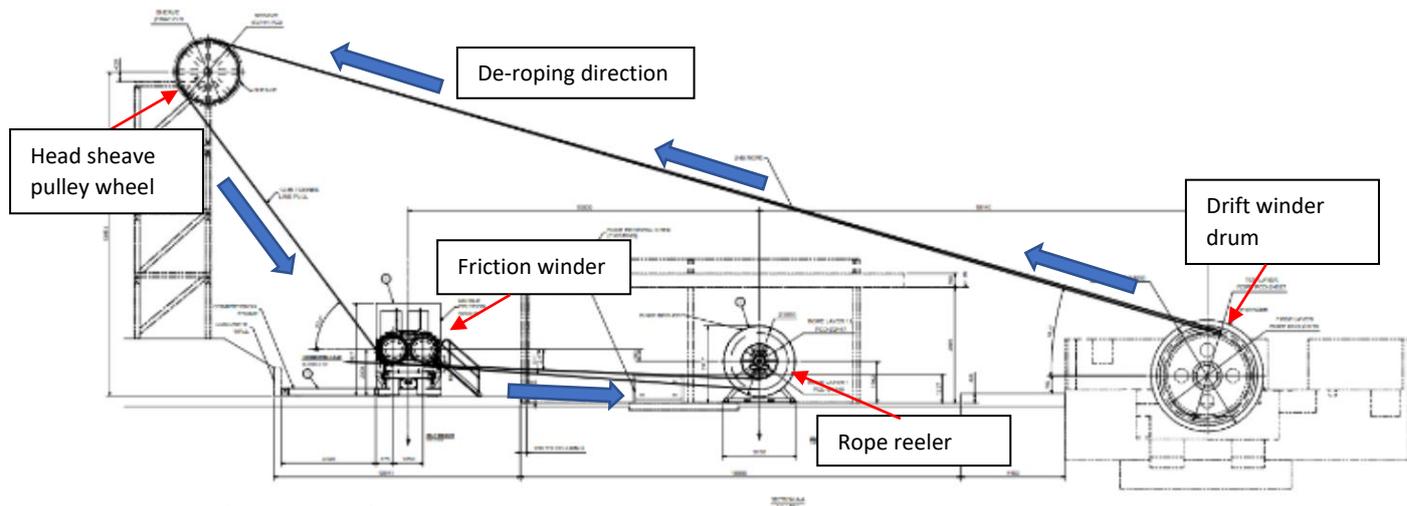
Figure 1 Drift winder de-roping procedure

In accordance with the procedure, the winder rope was to be fed through the head sheave pulley to a friction winder and then onto a rope reeler (see Figure 1).

WCA's procedure differed from the process previously utilised by the mine operator, which did not require the use of a friction winder or the rope to be traversed through the head sheave pulley.

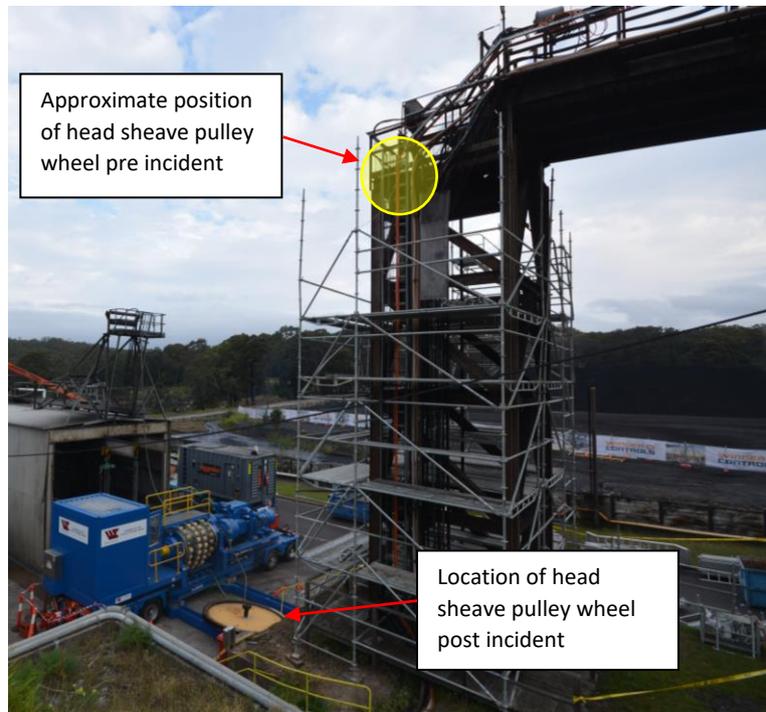
Figure 2 Head sheave pulley wheel location post incident

Initial inquiries have indicated that, during the de-roping process, the drift winder stopped winding out rope whilst the friction winder and rope reeler were still operating and winding in rope. This caused tension in the winder rope to increase, introducing significant forces on the head sheave pulley wheel assembly.

At around 4:53pm, nearby workers heard a loud cracking sound and observed the head sheave pulley wheel dislodge from its support frame and fall approximately 13 metres to the ground (see Figure 2).

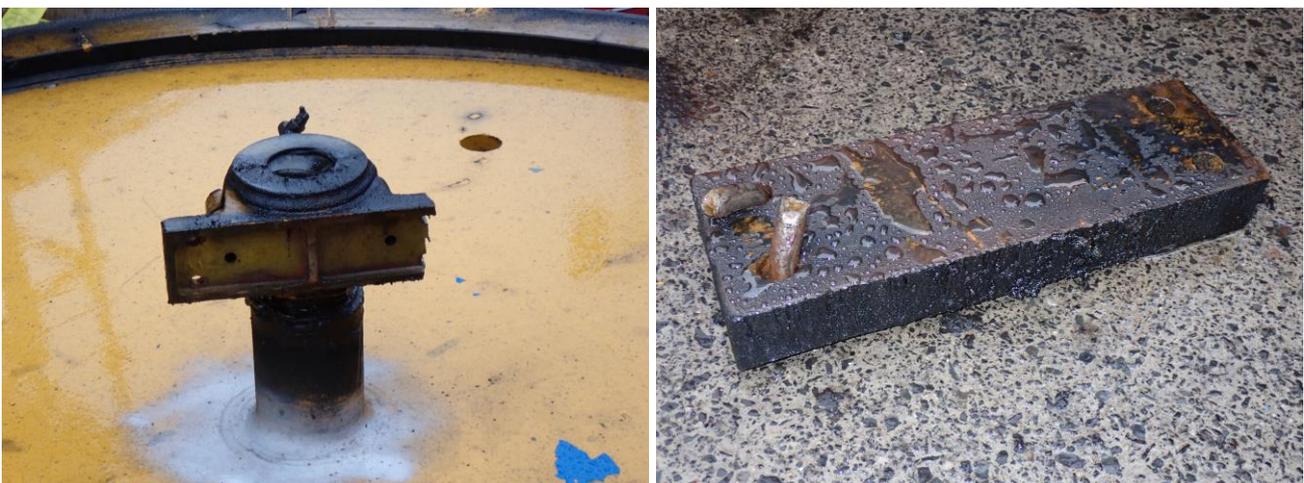
Figure 3 Damaged head sheave pulley wheel assembly components

Examinations conducted after the incident identified that the plumber blocks and associated fastening bolts, which form part of the pulley wheel assembly, were significantly damaged (see Figure 3).

- The friction winder's maximum rope pull force was set above the maximum safe working load limit of the head sheave pulley assembly.
- During the rope removal, significant forces were exerted onto the head sheave pulley wheel assembly which likely damaged the assembly components, resulting in the pulley wheel dislodging from its support frame and falling to the ground.
- Implemented communication protocols had not appropriately considered the work environment, such as loud background machinery noise.
- Restricted access areas were not clearly defined within procedures or adequately implemented through clear instruction and supervision.
- During the rope removal, a worker was positioned below the head sheave pulley wheel, within a restricted access area, under the assumption that approval had been given to do so.

- Ensure drift winder rope removal procedures and risk assessments incorporate appropriate engineering controls to prevent the safe working load limits of involved plant and equipment from being exceeded.
- Provide adequate instruction and supervision to workers to ensure that, when task procedures have changed from those originally planned, adequate new risk control measures are put in place.
- Review communication protocols to ensure that appropriate consideration is given to the work environment, such as loud background machinery noise.
- Ensure procedures clearly articulate no-go zones and restricted access areas with workers provided clear instruction, training and supervision to ensure they are adhered to.

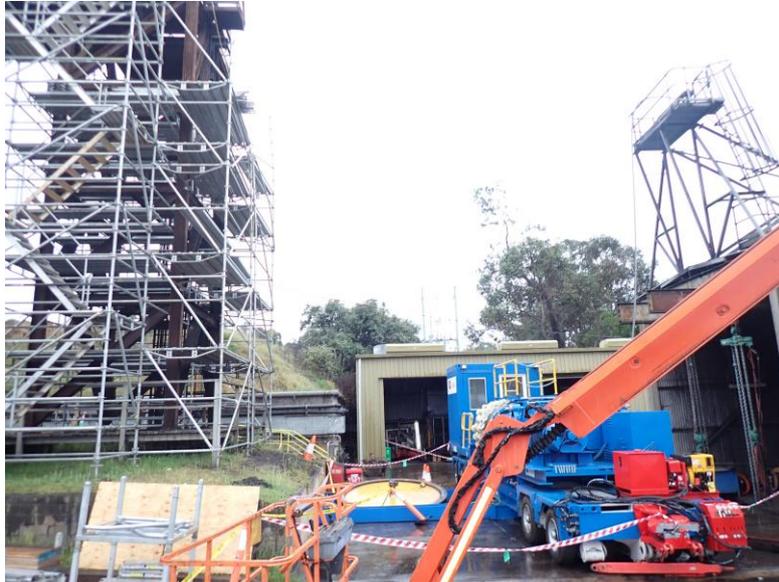
Figure 4 Final location of pulley wheel within taped off, restricted area near drift winder

Just before the failure, a member of the work crew was standing on ground level directly below the pulley wheel within a taped off, restricted access area (see Figure 4). The worker was monitoring the rope to ensure it was correctly travelling through the friction winder. After hearing the cracking noise, the worker took immediate evasive action, moving clear of the fall path of the pulley wheel moments before it hit the ground.

- never enter identified no-go zones in the potential line-of-fire of falling objects caused by equipment failure while energy is being applied to a pulling system.
