INVESTIGATION INFORMATION RELEASE

Drift winder head sheave pulley wheel falls from height during winder rope removal

Incident date: 6 October 2020

Location: Appin East Mine, Appin Colliery, Appin NSW

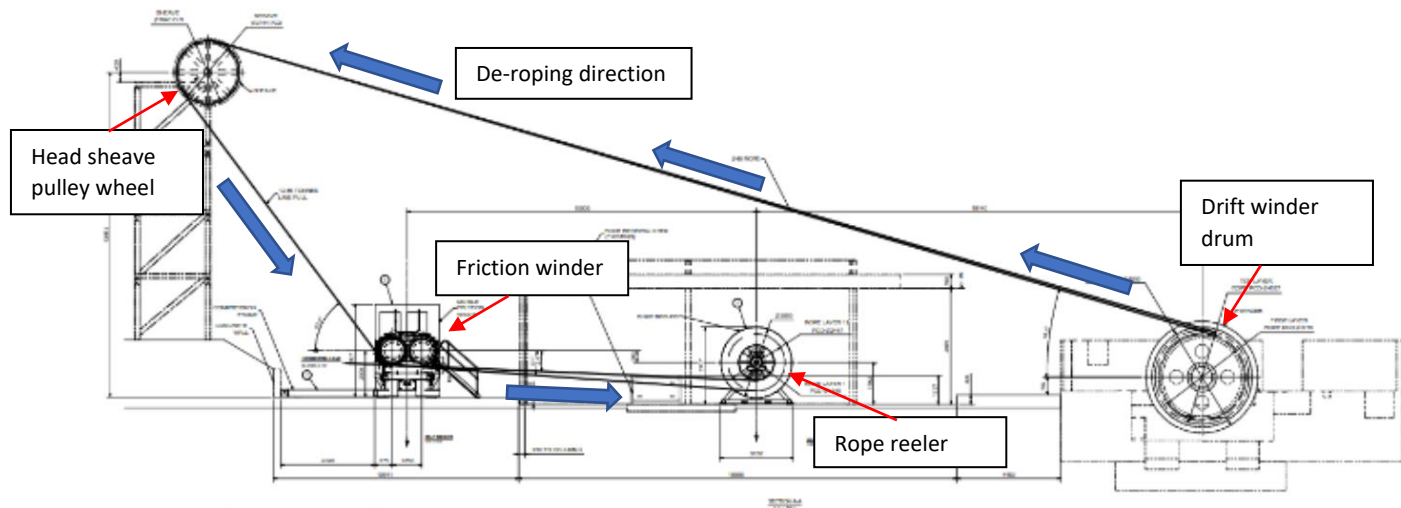
Figure 1 Drift winder de-roping procedure

In accordance with the procedure, the winder rope was to be fed through the head sheave pulley to a friction winder and then onto a rope reeler (see Figure 1).

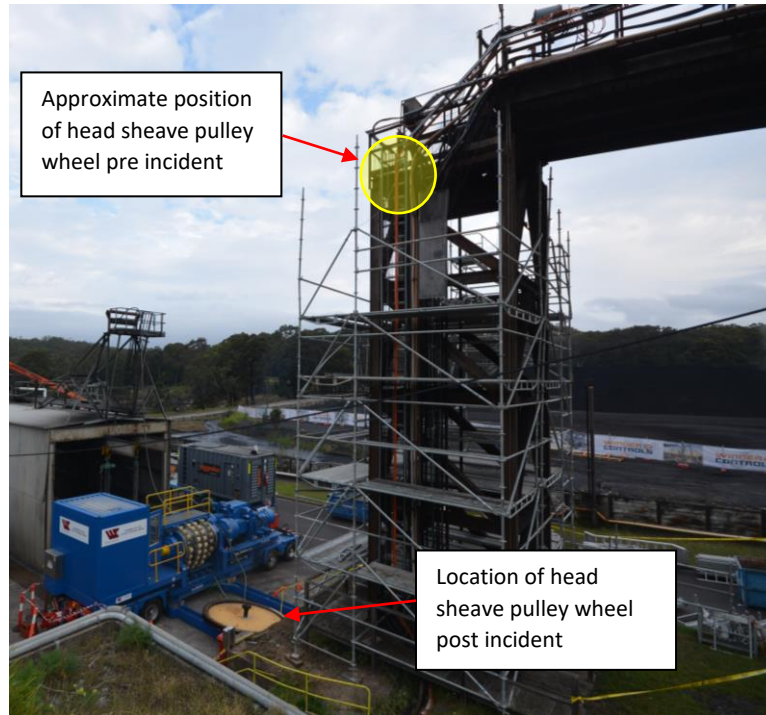
Figure 2 Head sheave pulley wheel location post incident

At around 4:53pm, nearby workers heard a loud cracking sound and observed the head sheave pulley wheel dislodge from its support frame and fall approximately 13 metres to the ground (see Figure 2).

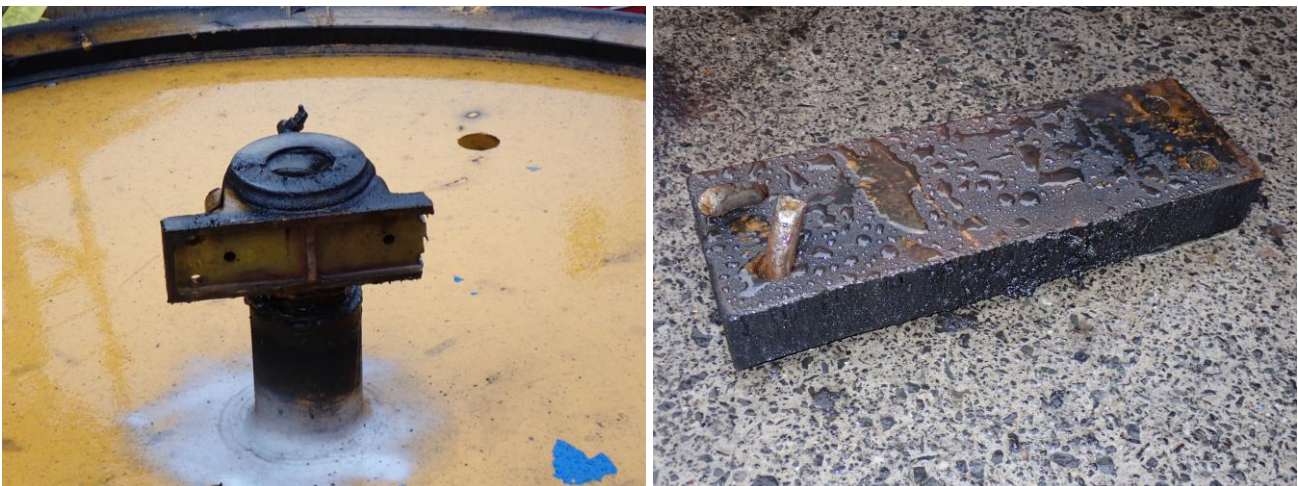
Figure 3 Damaged head sheave pulley wheel assembly components

Initial inquiries have indicated that, during the de-roping process, the drift winder stopped winding out rope whilst the friction winder and rope reeler were still operating and winding in rope. This caused tension in the winder rope to increase, introducing significant forces on the head sheave pulley wheel assembly.

Examinations conducted after the incident identified that the plumber blocks and associated fastening bolts, which form part of the pulley wheel assembly, were significantly damaged (see Figure 3).

- The friction winder's maximum rope pull force was set above the maximum safe working load limit of the head sheave pulley assembly.
- During the rope removal, significant forces were exerted onto the head sheave pulley wheel assembly which likely damaged the assembly components, resulting in the pulley wheel dislodging from its support frame and falling to the ground.
- Implemented communication protocols had not appropriately considered the work environment, such as loud background machinery noise.
- Restricted access areas were not clearly defined within procedures or adequately implemented through clear instruction and supervision.
- During the rope removal, a worker was positioned below the head sheave pulley wheel, within a restricted access area, under the assumption that approval had been given to do so.

- Ensure drift winder rope removal procedures and risk assessments incorporate appropriate engineering controls to prevent the safe working load limits of involved plant and equipment from being exceeded.
- Provide adequate instruction and supervision to workers to ensure that, when task procedures have changed from those originally planned, adequate new risk control measures are put in place.
- Review communication protocols to ensure that appropriate consideration is given to the work environment, such as loud background machinery noise.
- Ensure procedures clearly articulate no-go zones and restricted access areas with workers provided clear instruction, training and supervision to ensure they are adhered to.

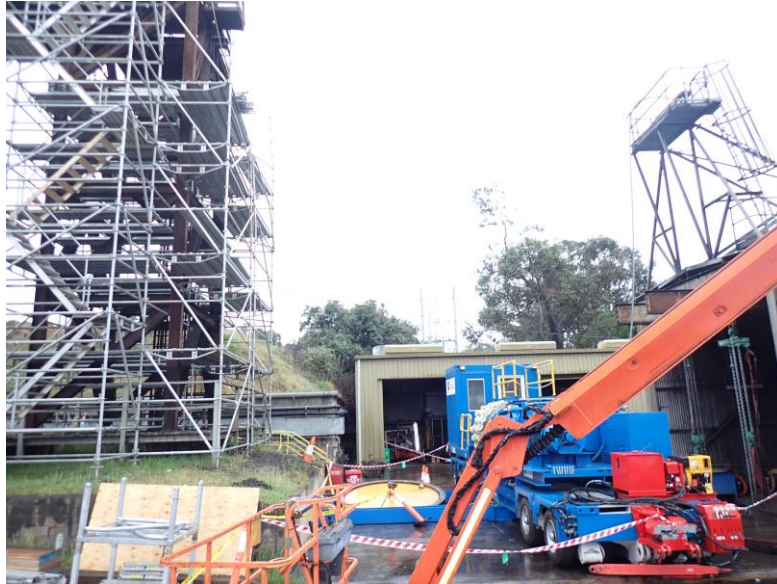
Figure 4 Final location of pulley wheel within taped off, restricted area near drift winder

Just before the failure, a member of the work crew was standing on ground level directly below the pulley wheel within a taped off, restricted access area (see Figure 4). The worker was monitoring the rope to ensure it was correctly travelling through the friction winder. After hearing the cracking noise, the worker took immediate evasive action, moving clear of the fall path of the pulley wheel moments before it hit the ground.

- never enter identified no-go zones in the potential line-of-fire of falling objects caused by equipment failure while energy is being applied to a pulling system.
