WEEKLY INCIDENT SUMMARY

Week ending Friday 05 March 2021

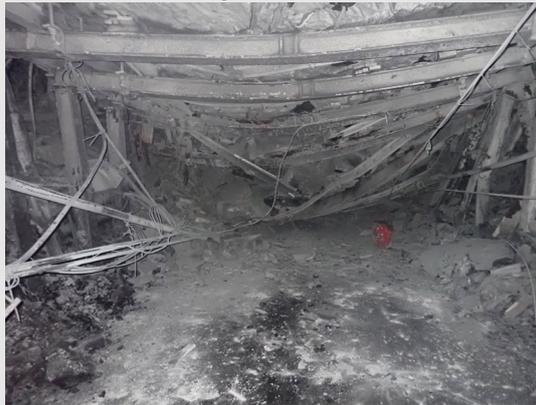
Dangerous incident
IncNot0039365
Underground coal
mine

Ground or strata

A roof fall occurred at an intersection in an underground coal mine. The fall was in an outbye area of the mine and extended into the cut-through, blocking the travel road.

All personnel were safely evacuated and there were no injuries.

This incident is under investigation and further information may be published at a later date. Underground mines should review the adequacy of their strata monitoring arrangements and associated trigger action response plans (TARPs), to ensure that workers are not exposed to unacceptable risks associated with strata failure.

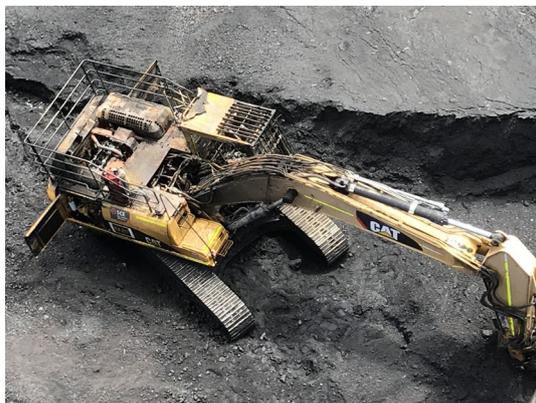
Dangerous incident
IncNot0039384
Underground coal
mine

Fire or explosion

An excavator operator jumped clear of the cabin to escape a fire that engulfed his machine. The operator did not have time to activate the fire suppression system and the cabin was destroyed. The position and extent of the fire indicates catastrophic engine failure, potentially caused by ruptured fuel or oil lines outside the engine envelope. The fire propagated forward towards the fuel tank, with evidence of significant heat around the main boom pivot. The excavator recently underwent a major overhaul.
