# WEEKLY INCIDENT SUMMARY

**Week ending Friday 04 June 2021**

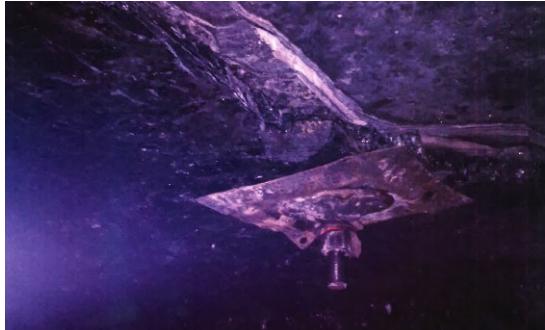
INCIDENT TYPE	SUMMARY	COMMENTS TO INDUSTRY
Dangerous incident IncNot0039992 Underground coal	A continuous miner driver was standing at the start of a breakaway. The roof had been bolted, but not meshed. A piece of bratt (coal tops), approximately one metre by one metre by 80 millimetres thick, fell directly onto the miner driver. The bratt broke off from between the roof bolts. The worker sustained soft tissue injuries.	<p>The risk of falling bratt was not identified and the absence of suitable restraint meant that the risk was not adequately controlled. When developing extraction plans mines should consider:</p> <ul style="list-style-type: none"> <li>▪ support plans that address the risks to workers associated with unconstrained roof material (coal tops and delaminated material)</li> <li>▪ extraction plans that include the removal of coal tops and/or delaminated roof material.</li> </ul>

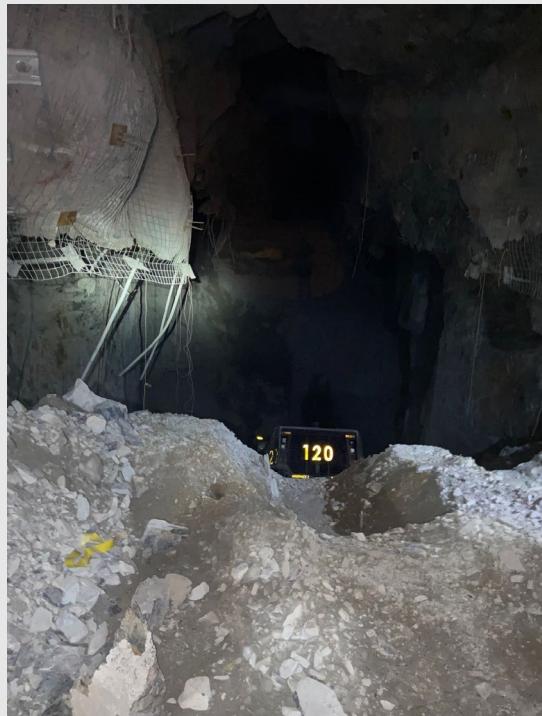
Dangerous incident  
IncNot0040010  
Underground  
metals

A loader has driven into a partially filled stope, dropping in at an angle of about 45 degrees. A rolling bund was not in place at the time of the incident. The operator sustained no injuries.

Mine operators need to ensure that risk controls are implemented and remain effective to prevent mobile plant from falling into stopes.

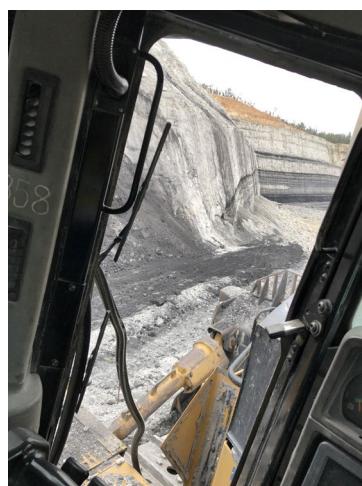
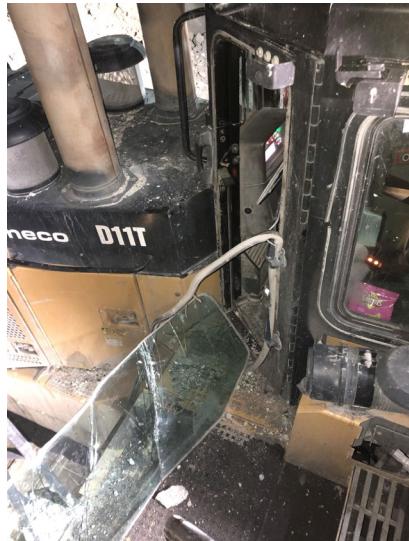
Dangerous incident  
IncNot0040022  
Open cut coal

A dozer was working below a highwall when a large rock dislodged and fell about 25 to 30 metres from the top of the highwall and struck the cab of the dozer. The rock shattered on impact, denting the cab and dislodging a pane of glass. The operator was not injured.

An assessment of the integrity of the highwall must be conducted prior to commencing work beneath the highwall.

Consideration should be given to:

- removal of loose or overhanging rocks
- the effects of prevailing weather conditions
- a process for communicating high wall conditions to workers, including the presence of loose or overhanging rocks that cannot be removed.
