# WEEKLY INCIDENT SUMMARY

Week ending Friday 12 November 2021

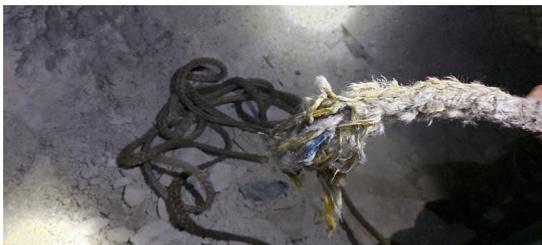
INCIDENT TYPE	SUMMARY	COMMENTS TO INDUSTRY
Dangerous incident IncNot0041037 Underground metals	<p>A contract worker was operating a winch to pull new belting onto a conveyor. The third section of belting was winched into position and a clamp was applied to the belt. The winch rope then failed. The synthetic fibre rope failed at a snatch block and recoiled 25 metres, passing the winch and worker. The recoiling rope missed the operator by about a metre.</p>

<p>When winches are being used, controls such as safe standing zones and guarding must be in place to protect workers in the event of a failure.</p> <p>Operators must ensure all ropes used are within their working load limits.</p> <p>While synthetic fibre ropes usually do not recoil when they fail, workers should be reminded that any rope, including synthetic ropes, can recoil and place them at risk of serious injury.</p>

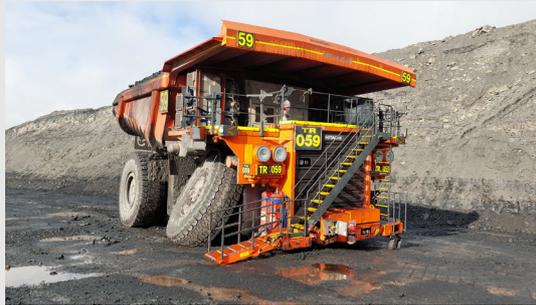
A haul truck was travelling fully loaded from an excavator when the position two trailing arm failed and caused the front of the truck to collapse and hit the ground. The truck slid about 20 metres. The operator of the truck did not suffer injuries.

The cause of the component failure is yet to be determined. Further information may be published later.

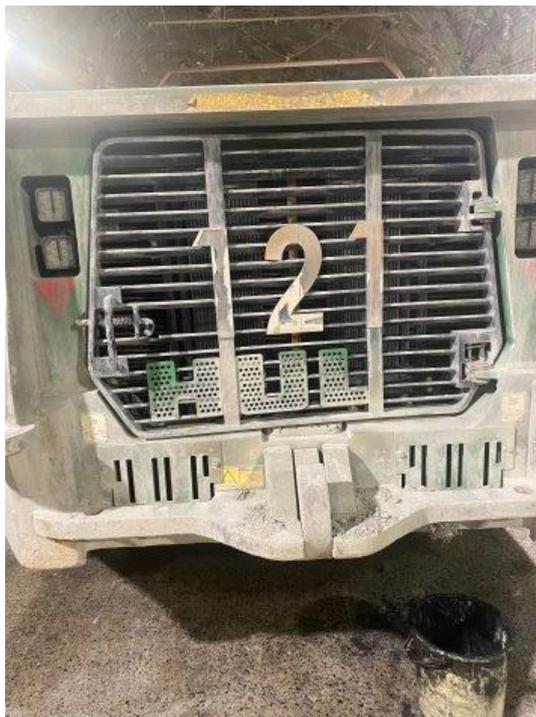
A loader was being refuelled underground. A bolt retaining the air filter housing (mounted to the fuel tank) compromised the integrity of the fuel tank, allowing fuel to spray onto the turbo exhaust system and DPF box. A worker used two fire extinguishers to put out the fire.

Mine operators should ensure stringent monitoring and quality control of maintenance and repair activities. Refer to Safety Bulletin: [SB21-01 Fires occur while refuelling plant](#)

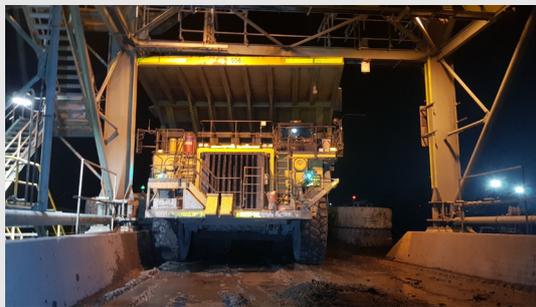
A haul truck made contact with a reject loading bin twisting a structural support. The worker incorrectly aligned the truck with the approach guides resulting in the rear wheels hitting the tyre barriers. This caused the truck to pivot and the headboard to hit the support column. The barrier was not effective in preventing a collision.

Structures must be protected from impact with mobile plant. The extension of headboards and trays should be considered during the design of barriers and guides. Equipment operators must maintain situational awareness and remain vigilant to manage the risk of collisions while operating mobile plant.
