# **Investigation Report**

Injury resulting in death involving a mobile  
bolter at the Myuna Colliery on

24 July 2008

Report prepared for the Director General of the  
Department of Industry and Investment by the  
Investigation Unit, Thornton

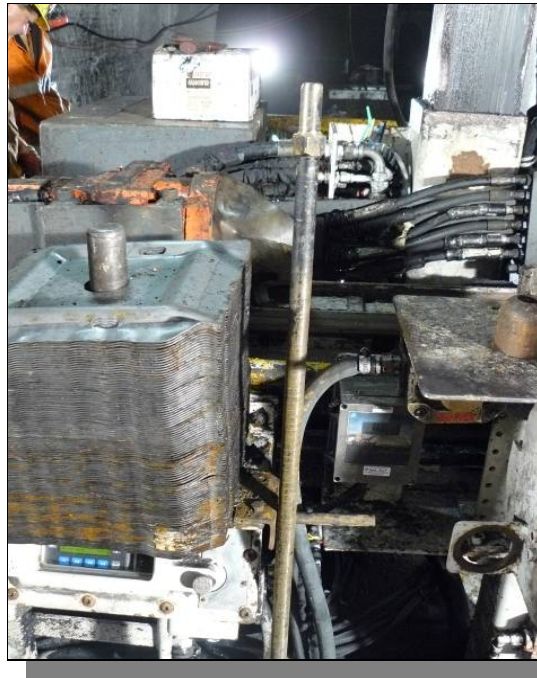
It appears that before or while he retracted the drill head the drill steel fell between the butterfly plates and the drill control box resting against a retractable hand railing above the drill head carriageways (see yellow round bar in second photo). When the drillhead was brought back it has pushed against the top of the drill steel placing it in tension and bending the drill steel.

The drill steel in the approximate position when it fell between the butterfly plates and the rib bolter control panel.

Note drill steel resting on bar installed post-incident.

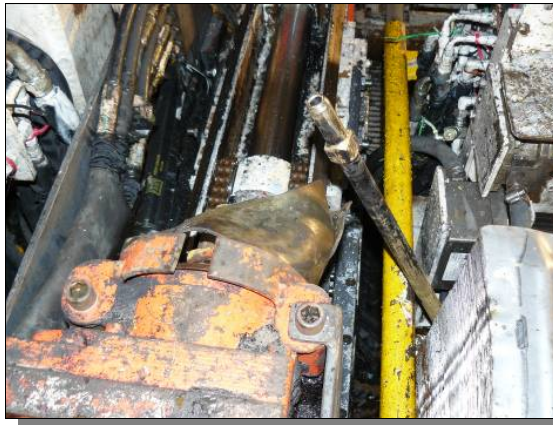
The top of the drill steel lying over near the rib bolter drillhead.

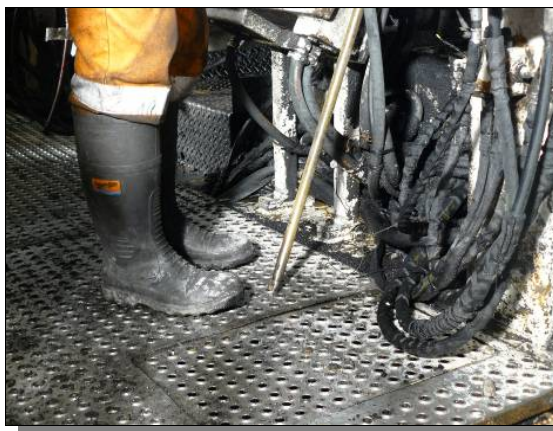
The drill bit was released from the floor plate and struck Mr Burgess on the outside of his left foot with considerable force. The drill bit cut his gumboot, lacerated his foot and fractured the 5th metatarsal.

The drill steel and drill bit in the approximate position on the metal plate floor of the mobile bolter.

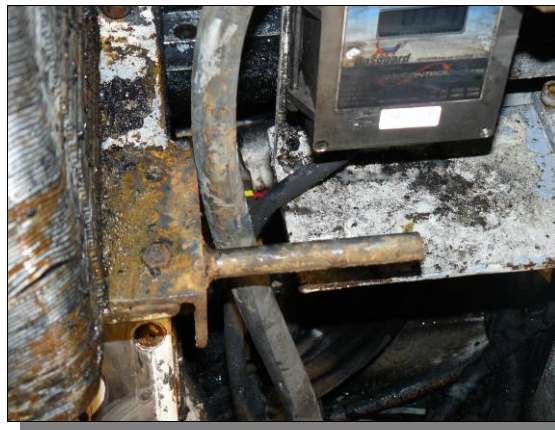
The bar or handle fitted at the rib bolter.

- A “bar or handle” was manufactured and fitted to prevent drill steels or bolts from falling onto the rib bolter carriageway. These were fitted to both the mobile bolters on 29 July 2008.

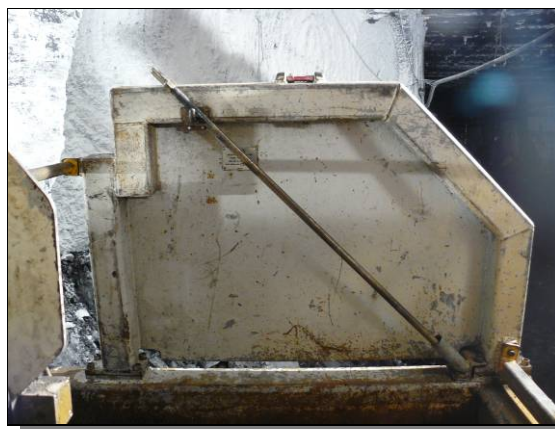
Note: this arrangement is made to hold one drill steel only.

The “hook and cup” fitted to the rib protection shield.

- Manufactured and fitting of a “hook and cup” arrangement on the end rib protection shield for temporary storage of the drill steel while not in use. These were fitted to both mobile bolters on 29 July 2008.
