## Investigation report

Report into the death of James Leslie Stocks, found at the bottom of a shaft on Mineral Claim 32904 at Lightning Ridge on 7 March 2013

Prepared by Investigation Unit, Thornton

July 2014

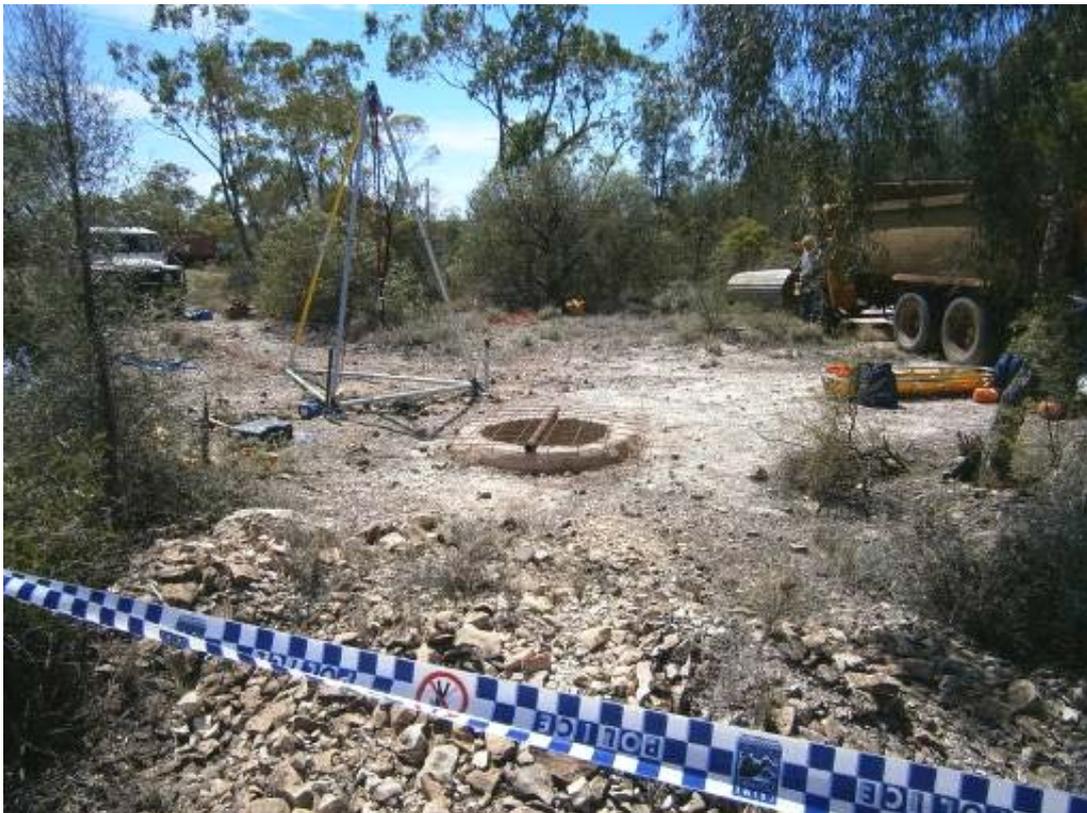
The shaft had a cement collar that was usually covered with a piece of steel mesh. It was not pinned down in any way (see Figure 1 below). The companions who were with Mr Stocks the previous evening saw that the steel mesh was not on top of the shaft, which led to the discovery of Mr Stocks' body.

**Figure 1.** The incident site on 7 March 2013. Note: the shaft cover was replaced for safety purposes. When Mr Stock's body was discovered the mesh was not covering the shaft.

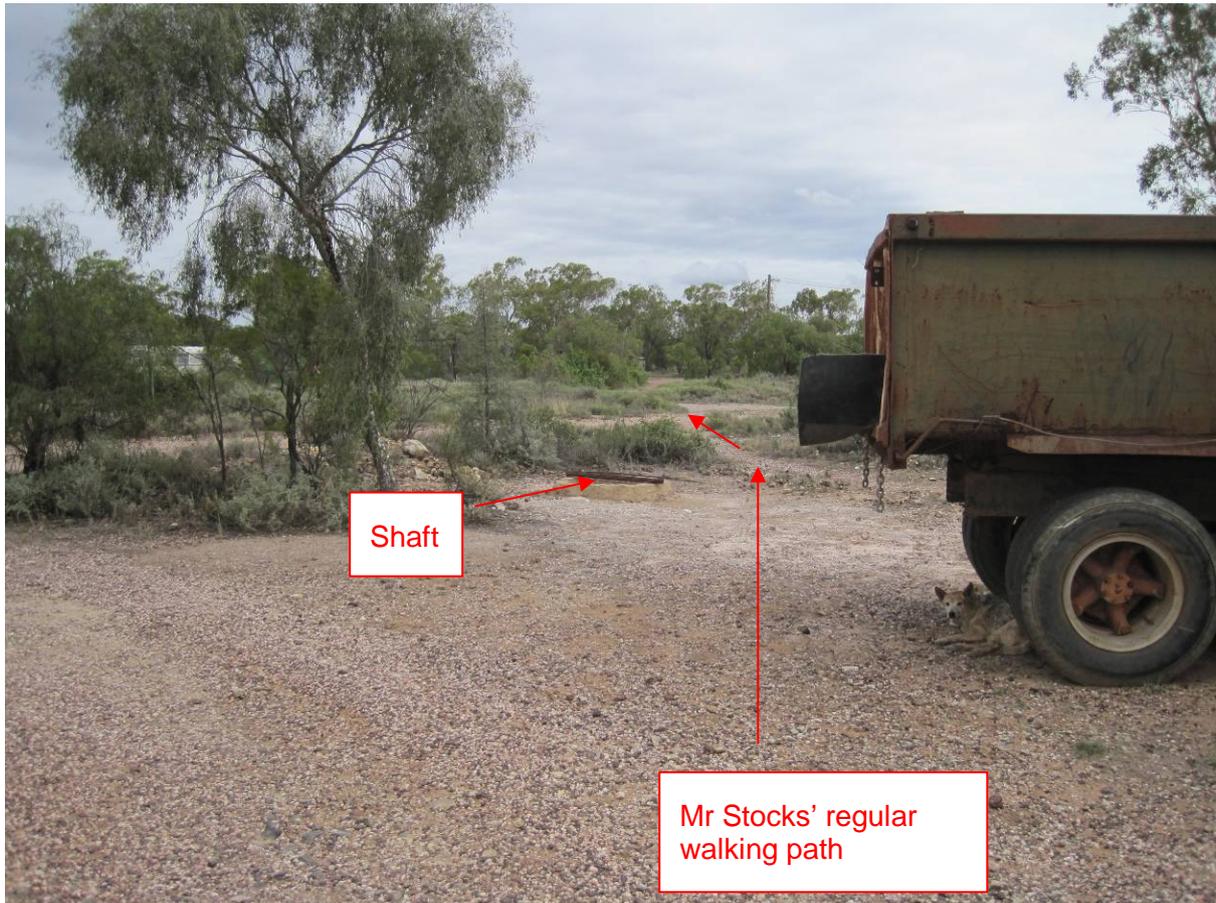
Mr Stocks left the camp between 8pm and 9pm. Witnesses reported that it was dark when Mr Stocks left and he took a schooner of wine with him. Figure 2 shows the shaft in relation to Mr Stocks' regular walking path home.

**Figure 2.** The mineral claim on 9 March 2013.

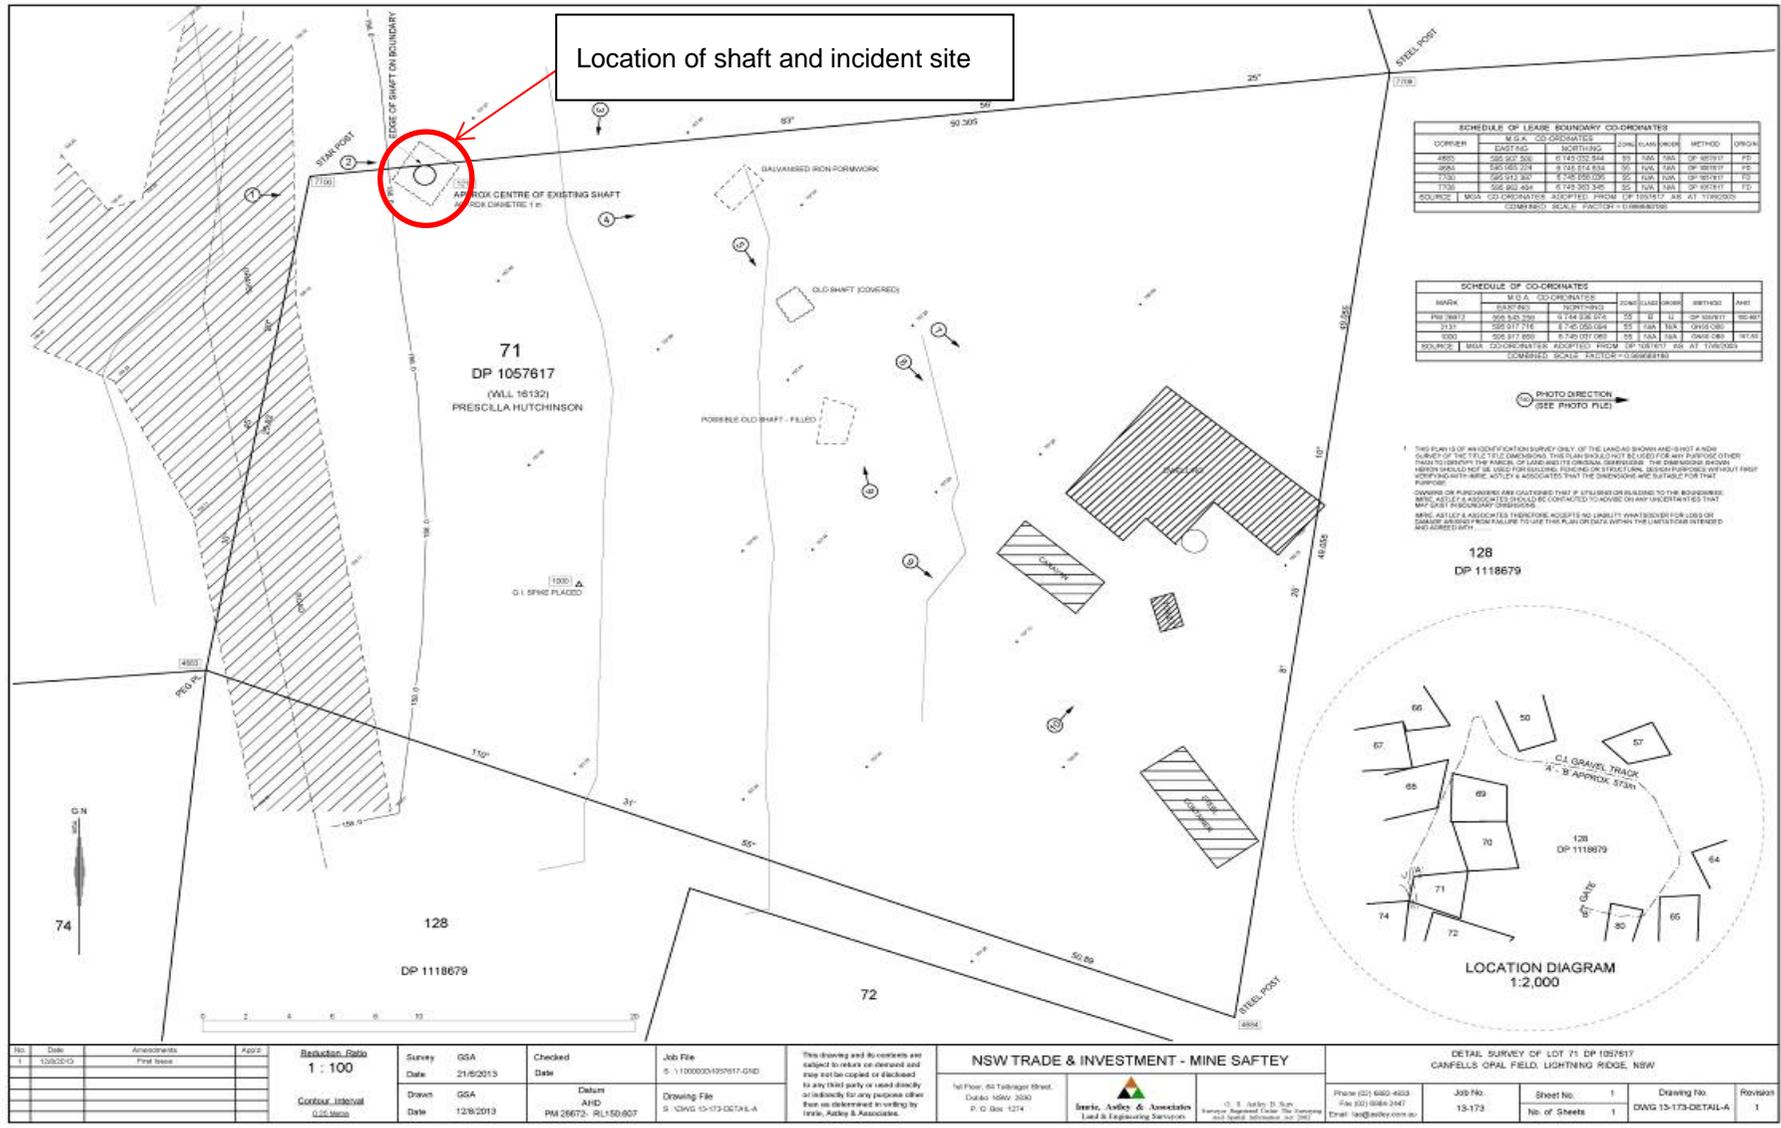
Figure 4 is a survey of the mineral claim which shows the dimensions of the claim as well as the location on the claim of the shaft, two older shafts, the camp, a caravan, a toilet, a steel container and iron formwork.

Figure 4. Survey of Mineral Claim 32904.

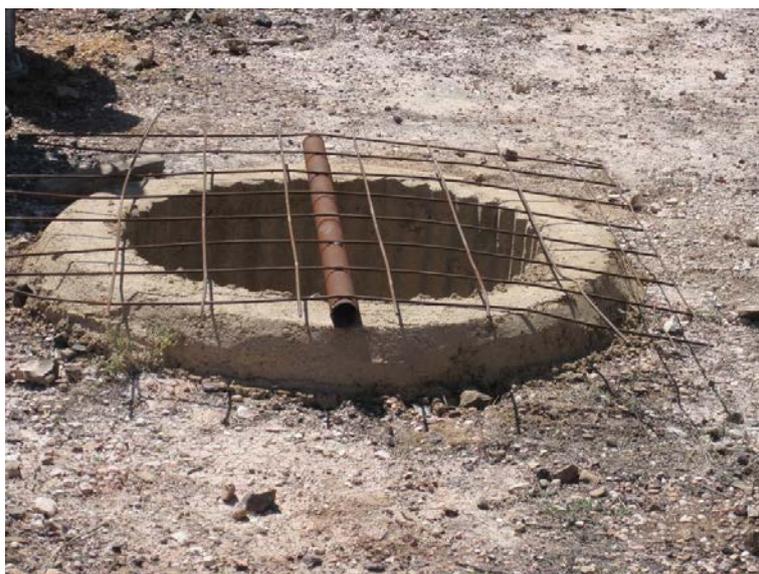
The mine operator reported that immediately after the shaft was drilled, he placed a cover over the shaft and pinned it down on the diagonal corners with two pins. The cover consisted of a piece of steel mesh 1.62 metres by 1.52 metres, with spacing between the transverse and the longitudinal wires of 0.2 metres by 0.2 metres. The gauge of the mesh is 0.007 metres and the diameter of the supporting pipe is 0.06 metres (see Figure 7). After the concrete collar was constructed the mesh was placed over the shaft but not pinned down at any time.

According to the mine operator, whenever he visited the claim he always checked to ensure the cover was in place. The last occasion he was at the mineral claim before the incident was 3 March 2013. He said the shaft was covered with the steel mesh on that occasion. Figure 7 shows how the mesh would normally be placed over the shaft.

**Figure 7** The shaft showing the steel mesh in what was alleged to be its usual position on 7 March 2013. Note that the mesh was placed over the shaft after the incident.

The cover weighed 14.6 kg and any attempt to kick it off the top of the shaft would appear to be improbable. Mr Stocks was not wearing shoes, the edges of the shaft cover were sharp and irregular and the autopsy did not disclose any injuries to Mr Stocks' feet.

Shaft covers that are not pinned down can be easily moved. All shaft covers should comply with the department's guidelines and be adequately secured. The *NSW Opal Mining Safety Guidelines* also recommend a higher standard for shaft security that includes extending the height of the collar, erecting fences and warning signs and installing a lockable cover.
