# SAFETY ALERT

NSW DEPARTMENT OF  
PRIMARY INDUSTRIES

## NEAR MISS FLUID INJECTION HIGH POTENTIAL INCIDENT

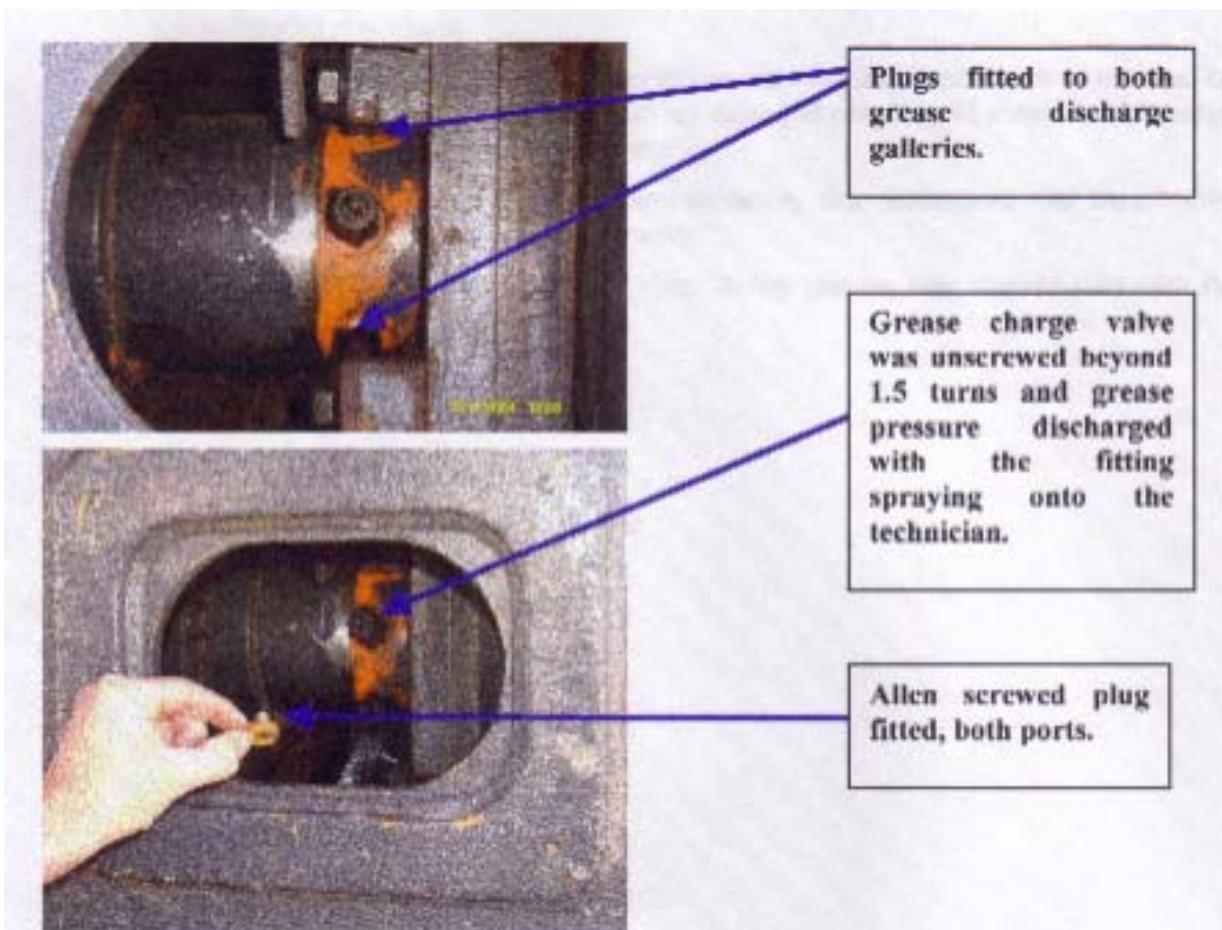
To release the pressure from the track adjuster, the grease charge valve (refer to the picture) needed to be unscrewed 1 - 1.5 turns. This was done but no grease discharged from the grease bleed valve. The technician then removed the grease nipple and no grease was released because there was a non return valve fitted in the charge valve. The technician proceeded to further undo the grease charge valve, beyond the recommended 1-1.5 turns, to the point where it blew out under pressure of the grease.

1. There are two grease outlets through which grease could discharge after unscrewing the charge valve 1 - 1.5 turns, both of these outlets were plugged by grub screws. The manufacture parts manual shows only one plug should be fitted into the top port only.

2. The maintenance procedure did not refer to the presence of any plugs in the grease discharge galleries.
3. The location of the grease outlet gallery made it difficult to see the presence of the plugs in the gallery and it was assumed, due to the location of the track adjuster, that mud or dirt was the most likely cause of the blocked grease outlet.

6. The fitting of the plugs into the discharge gallery was found to have happened at the recent overhaul of the adjuster assemblies. The plugs had been fitted to prevent the ingress of dirt during transport and storage of the components.

*Photo of the track adjuster showing location of grease discharge galleries.*

1. The manufacturer recommends a single plug to be fitted into the top discharge gallery to prevent dirt ingress when installed in the track frame. Two galleries are provided to enable the use of the same track adjuster assembly in the LH and RH track frame.

2. Plastic plugs should be used to seal orifices in components when sealing against ingress of contaminants during the transport and storage of components. Plastic plugs will be easily expelled under pressure if not removed during installation.

3. When it is absolutely necessary to use screwed plugs, clear warning labels need to be supplied with overhauled components explaining the need to remove threaded plugs during installation and risk to be evaluated.

6. All owners and OEM of track mounted equipment or equipment that uses grease for track tension to check that the bleed galleries in the track adjuster mechanism are clear and not blocked.
