# WEEKLY INCIDENT SUMMARY

Week ending 22 and 29 March 2019

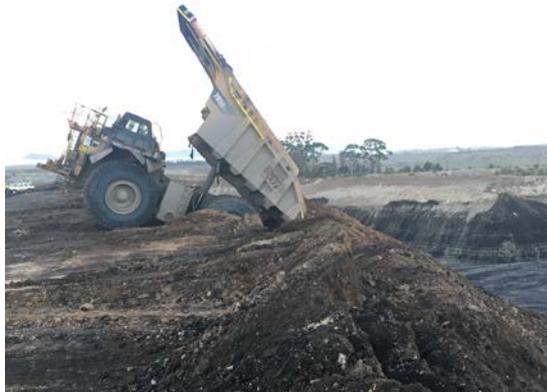
INCIDENT TYPE	SUMMARY	RECOMMENDATIONS TO INDUSTRY
Dangerous incident IncNot0034201	A tip head slumped while a truck was dumping in an open cut coal mine. As the truck was tipping its load, the edge dropped, and the truck was unable to move forward.	Tip heads and dumps must have suitable inspection regimes in place. Changes in conditions, such as wet weather, should trigger a change in inspection frequency.

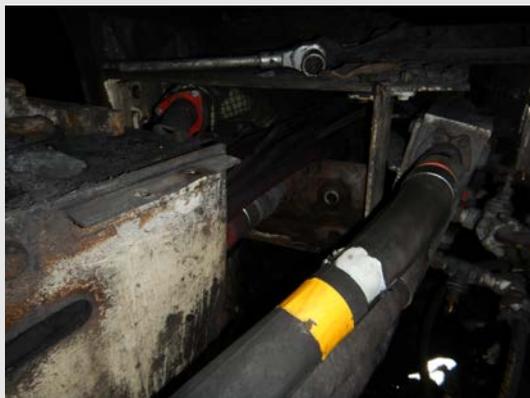
Dangerous incident  
IncNot0034194

An operator was sprayed with high pressure fluid when a hose failed. No injury was reported. A beam stage loader in the longwall maingate was tight against a block due to off-centre drivage and steering issues. While correcting this, the dog bones between the maingate cube and ramp pan failed. This resulted in the misalignment of the cable tray. A bulkhead fitting then failed, releasing the fluid and spraying the worker's forearm. The worker was taken to hospital but cleared of injury.

When misalignment of longwall components occurs, increased inspections and suitable controls must be put in place. This is to protect workers from an unplanned energy release. This is applicable to damage to hydraulic hoses and face cables and sudden failures of joiners between equipment (such as dog bones).

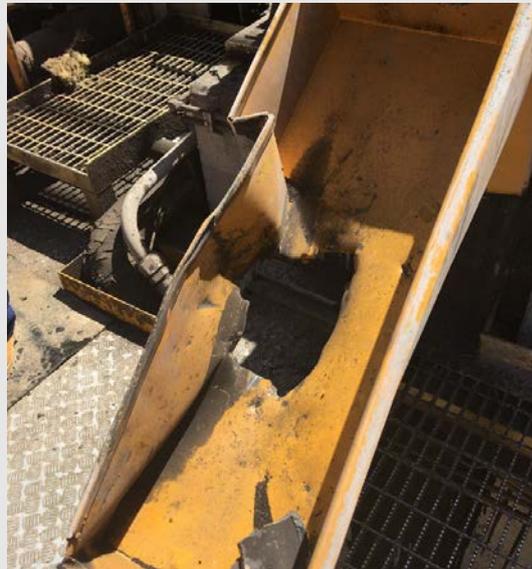
Dangerous  
incident  
IncNot0034149

A brake failure occurred resulting in projectiles being thrown from a brake unit. At a planned shutdown for the relining of a mill, the mill was being inched in an anticlockwise direction. The mill was stopped and then started to move in a clockwise direction and increase in speed. The brake failed, and metal parts were ejected from the brake unit.

Hold brakes must be suitably sized for all intended operations and should be suitable for their operation.

Standby equipment such as slow run drives and pony drives should have an appropriate maintenance strategy documented and implemented.

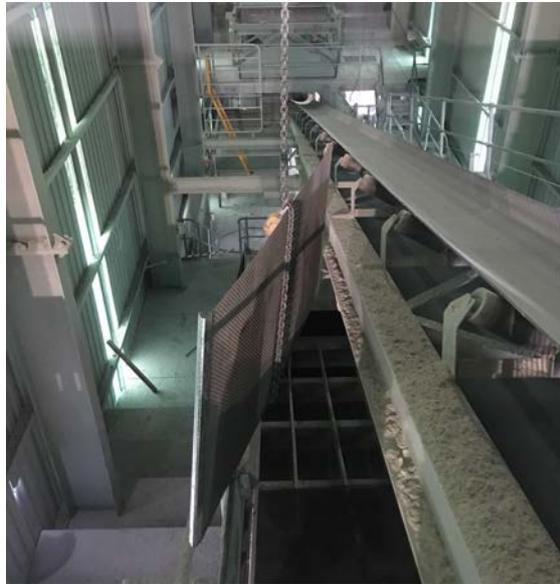
Dangerous  
incident  
IncNot0034226

A worker suffered an electric shock in a processing plant. An overhead crane was being used to change screen mats. While the screen was being lowered, the worker was holding the screen and had the other hand on an adjacent beam. When the crane was activated, the worker felt an electric shock.

Mines that operate overhead cranes that rely on earthing via the rails and the drive wheels, should implement regular earth continuity checks to ensure compliance with AS/NZS 3000.

Mine operators should also consider install an earthing rail to these types of installations.

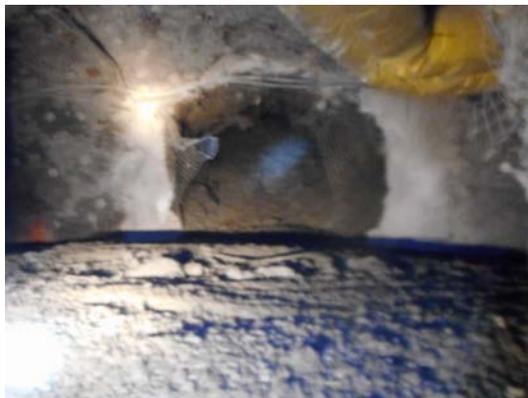
Dangerous incident  
IncNot0034220

A ventilation wall collapsed in an underground metalliferous mine. The wall had been built to control dust and air flow. Wet material had been stowed against the wall, causing it to fail. The wet material flowed into the drive below.

When assessing areas to store material, the surrounding infrastructure must be assessed as suitable. When storing wet material, the risk of inundation must be assessed.
