WEEKLY INCIDENT SUMMARY

Week ending Friday 3 September 2021

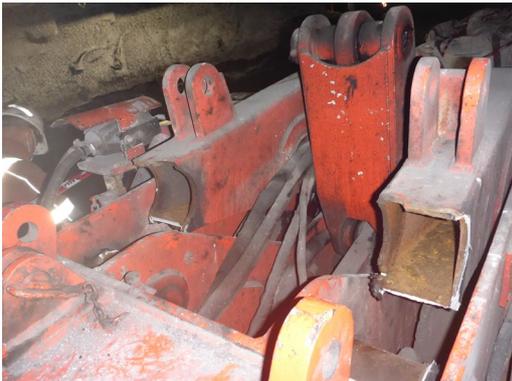
INCIDENT	SUMMARY	COMMENTS TO INDUSTRY
<p>Dangerous incident IncNot0040631 Underground coal mine</p>	<p>The lift frame welds failed and dropped the load of an Eimco 130 LHD. At the time, the operator was stopping at a set of block lights. The LHD was carrying a QDS pod loaded with four pallets. The operator was uninjured.</p>

<p>The maintenance regimes for mobile plant must include inspection and testing of lifting components on mobile plant, including hired plant. Where mobile plant may be used with man baskets, the risk profile increases and requires a more rigorous regime. Mine operators must ensure that equipment used for lifting and carrying is operated within the safe working limits of the mobile plant and any attachments.</p>
