SAFETY ALERT

Drill rig incident

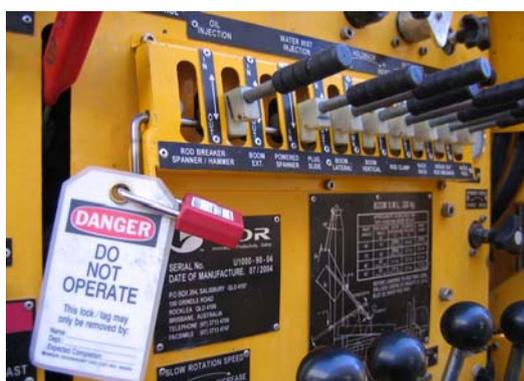
The above photo shows the recommended isolation of a drill rig control panel. It was not in use at the time of the incident outlined in this Safety Alert. However this isolation device allows for selective isolation of individual levers as required.

- Mechanically isolate drill rig controls to enable selective isolation of control levers. (See attached photo for example)
