WEEKLY INCIDENT SUMMARY

Week ending Friday 6 March 2020

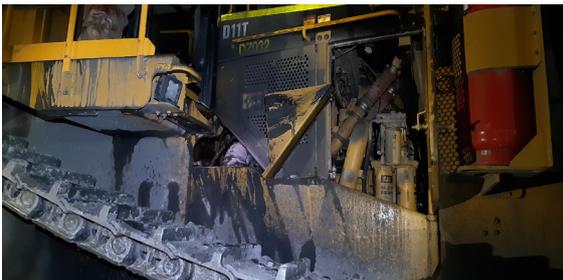
INCIDENT TYPE	SUMMARY	RECOMMENDATIONS TO INDUSTRY
Dangerous incident IncNot0036840 Open cut coal mine

Fire or explosion	A dozer driver noticed an oil leak and smoke coming from the front of the machine. Flames were coming from the engine bay. The driver manually activated the fire suppression system but it did not fully extinguish the fire. The driver used a fire extinguisher to fully extinguish the fire.

The cause of this fire has not yet been established. For further information refer to our dedicated website page about fires on mobile plant Also see: <ul style="list-style-type: none"> ■ Fires-on-mobile-plant-position-paper-October-2019.

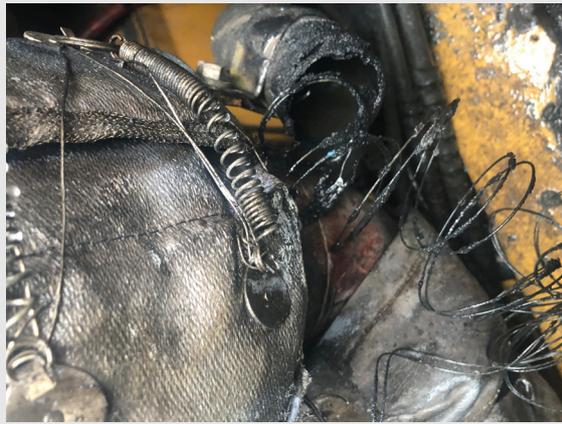
IncNot0036843

A dozer driver was pushing material when a glow was noticed at the front of the machine. At the same time, a truck called in an emergency. The driver immediately reversed and saw flames. The operator manually activated the fire suppression system.

The cause of this fire has not yet been established.

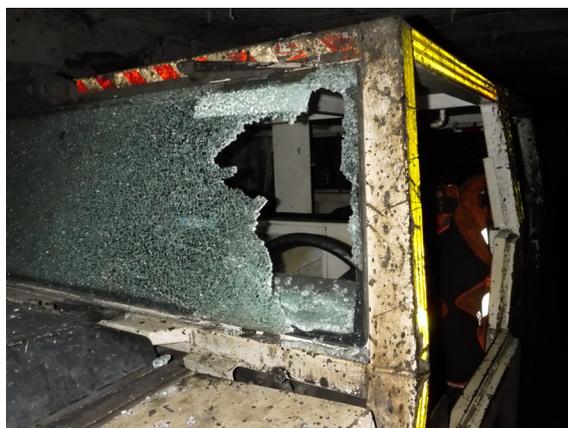
IncNot0036845

A personnel transporter was travelling outbye with two occupants. As it left a dogleg section of the roadway, the steering pulled hard to the right. The operator braked and stopped. As the transporter slowed, it hit a fire hydrant dropper that penetrated the driver's side windscreen. No-one was injured. A preliminary mine investigation found a loose steering hose had allowed hydraulic oil to leak out – this left no hydraulic oil to provide the steering function.

Mine operators must develop and adhere to strict inspection and maintenance standards and practices to prevent loss of fluid due to loose fittings or damaged hoses.

Operators should review their maintenance procedures to ensure commissioning checks are carried out by competent people before plant is returned to service as fit-for-purpose.

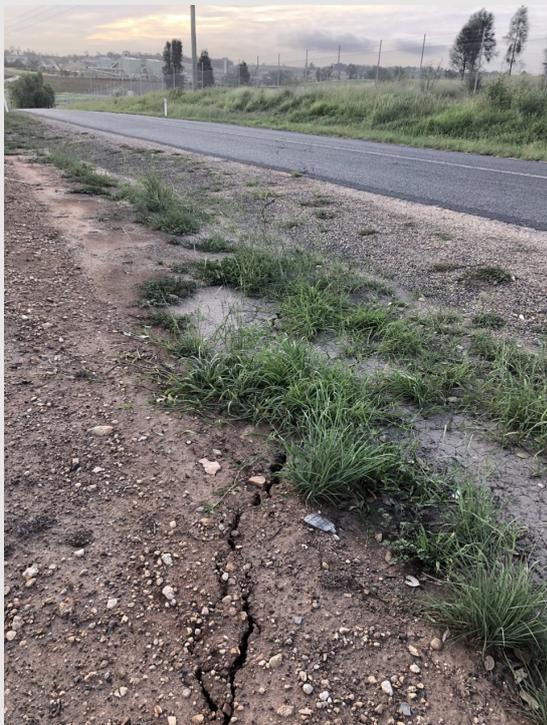
IncNot0036890

Localised cracking has occurred on a public road adjacent to a highwall at an open cut coal mine.

The mine had identified minor deterioration of the highwall a number of weeks prior to the cracking first being identified, and had commenced stabilisation and remedial works.

Regulator inspectors attended the mine site and assessed the extent of the road cracks and the highwall deterioration, as well as the remedial works and monitoring implemented by the mine.

Mine operators are reminded that when developing the control measures to manage the risks of ground or strata failure, consideration must be given to:

- the means by which water may enter the mine, and the procedures for removing water from the mine and how those procedures influence rock stability over time
- the geotechnical characteristics of the rocks and soil, including the effects of water on rock support and stability.
