# SAFETY BULLETIN

DATE: NOVEMBER 2019

## Hoist rope unravels over head sheave

This safety bulletin provides safety advice for the NSW mining industry relating to small gemstone mine person-riding hoists (winding systems).

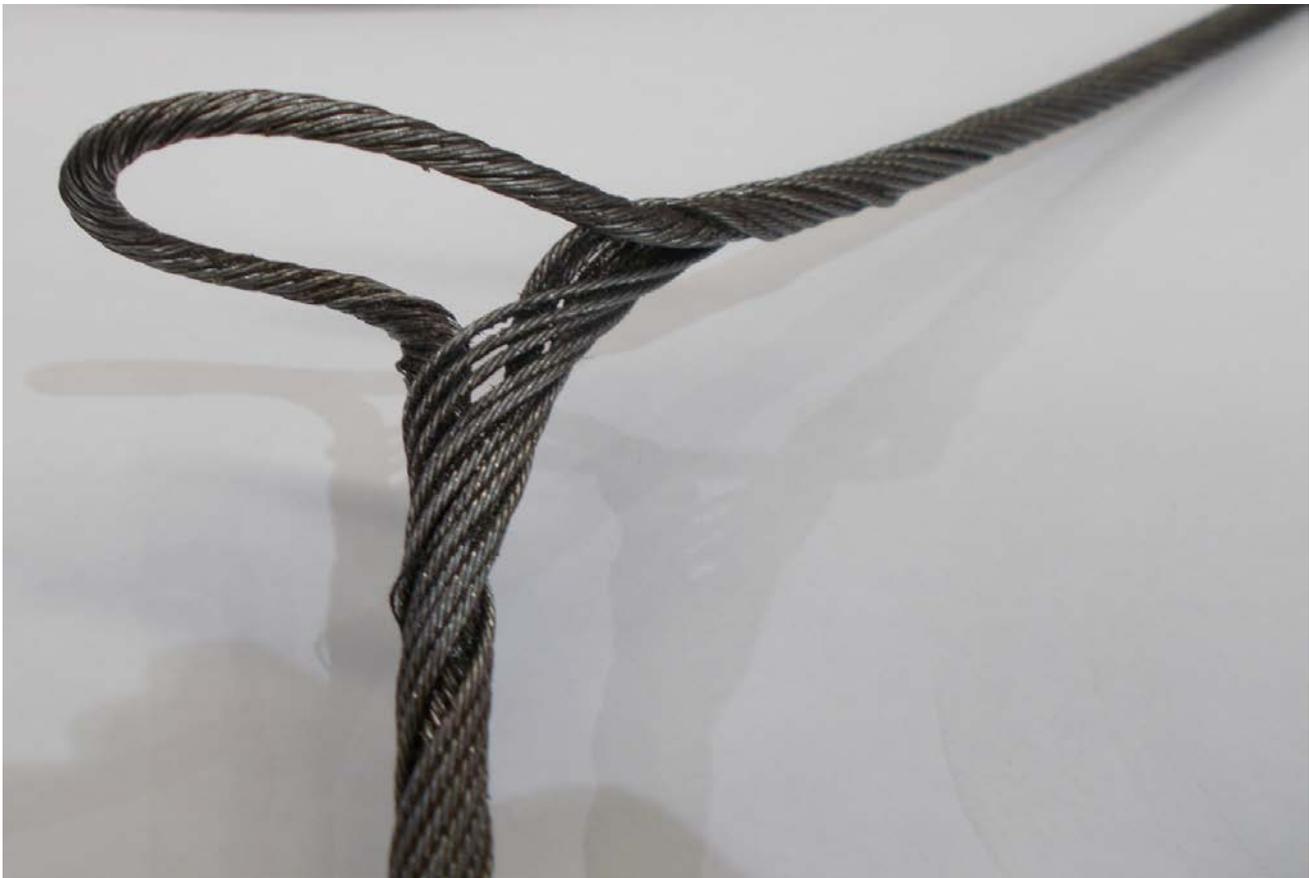
A person-riding gemstone hoist winch rope was found with the inner strand of the rope protruding from the rope lay in two places. This condition reduced the strength of the rope. This may have caused it to break and injure people, on or under the conveyance.

*Figure 1 Hoist rope with inner strand protruding*

In two places, the inner strand protruded from the outer rope layer as shown in figure 1. In other areas, some wires were found to be proud of the rope profile, as shown in figure 5 below.

When the rope was unloaded, the built-up torque in the rope resulted in two rope distortions occurring where the inner strand protruded from the rope.

The rope breaking force of the damaged rope was found to have lost 10% of its strength where the wire was proud of the rope and up to 50% loss of strength where the inner strand had protruded.

- carry out a visual inspection of hoist ropes to look for evidence of protruding wires or strands. If protruding strands are found, the rope must be replaced.
- measure both the head pulley groove diameter and rope diameter. Ensure that power to the hoist is isolated, all energy has been dissipated and safe access for working at heights is in place before taking measurements.
- consult the hoist designer to determine if the rope in service is compatible with the head sheave design.

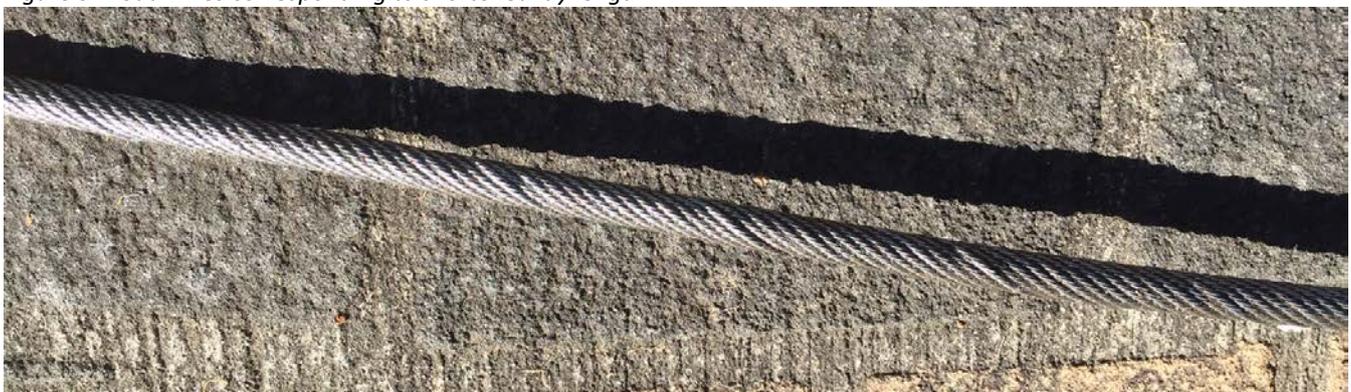
The rope lay length, which is the period of one strand from where it comes around the rope to the next in-line position was measured. The lay length was found to increase along the rope, affecting the non-rotating properties of the rope.

*Figure 5 Proud wires corresponding to shortened lay length*

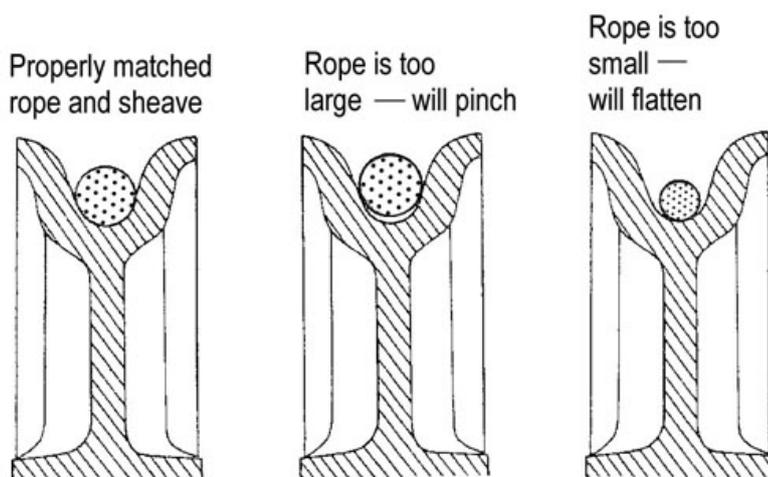
The rope condition is believed to be affected by compatibility factors associated with the head sheave groove dimensions.

Figure 7 Head sheave groove diagrams showing matched, tight and too large rope groove conditions.

- adhere to Australian Standard AS 3785.7 *Underground mining equipment – Sheaves* which gives guidance that the head sheave groove diameter should be 7.5% to 12% greater than the nominal rope diameter for which the sheave is designed.
- ensure that the sheave diameter should be equal to or larger than the diameter of the drive drum.
