WEEKLY INCIDENT SUMMARY

Week ending Friday 21 February 2020

CM9 reference	DOC20/138422
Mine safety reference	ISR20-08
Date published	27 February 2020
Approved by	Chief Inspector Office of the Chief Inspector

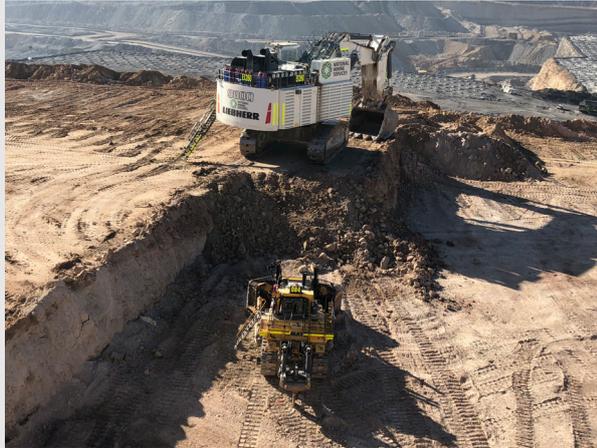
Dangerous incident
IncNot0036749
Open cut coal mine

An excavator was working across the face. A dozer was cleaning up and entered the swing radius of the excavator while it was placing a bucket of material in a truck. As the excavator bucket cleared the truck, it hit the lift cylinders on the dozer.

Effective communication protocols and procedures should be in place to ensure that positive communication between equipment operators is achieved. The proper use by operators of these protocols is monitored on a continuous basis.

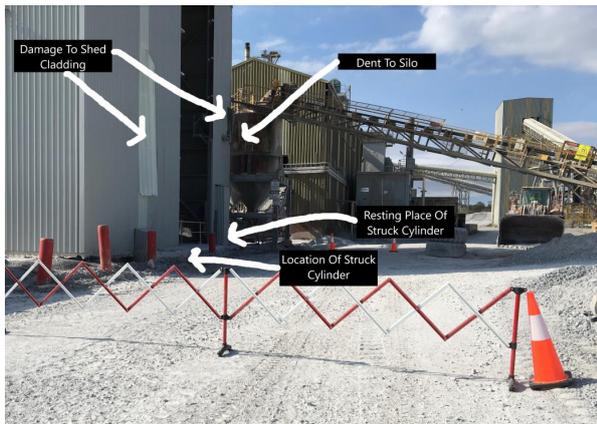
Dangerous incident
IncNot0036753
Open cut minerals mine

A loader was feeding a hopper, as it reversed it hit a red cylinder that was buried upside down. The cylinder was one of several that were being used as bollards for a collision barrier for a building. The cylinder was punctured, causing a pressure release that propelled it into the air where it hit buildings, before landing on the ground.

In developing control measures to manage the risks of interaction between mobile plant and fixed structures, mines should ensure that the control itself does not introduce a new level of risk.

Under **no circumstances** should gas cylinders be used for anything other than their intended use.

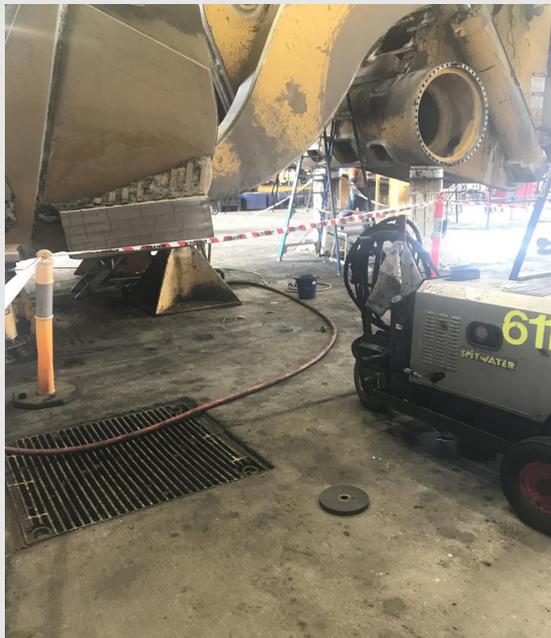
Dangerous incident
IncNot0036760
Open cut coal mine

While installing a body pivot bush on a dump truck using a hydraulic puller, a section of threaded bar failed. The threaded bar, nut and spacer were ejected in different directions.

The threaded bar landed about 5 metres away. The nut and spacer landed about 12 metres away in an adjacent workshop bay. No-one was injured.

Mechanical engineering control plans must set out the control measures for risks associated with the unintended release of mechanical energy by considering safe work systems for people dealing with plant or structures - including the isolation, dissipation and control of all mechanical energy sources from plant or structures.

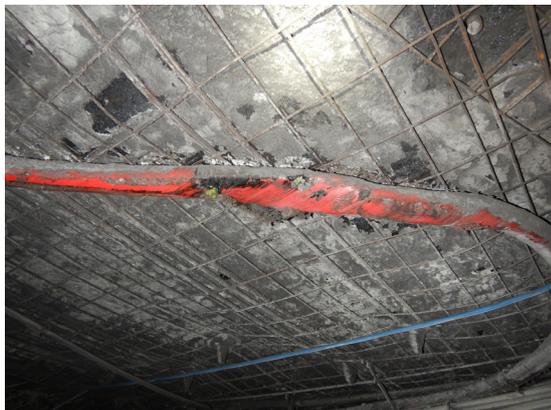
Dangerous incident
IncNot0036762
Underground coal mine

A longwall powered roof support was being transported out of the mine when the top of the support canopy contacted a high voltage cable that was looped across the roadway. Power was lost to inbye parts of the mine.

When developing control measures to manage the risks of roads or other vehicle operating areas, consideration must be given to the potential for interaction between mobile plant and fixed structures, including overhead and underground power lines, tunnel walls and roofs.

Factors for consideration include:

- roadway height and width
- load height and width
- location of cables and other services suspended from the roof.

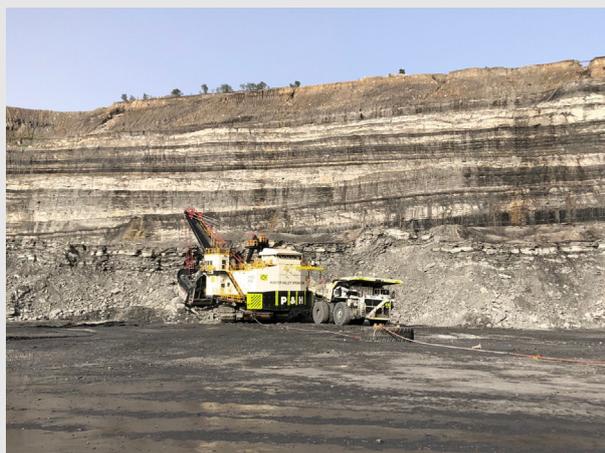
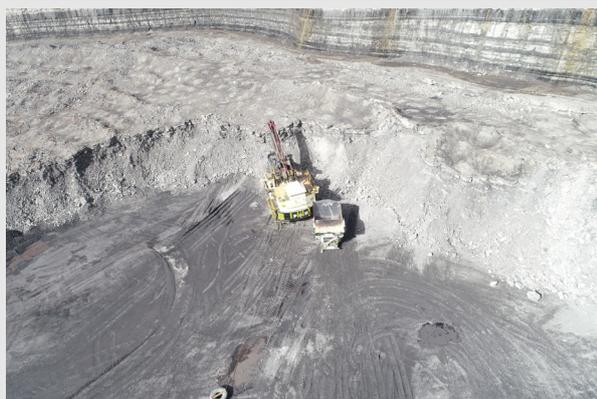
Dangerous incident
IncNot0036772
Open cut coal mine

A haul truck reversed into a shovel while self-spotting on the offside. The truck body penetrated the housing of the shovel. No one was injured.

Operational procedures for truck loading need to identify adequate controls for operators to use to guide them when self-spotting under shovels. Regular verification of the implementation of these controls should be undertaken by supervisors.

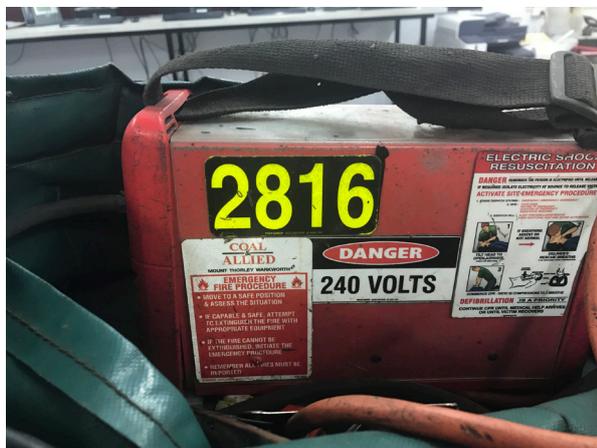
Dangerous incident
IncNot0036782
Open cut coal mine

A person suffered an electric shock from a welder while applying the earth clamp to a work piece.

People involved with welding activities should remain insulated from the welding job. Welding gloves are not electrical insulators and if they are damp, they can enhance the effect of an electric shock.
