**NSW
Resources
Regulator**

WORKERS EVACUATED AFTER GAS LEVELS RISE

Causal investigation

Title: Causal investigation report - Workers evacuated after gas levels rise

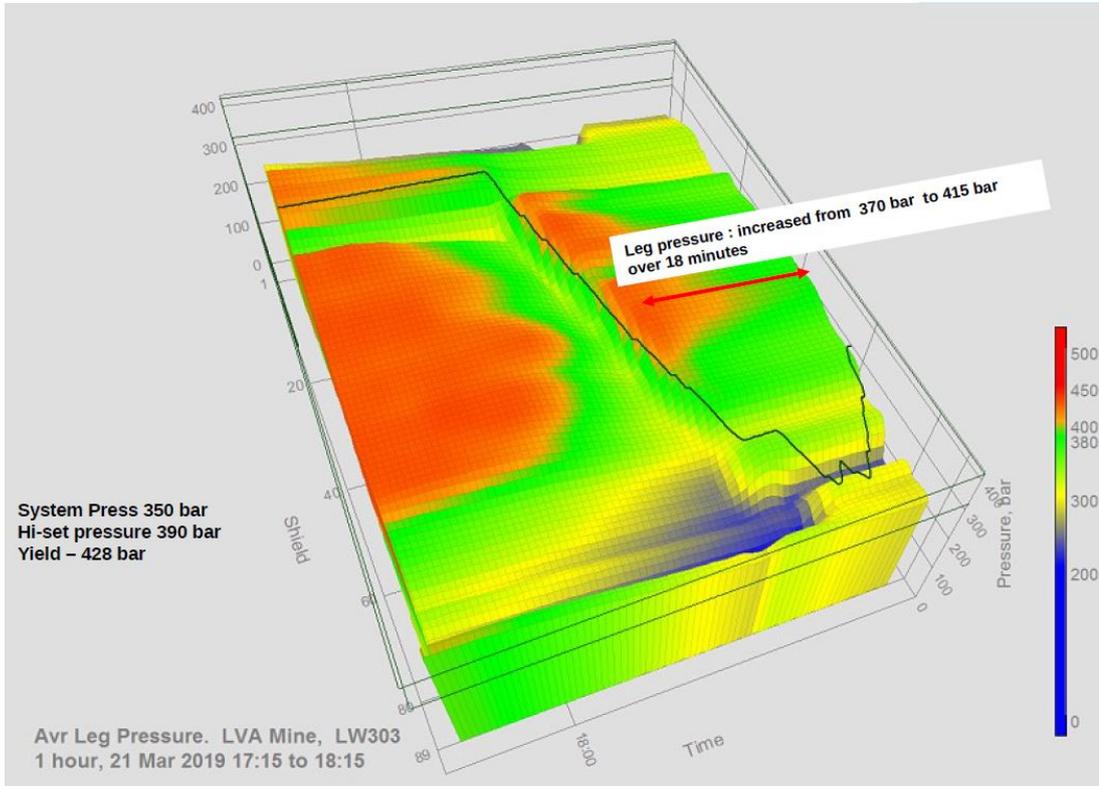
Figure 1- Longwall visual analysis shows the shearer position and chock pressures

Loading of shields recorded by longwall visual analysis monitoring system demonstrates rapid leg pressure increase across the face (tailgate in foreground/maingate in background - Figure 1) at the time of the incident.

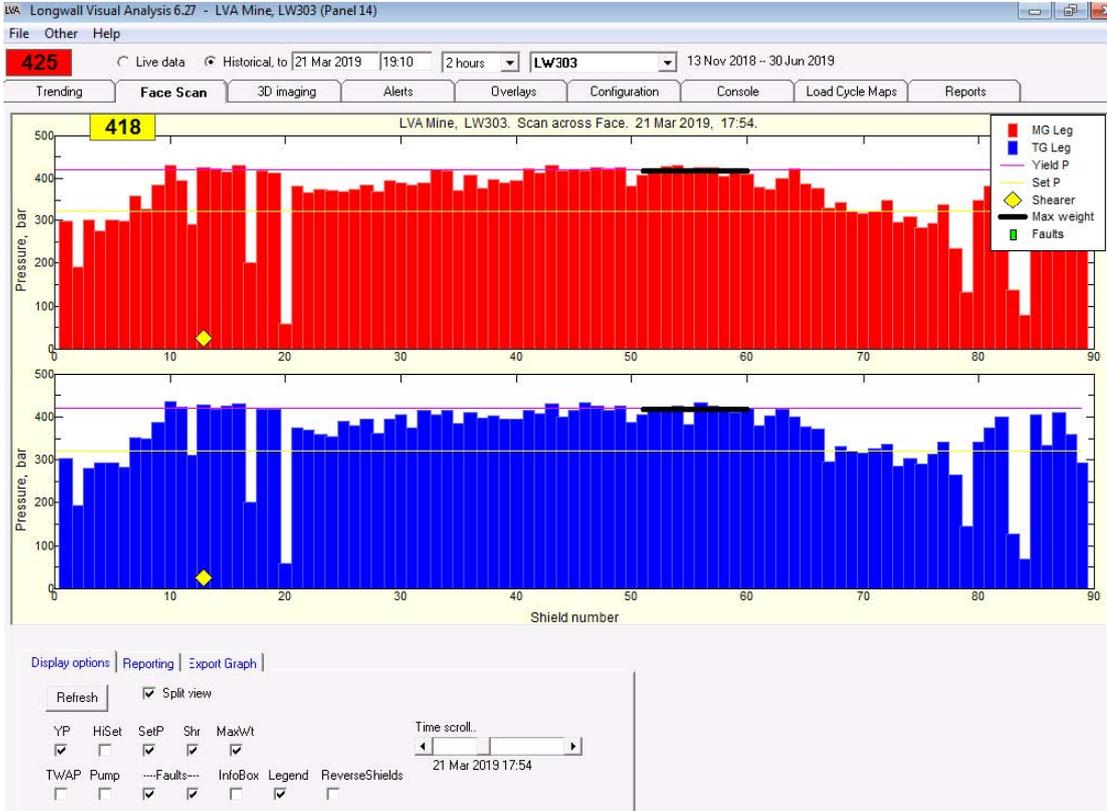
Figure 5 – Longwall visual analysis shows the shearer position and chock pressure at 5.54pm.

Note: yield areas.

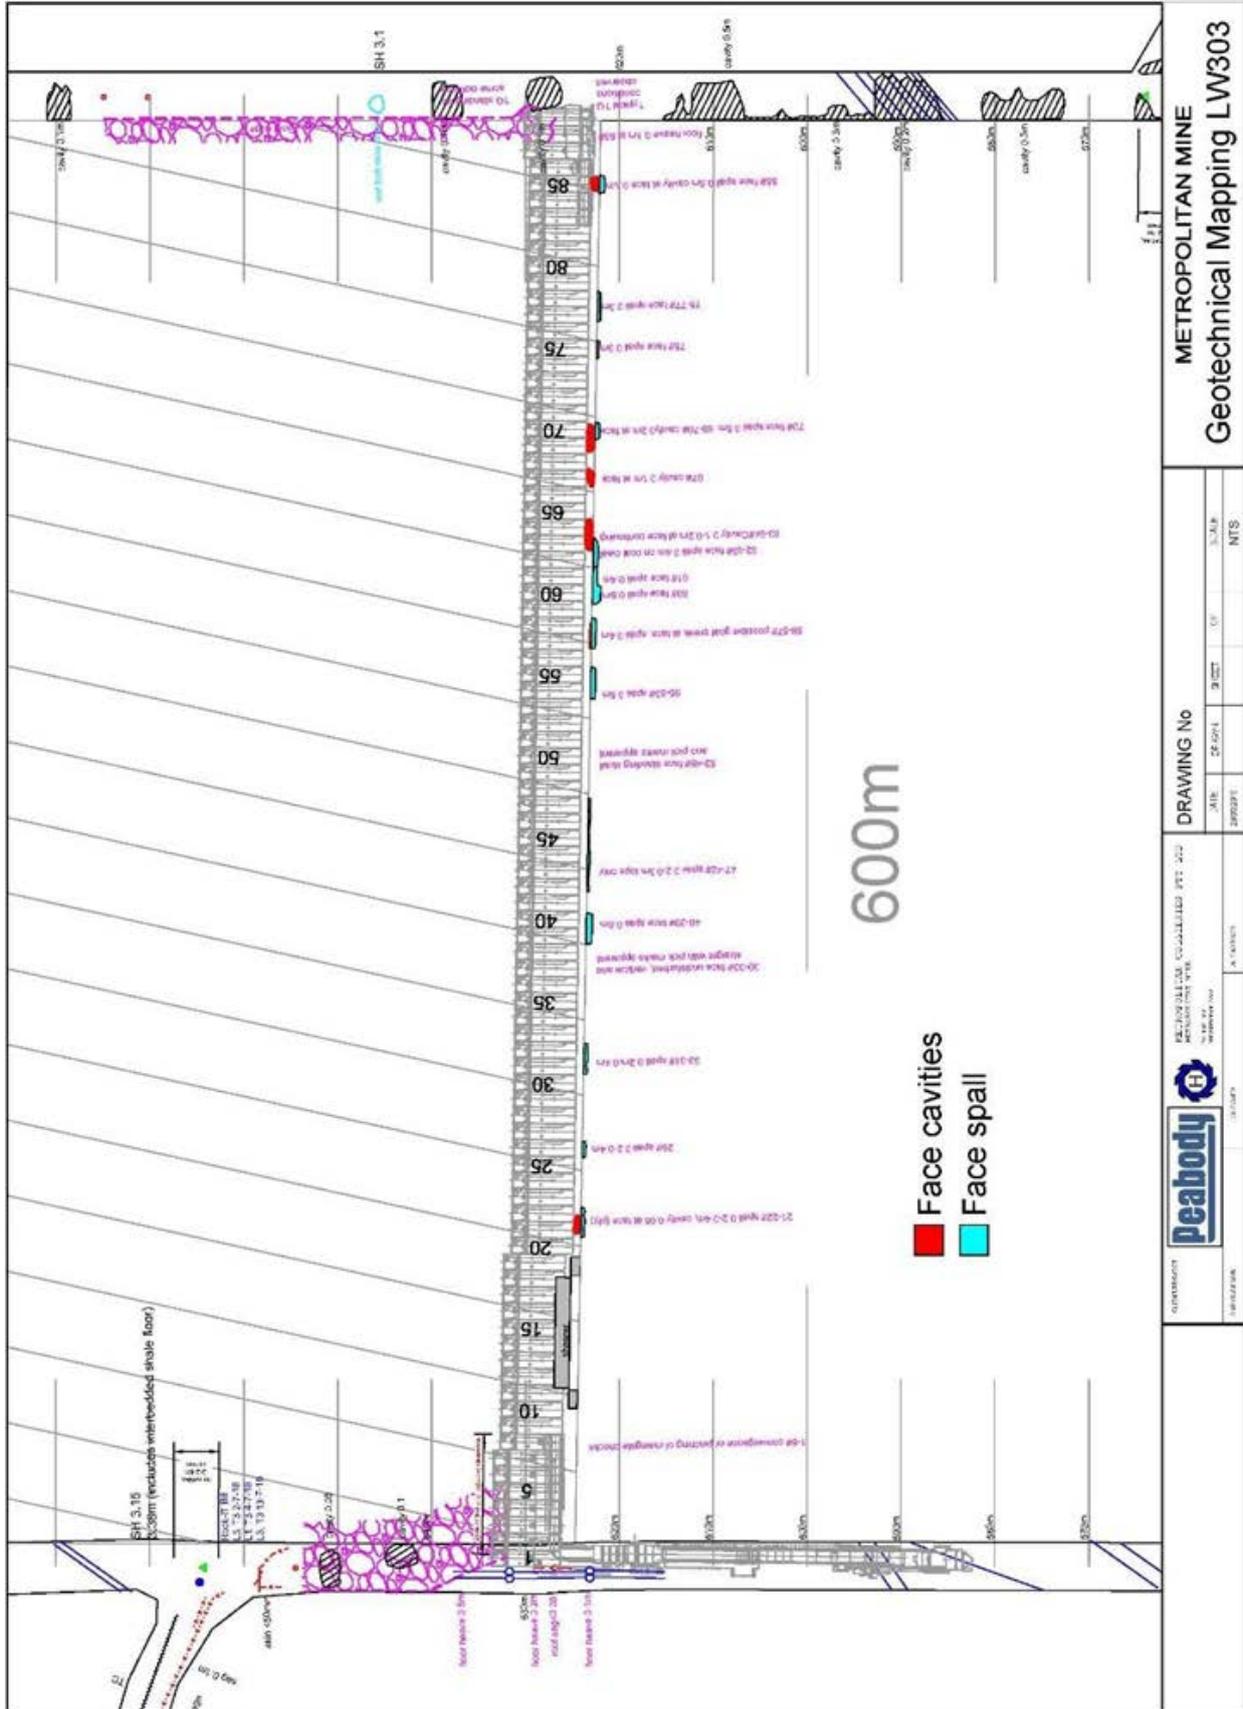
Figure 12 Geotechnical mapping of longwall 303 face after the incident

- There was no apparent faulting or fault-related characteristics (i.e. slickensides, mylonite, slickensides on bedding planes, intense jointing, changes in coal cleat direction/dip) that would raise suspicions that a fault may be present.
- There was no abnormal face spall or extended tip to face outside of normal operating conditions. Face spall ranged between 0.1 to 0.6 metres, most commonly observed between

0.2 and 0.4 metres. Sections of the face were noted as undisturbed since the last completed shear characterised by a vertical standing, straight face with visible pick marks. The locations were: 52-58# and 39-33#.

- 67# 0.1m cavity at face
 - 69-70# cavity 0.2 metres at face and
 - 84# cavity 0.1 metres at face.
- The goaf was observed to readily cave immediately at the rear of the canopies, with no abnormal hang ups or areas of concern outside of normal face conditions.

- Maingate floor heave and chain pillar rib side fracturing/softening. Floor heave was estimated to be less than 0.1 metre at chainage 623 metre increasing to approximately 0.2 metre at the maingate corner (approximate chainage 630 metre) and into the goaf besides number one face support where it is estimated to be 0.5 metre. The face is at chainage 624.7 metre.

- Maingate roof sag was less than 0.05 metre besides and above number one face support.

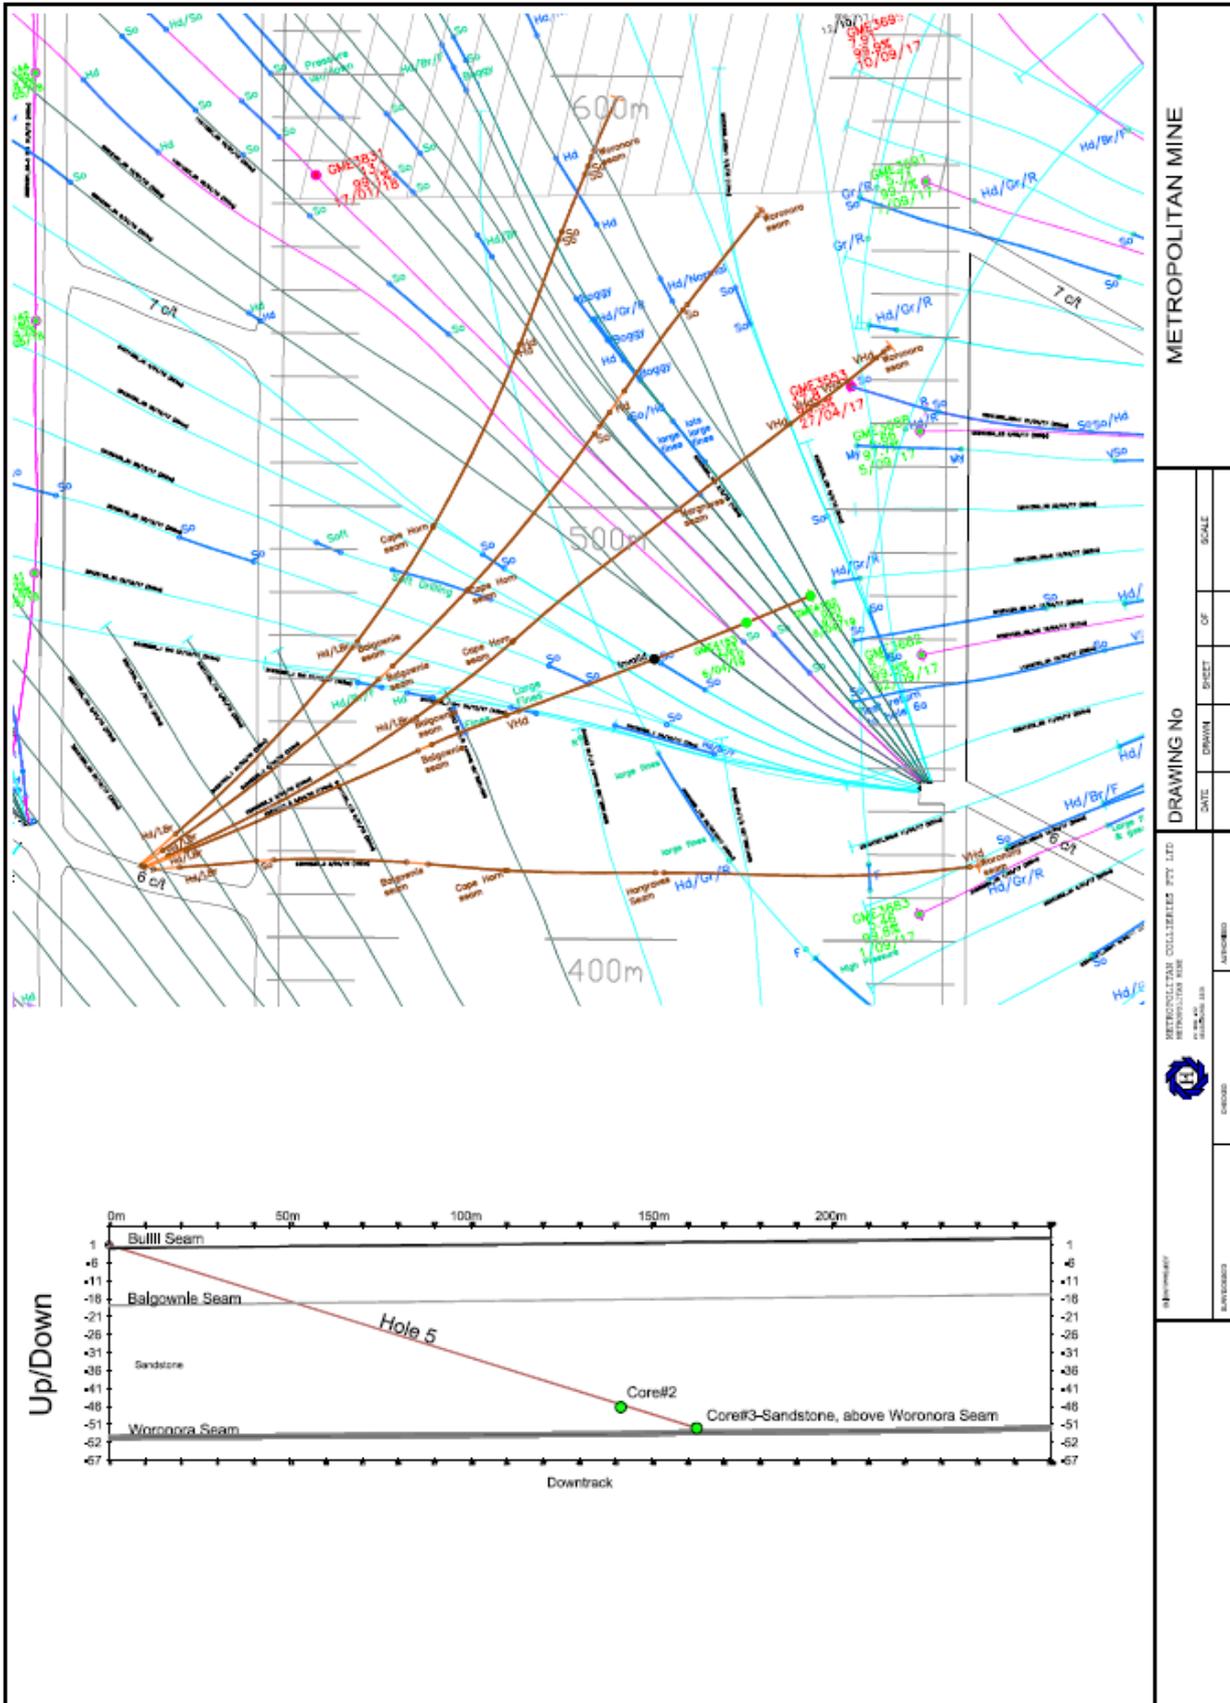
Figure 19 Interburden gas drainage holes drilled after re-entry

In the week following the re-entry to the underground workings, five cross measure gas drainage holes were drilled into the interburden below the Bulli seam to the Woronora seam some 50 metres below.

One core indicated a gas content of 2.63m³/t in the sandstone above the Woronora seam.

Further measurements taken on 16 May 2019 indicated the flows generally decayed.

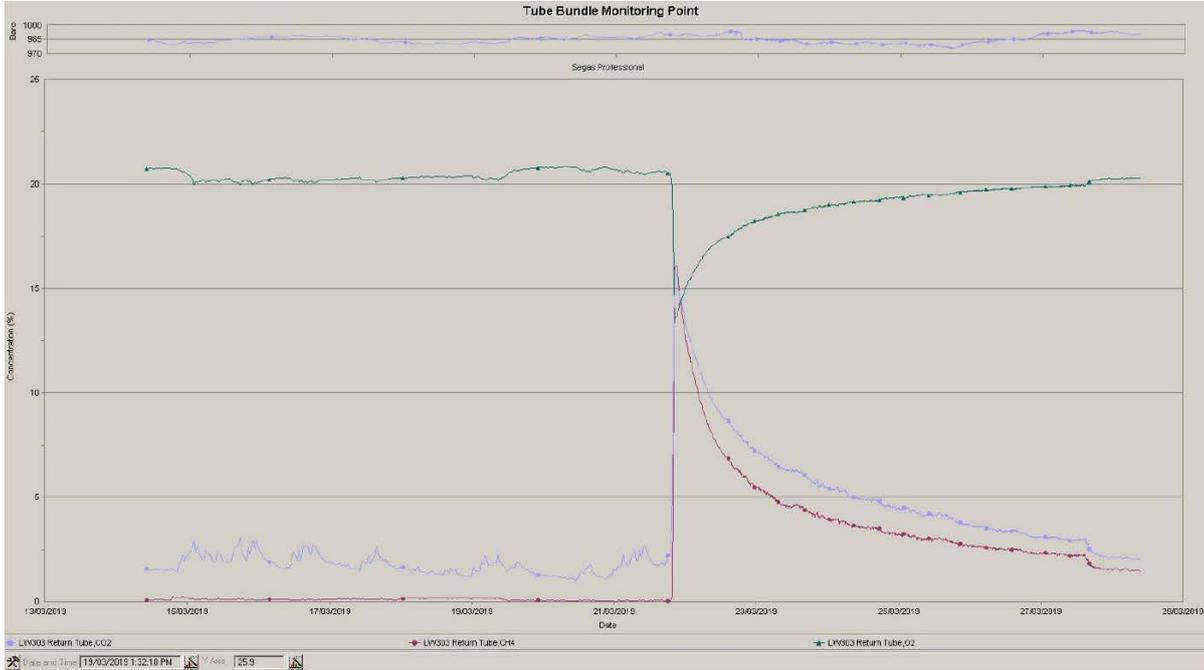
Figure 21 Longwall 303 tube bundle gas trends

As can be seen in the longwall 303 return airway tube bundle gas trends, methane reached 16.1%, carbon dioxide 15.9% and the oxygen decreased to 13.5% before slowly trending towards normal background levels. Longwall 303 return ventilation quantity at the time of the event was 43m³/s.

Note the increased longwall 303 ventilation adjustment effects on the trends at the lower right-hand side of the graph.

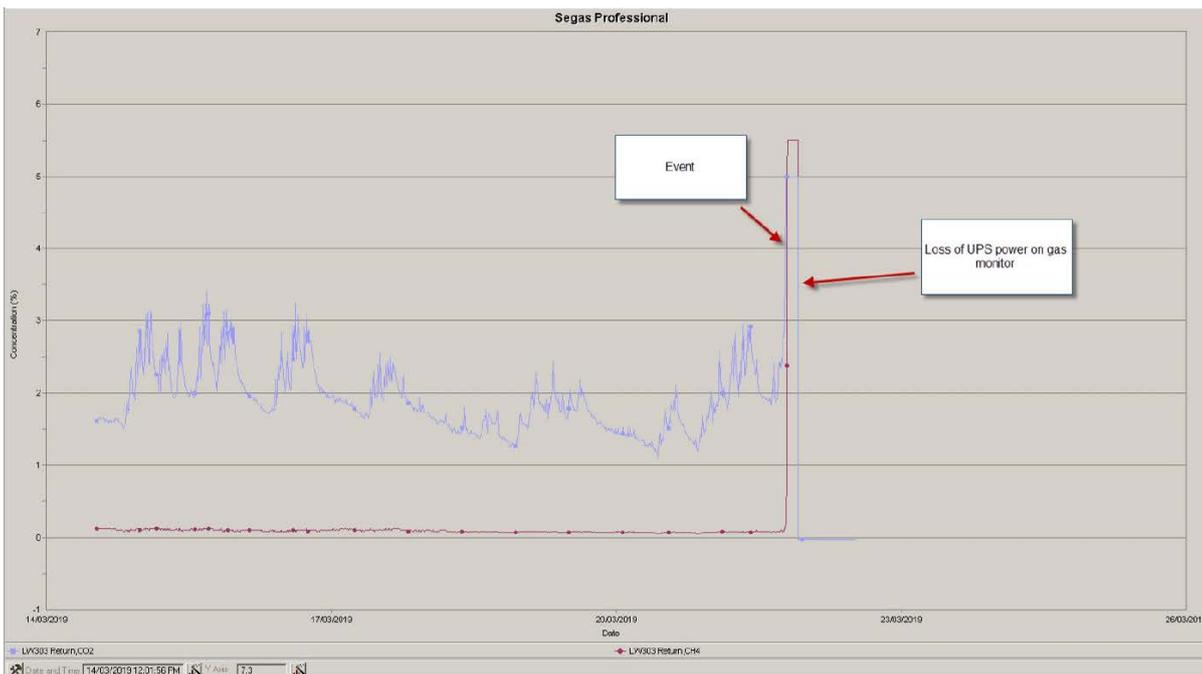
Figure 22 Longwall 303 real time gas trends

As can be seen in the real time gas trending, the monitors detection capacity was limited to the vicinity of 5% and the uninterrupted power supply loses functionality after one hour and 10 minutes.

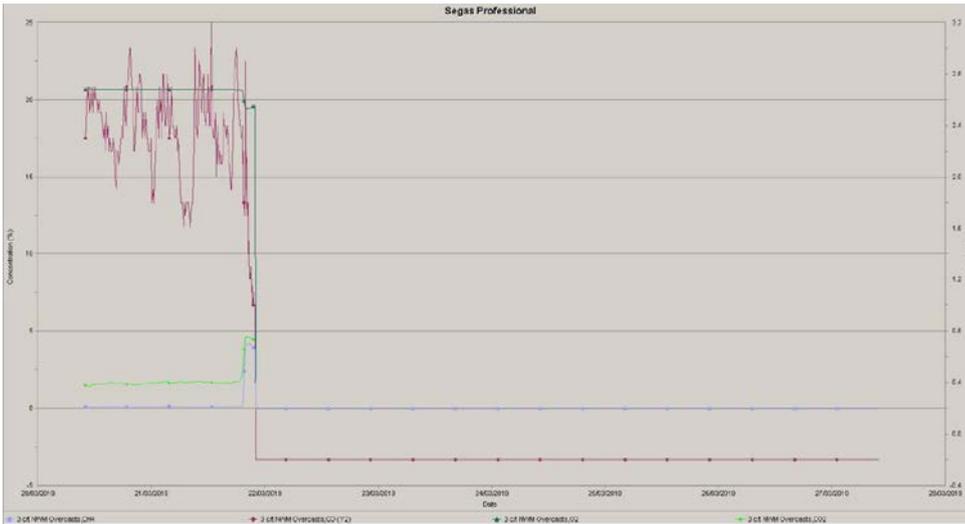
Figure 23 North west mains three cut through real time gas trends

This real time gas trend for the north west mains return airway shows the carbon dioxide in green increased from 1.7% to 4.7% and the methane from almost zero to 4.2%. The uninterrupted power supply here again ceased functioning after one hour and 10 minutes.

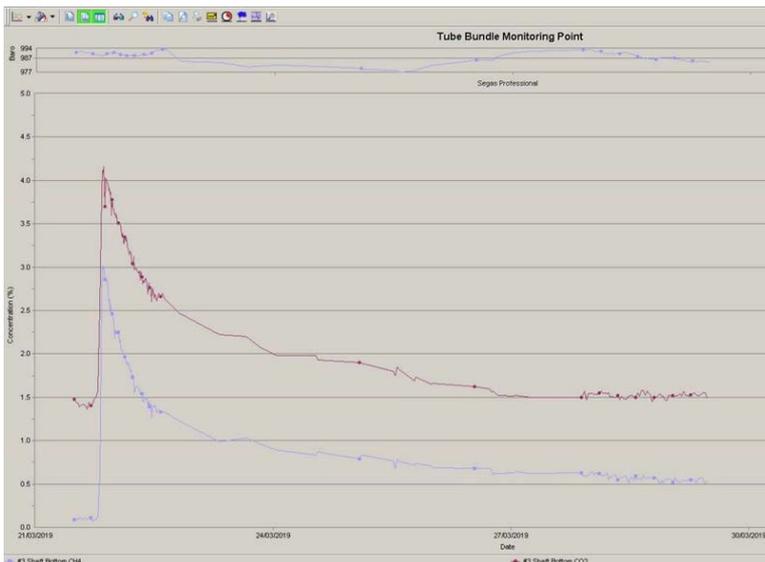
Figure 24 Upcast #3 shaft bottom tube bundle gas trends for carbon dioxide and methane

The gas content exhausted through the main fans reached 4.16% carbon dioxide and 3.01% methane with 285m³/s of ventilation.

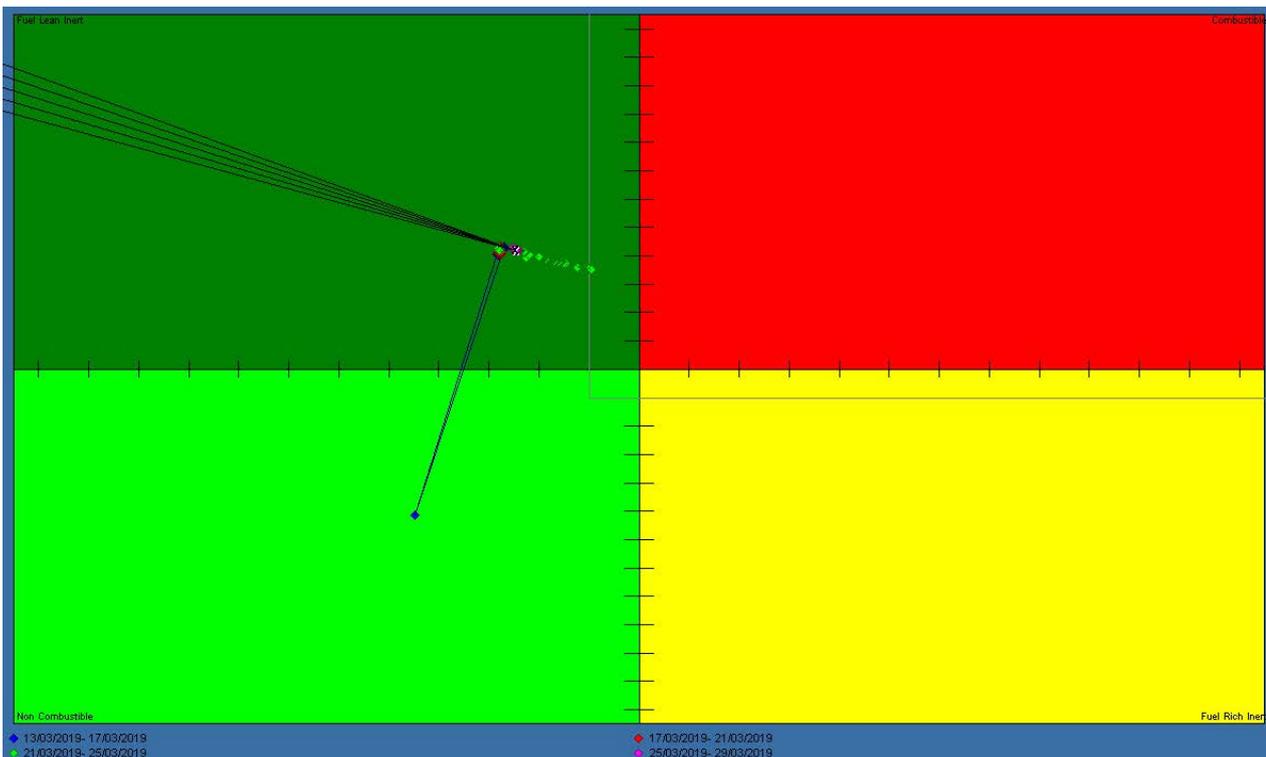
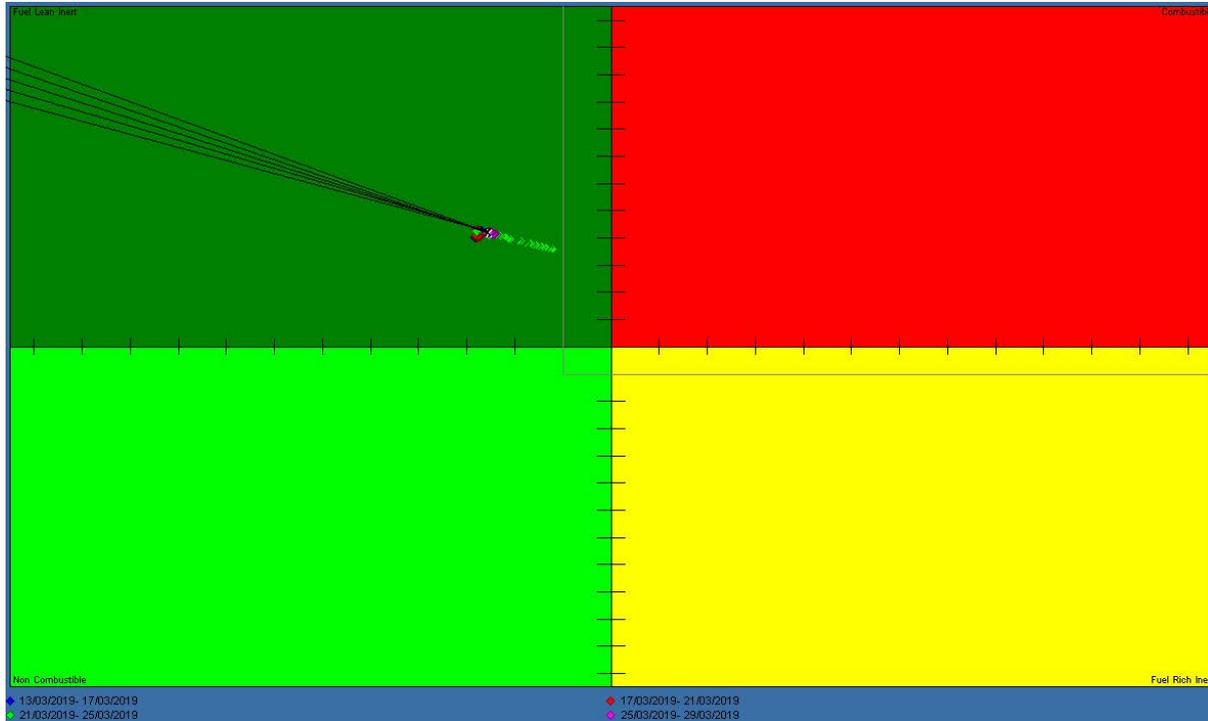
The methane levels in north west mains and the #3 return shaft did not reach an explosive atmosphere on the above two Ellicott trend diagrams.
