# WEEKLY INCIDENT SUMMARY

Week ending Friday 15 May 2020

This incident summary provides information on reportable incidents and safety advice for the NSW mining industry. To report an incident to the NSW Resources Regulator: phone 1300 814 609 24 hours a day, 7 days a week.

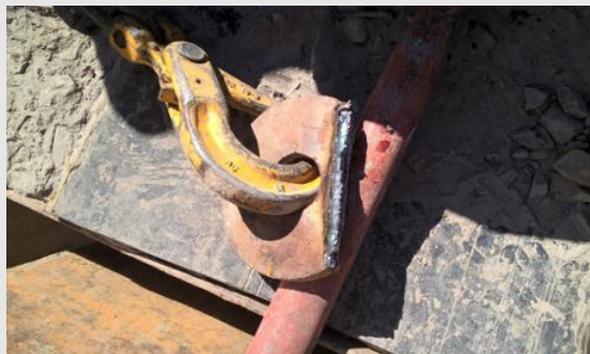
Serious injury  
IncNot0037349  
Underground metals  
mine

A boilermaker was conducting repairs to a jaw crusher and welded a lug to the upper centre portion of the fixed plate before trying to lift it out using an excavator and lifting attachments.

The plate appeared to be stuck so the lift was stopped, but tension remained on the lifting equipment. While standing on the crusher platform, the boilermaker leaned over to see what was preventing the plate coming free. At that point, the welded lug broke away and hit the boilermaker's hard hat, causing damage to the hat, which in turn caused an eight centimetre cut to the boilermaker's forehead.

Without protection from the hard hat, the consequences could have been far more serious.

In this instance, the hazard introduced by welding a temporary lifting lug and connecting it to lifting equipment was not identified, therefore the risk of the weld failing was not assessed.

Mine operators should review how workers and supervisors are trained in recognising the potential hazards associated with all energy sources including the stresses and strains introduced by lifting equipment on plant.

This is especially important when there is the potential for unexpected stored energy to be released without warning.

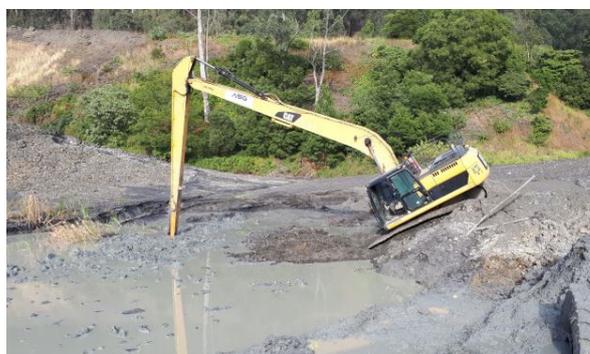
Dangerous incident  
IncNot0037359  
Quarry

An operator was digging out a sediment pit with a long-reach digger when the ground at the front of the digger gave way and the digger tipped forward about 45 degrees.

The operator lowered the bucket to stabilise the digger and exited the machine.

The excavator was working from a constructed bench to remove sediment and load it into a haul truck.

Equipment operators must maintain situational awareness and remain vigilant to the risk of machine rollovers.

Suitable bunding should be in place to protect mobile plant from accessing edges of benches. If bunding is not installed, there should be adequate demarcation of the work area, so operators are aware of their positioning in relation to the bench edge.

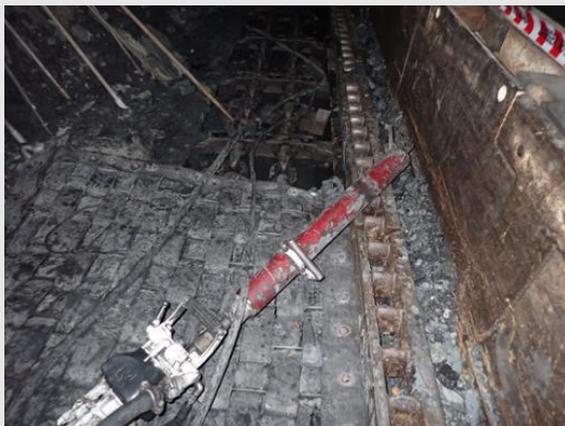
Serious injury  
IncNot0037358  
Underground coal mine

A work crew was using a panther drill with an air leg to drill shot holes in a longwall dyke.

When drilling a hole just above ground level, the air leg was braced against the vertical face of the shearer drive rack bar. Due to the drill orientation and the air leg resting on the rack bar, an offsider placed his foot on top of the air leg to stop it from slipping.

During drilling, the pusher leg feed control knob became caught on the rubber woven explosion mat that was laid over the AFC, resulting in activating the air relief button. This depressurised the air leg and it no longer had positive contact with the rack bar.

As the drillers pulled at the drill to free it, the relief button was released and repressurised the air leg, pushing it over the

top of the rack bar and pinning the offsider’s foot against the AFC spill plate.

The hazards introduced by using the rubber matting and an unsecured airleg were not identified and therefore not risk assessed.

When work tasks vary from existing standard procedures, workers and supervisors must identify any new hazards, assess the risk arising from those hazards and implement additional controls where necessary. No-go zones should form part of the job instruction when there is a risk from moving parts, such as an air leg.
