**NSW
Resources
Regulator**

INVESTIGATION REPORT

REPORT INTO THE DEATH OF MR ANDREW BRAY

Snapper Mineral Sands Mine 12 August 2019

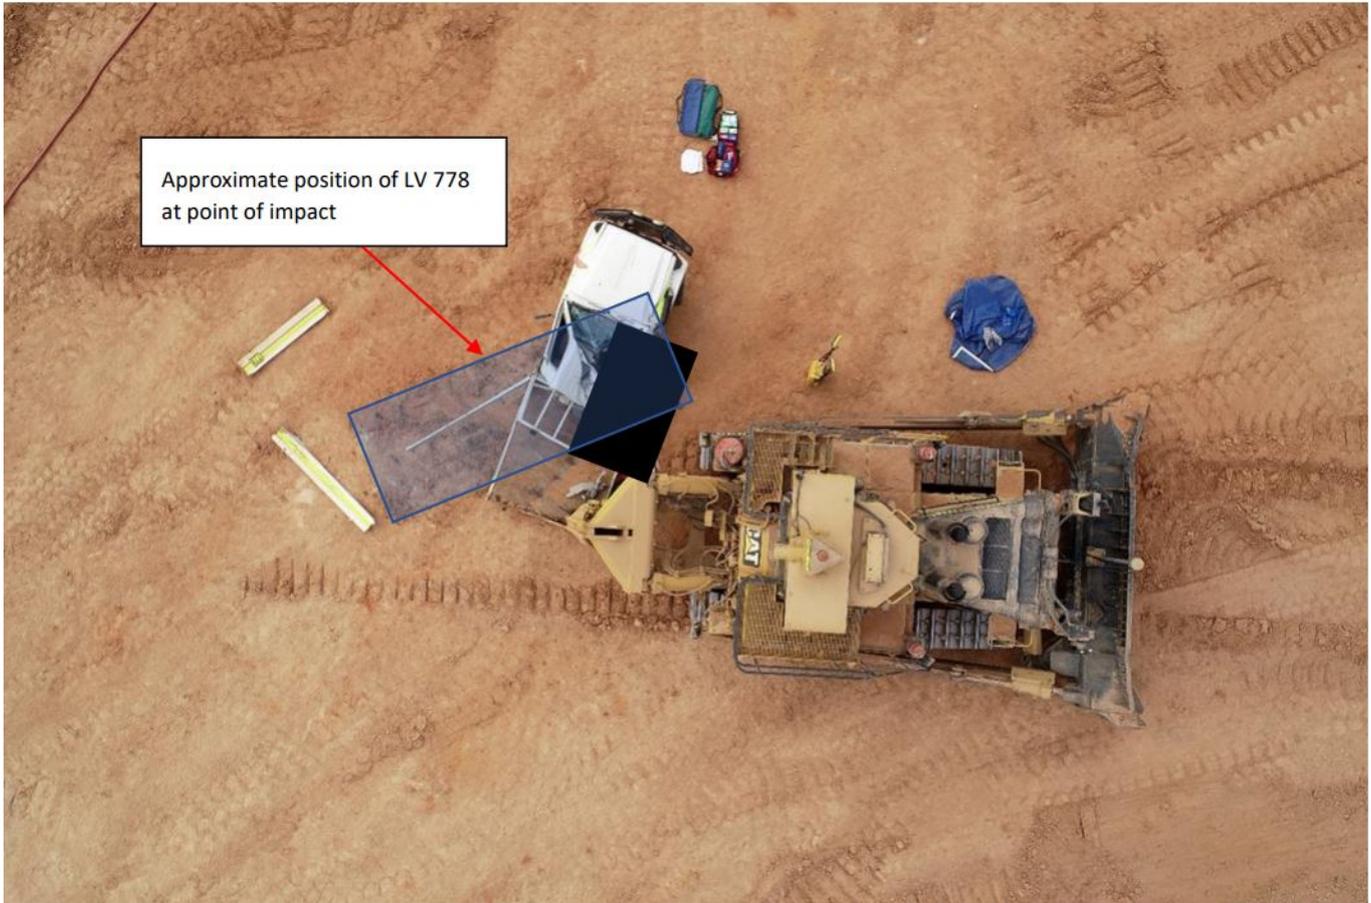
Figure 7: Approximate position of LV 778 at point of impact

It is also not known if LV 778 was stationary or moving at the time of impact. After the incident, the light vehicle was found with its engine idling, gear stick in neutral position and park brake not applied, providing some indication that it may have been stationary at the time of impact.

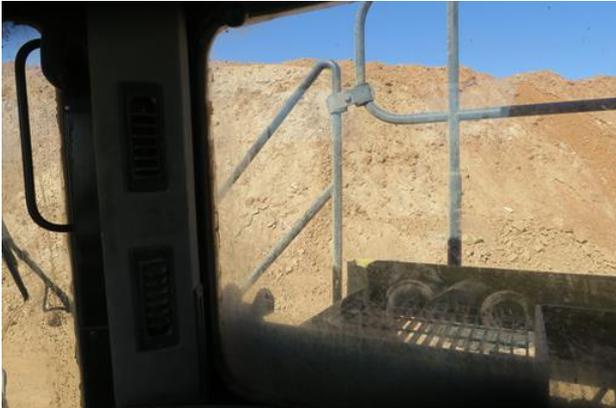
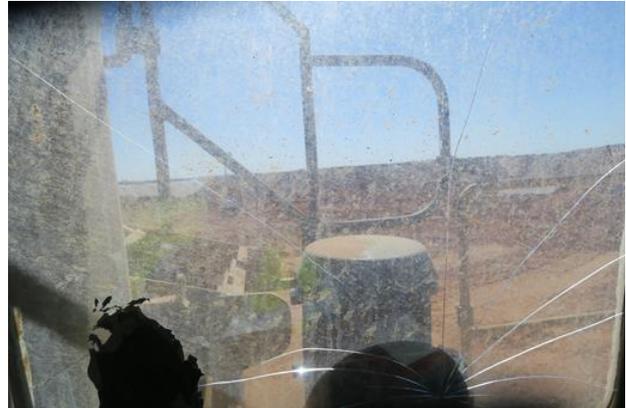
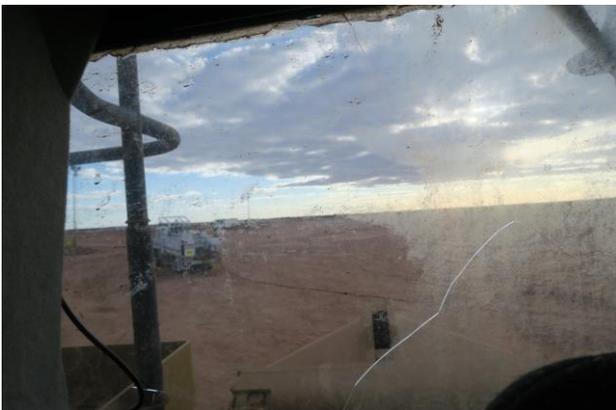
Figure 10: Caterpillar D10T dozer 813 in cabin view at incident location

The DZ 813 operator recalled that, at the time of the incident, visibility from the rear of the dozer was very poor due to the glare from the low afternoon sun position and dust blowing around the area caused by the unloading of the dump trucks. The DZ 813 operator estimated that visibility from the rear of the dozer was two to three metres.

BSL operations at the Snapper mine comprised a fleet of four Caterpillar D10T dozers. The design and configuration of the dozers' access platforms, roll-over protection system, ripper implement and other componentry caused areas of limited visibility, particularly from both side and rear cabin windows. Figure 9 shows the visibility diagram contained within the CAT D10T OEM operator's manual with the shaded areas depicting the approximate areas with significant restricted visibility. Figure 10 depicts the view from the operator's cabin of DZ 813 at the incident location.
