# WEEKLY INCIDENT SUMMARY

Week ending Friday 20 August 2021

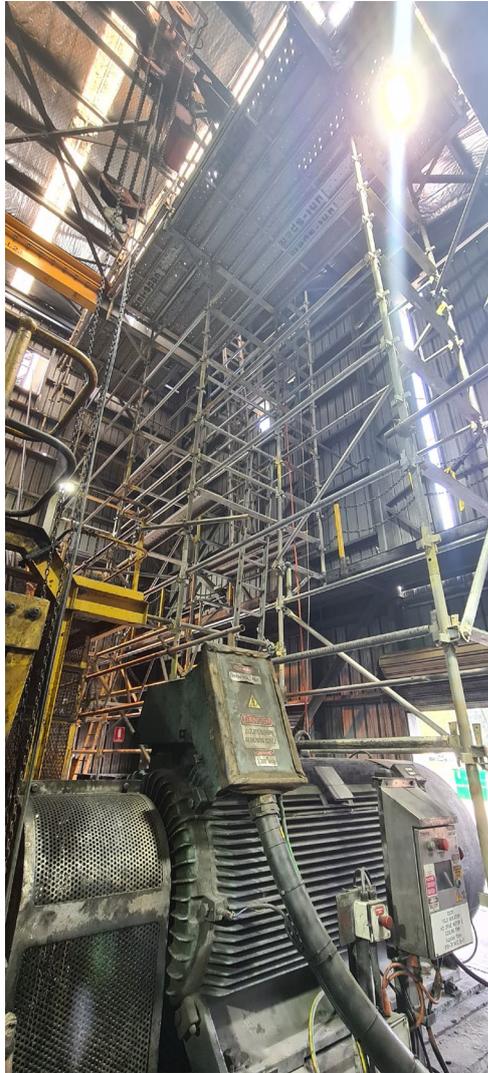
INCIDENT	SUMMARY	COMMENTS TO INDUSTRY
Dangerous incident IncNot0040523 Open cut coal mine	A mine worker has fallen while climbing a ladder to access scaffold. The worker fell approximately four metres, landing on a co-worker, who was standing at the base of the ladder, on a scaffolding platform. The worker who fell, lost consciousness and sustained a head laceration which required 16 stitches. The worker who was fallen on, sustained a neck injury. Both workers were transported to hospital for treatment. The outcome of this incident could have been far more serious, as there was a drop of several metres from the lower scaffold platform to the floor of the work area.	This incident is under investigation. Further information may be published in future.  Mine operators must ensure that there are effective controls in place to manage the risk of falls while climbing onto and from scaffold ladders. All workers, who install or work on scaffolding should be familiar with site scaffolding procedures. This should include design and construction requirements, and necessary safety equipment, such as when fall protection equipment is required.

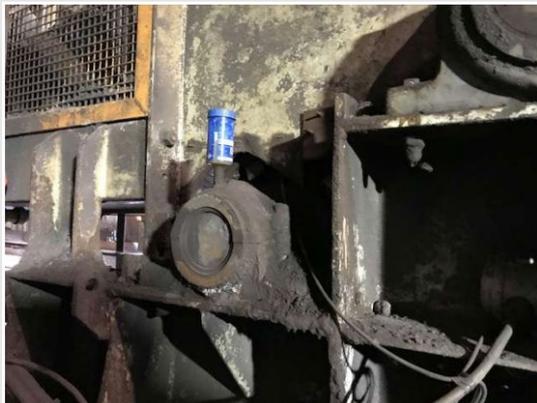
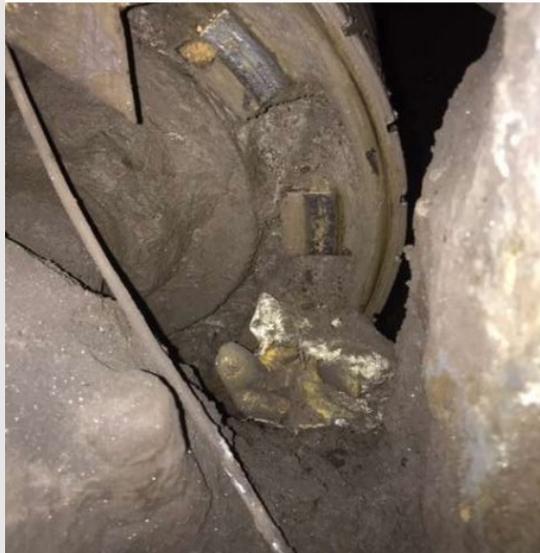
Dangerous incident  
IncNot0040503  
Surface fixed plant

A worker lost his footing, stumbled and his right hand hit an unguarded conveyor snub pulley. The worker required surgery for injuries to his hand.

Mine operators and workers must ensure that, before guarding around plant is removed for maintenance or cleaning purposes, all energy sources are isolated. Guarding must be restored to its secured position before the plant resumes operation. Mine operators should review:

- Work Health and Safety Regulation 2017 cl 208 and cl 210.
- SafeWork NSW – Code of Practice – Managing the risks of plant in the workplace.
