## Investigation report

Investigation into the death of Jeremy Mathew Junk at  
the CSA Mine, Cobar NSW on 16 March 2013

Report prepared by the NSW Mine Safety  
Investigation Unit

June 2014

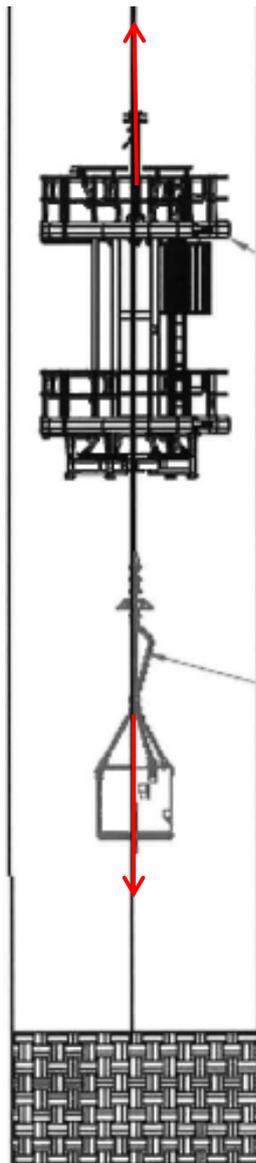
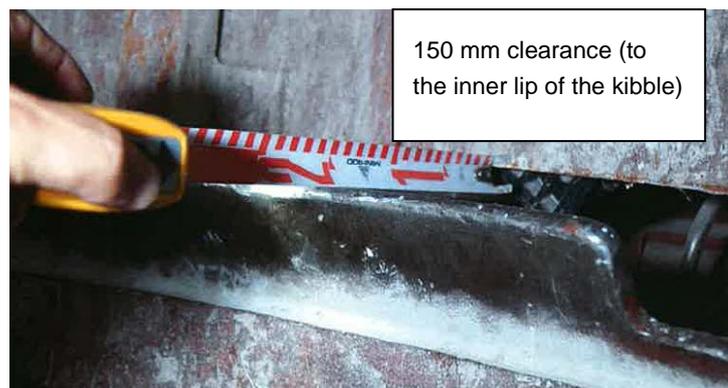
Figure 10. Clearance between kibble and stage.

Figure 11. Diagram of ability of kibble well to traverse through the stage.

The diagram (left) demonstrates the ability of the kibble to traverse through the stage's kibble well vertically. This enabled the stage and kibble to be used in the shaft at the same time. The interaction between the kibble and stage was a significant factor in the investigation. The design dimensions of the Ballarat dual platform stage and the dimensions of the kibble provided very small clearances when the kibble traversed through the kibble well. These small clearances resulted in the creation of three hazardous pinch points in the kibble well. These were identified as the lower platform bell mouth, centre core bracing and upper platform of the stage. These pinch points were highlighted in several risk assessments before the 'blind sink' began. According to the design specifications of the stage and kibble there was a total of 70 millimetres clearance between the kibble and the inside diameter of the kibble well. Investigators measured clearances between the inner lip of the kibble and the upper platform of the stage to range between zero and 150 millimetres. These clearance distances varied depending upon the swing of the kibble on the kibble rope. The following photograph depicts the proximity of the kibble to the upper platform of the stage.

The design of the stage created three pinch hazardous points in the stage kibble well identified as the lower platform bell mouth, centre core bracing and upper platform of the stage. The design of the stage did not provide adequate clearances to eliminate potential pinch points, nor did it incorporate any form of physical barrier in the kibble well to prevent persons riding in the kibble from exposing their body parts to these pinch points. The design of the stage and absence of elimination, substitution or engineering controls to prevent persons from exposing their body parts to hazardous pinch points is a key contributing factor in this incident.

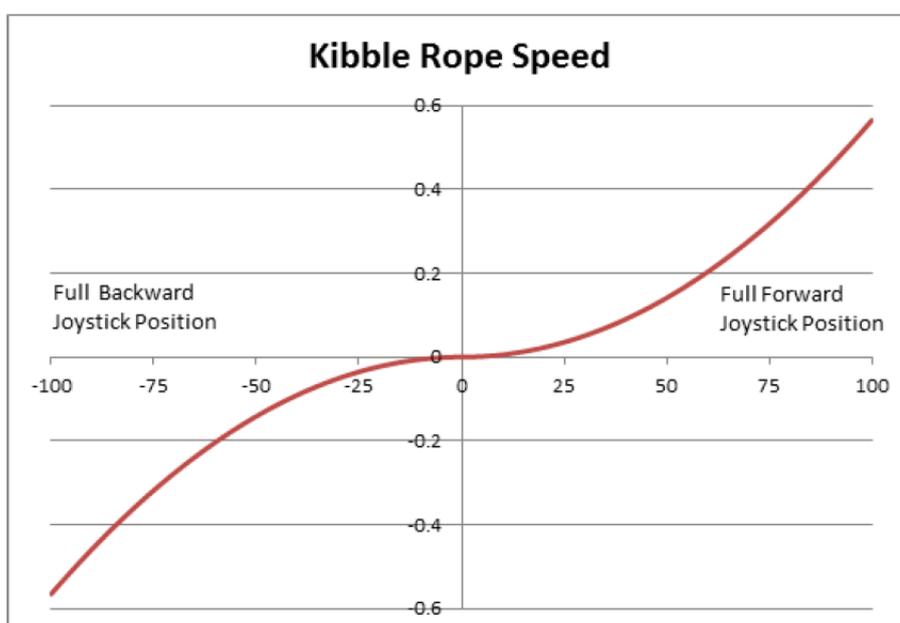
Figure 13. Kibble winder (Man 78) variable speed range.

The above diagram highlights that the kibble winder could be operated at any speed up to its maximum speed of 0.55 metres per second. The investigation did not determine the exact speed of the kibble winder when the incident occurred, but shaft workers reported that the kibble speed appeared normal. Subsequent testing of the winder system by investigators found the system to be functional and there was no evidence of winder system error or malfunction.

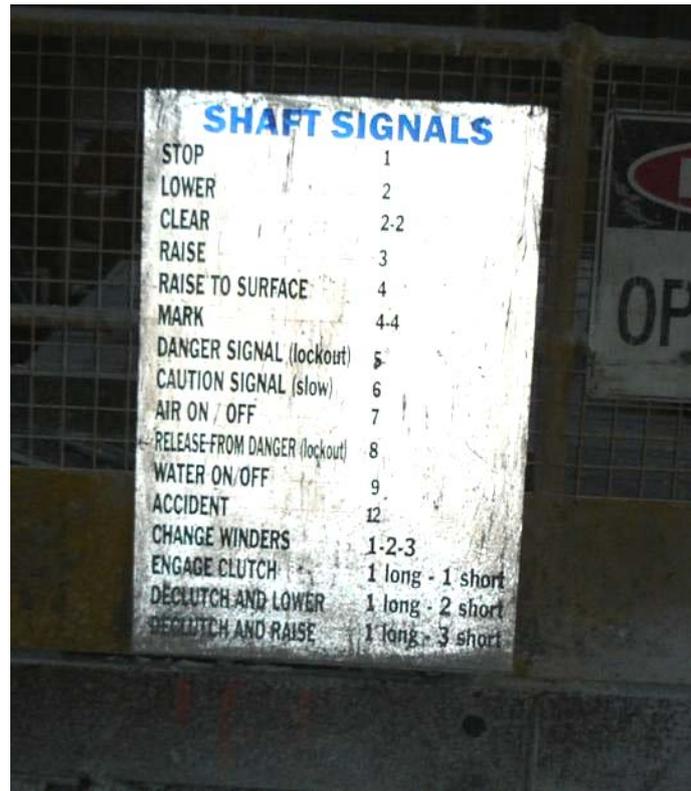
Figure 16. Shaft signal signage at the 9240 brace level.

The shaft signalling system did not encompass a specific signal identifying when people were riding in the kibble in accordance with recommended industry practice. Accordingly there was no way for the winder driver to know that Mr Junk was in the kibble when the incident occurred.

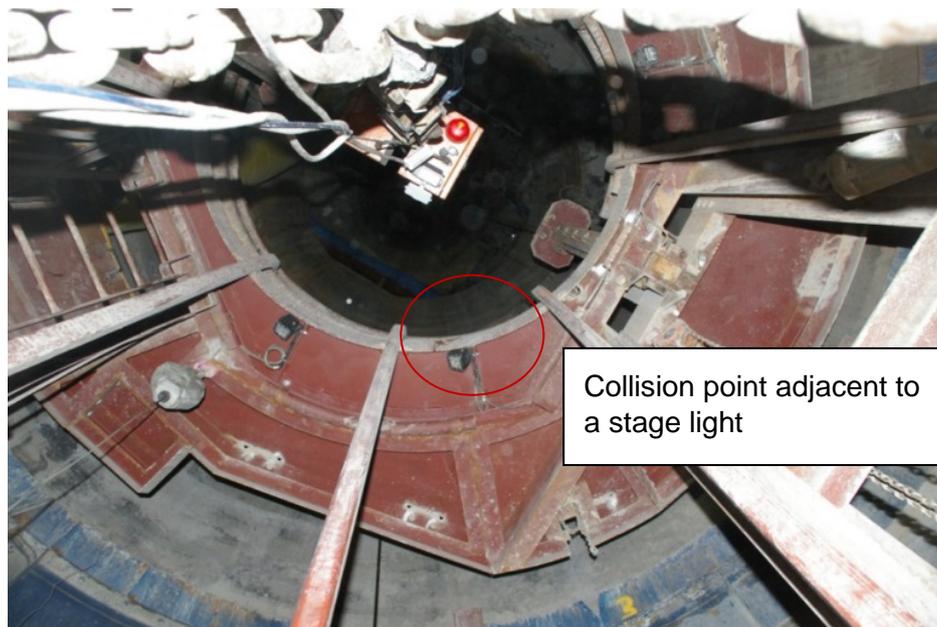
Figure 18. Photograph of stage lighting looking upward toward collision point.

The collision point where Mr Junk's head hit the upper platform of the stage was directly adjacent to one of the stage lights.

CCTV footage confirmed that the stage lighting was not operating when the incident occurred. The non-operational stage lighting had the capacity to project 480 lux onto the stage work environs. The absence of this lighting created a working environment with limited peripheral illumination and likely impaired situational awareness.

When operating machinery or performing maintenance or assembly tasks recommended lighting levels should range between 200 and 800 lux. Inadequate lighting impairs one's ability to identify peripheral hazards and judge movement and speed of equipment. A miner's cap lamp provides limited range and limited peripheral illumination.

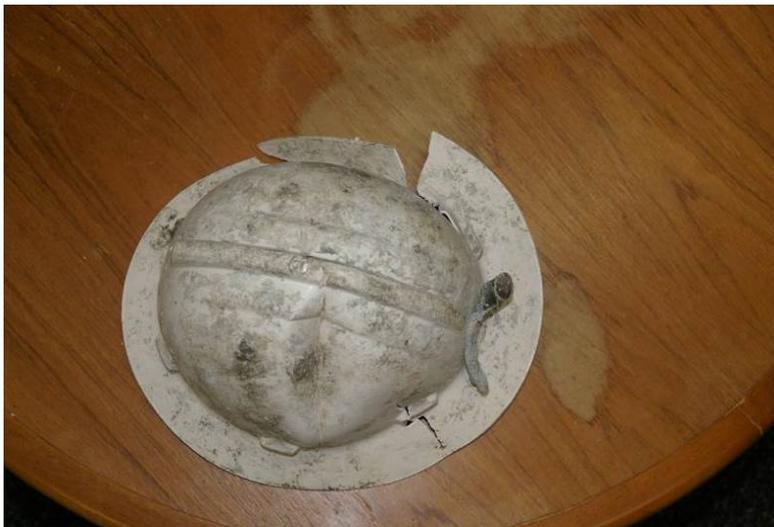
**Figure 20. Mr Junk's hard hat.**

At the time of the incident, Mr Junk was wearing personal protective equipment, including high visibility clothing and a hard hat. During the impact with the upper platform of the stage Mr Junk's hard hat was crushed and dislodged from his head. Investigators found Mr Junk's hard hat on top of the upper platform of the stage. The following photograph shows the damage to the hard hat.

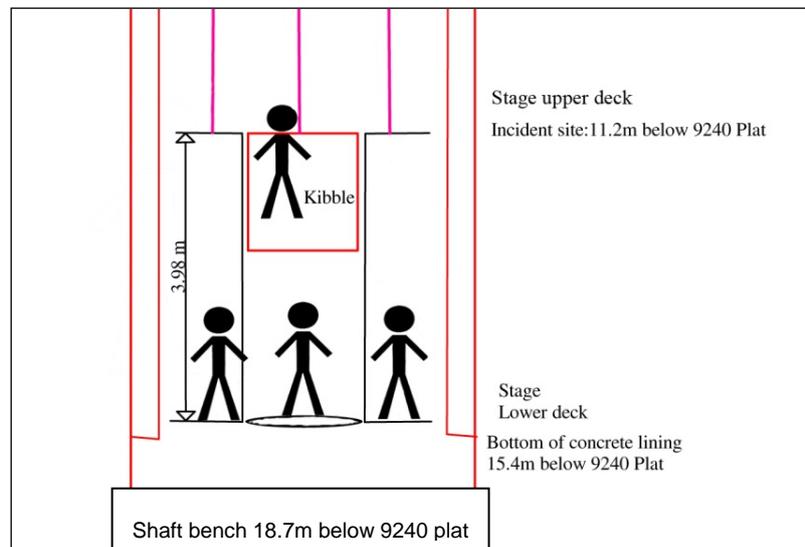
Figure 21. Position of workers in relation to the stage and kibble at time of incident (not to scale).

The incident occurred while the kibble was being raised through the stage's kibble well. Survey plans identified that the incident occurred 11.2 metres below the 9240 brace level. At the time of the incident the concrete shaft lining ended 15.4 metres below the brace and the shaft bench (base) was 18.7 metres below the 9240 brace level.
