Week ending 4 January 2019

This incident summary provides information on reportable incidents and safety advice for the NSW mining industry. To report an incident to the NSW Resources Regulator: phone 1300 814 609 24 hours a day, 7 days a week.

CM9 reference	DOC19/21314
Mine safety reference	ISR 19-01
Date published	15 January 2019

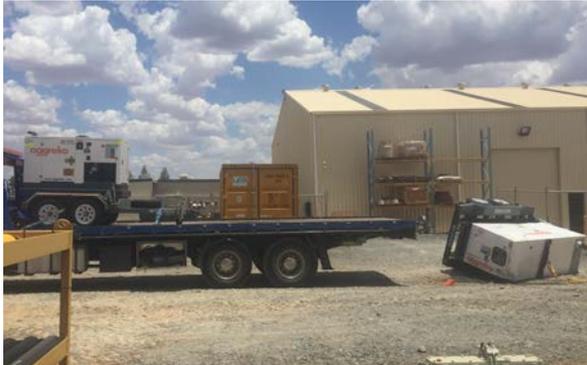
Incident type	Summary	Recommendations to industry
Dangerous incident IncNot0033518	<p>A trailer-mounted generator fell from the back of a tilt-tray truck. Two generators were being delivered. The rear generator was unstrapped, and the truck was repositioned. When the truck stopped, the generator rolled off the back of the truck. A spotter was clear of the area where the generator fell.</p>

<p>Mines must have procedures in place for unloading deliveries to sites. This should include procedures for unloading by tilt tray, Hiab, forklift/telehandler, crane, as appropriate. Systems should be put in place to ensure this is available to delivery drivers.</p>

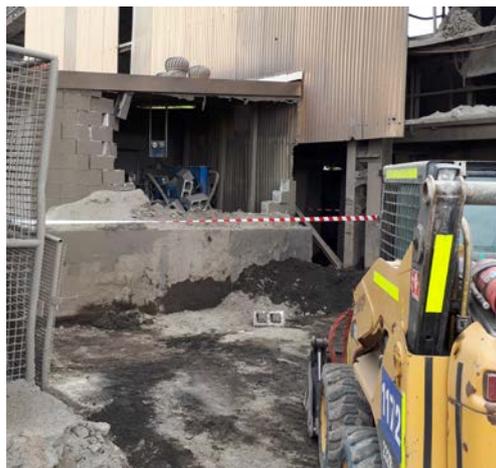
Dangerous incident
IncNot0033509

A skid street loader knocked over a wall at a large quarry. A worker was using the loader to clean up spilled material and was loading against a shed wall. As the worker raised the bucket for the third load, the wall bowed and collapsed. No other workers were in the area.

Spills should be eliminated as far as is reasonably practicable. In areas where spills cannot be avoided, the area should be designed to allow for safe cleaning and removal of material. The risk of falling material must also be controlled.

When establishing no go zones around mobile equipment, adjacent work areas should be considered.

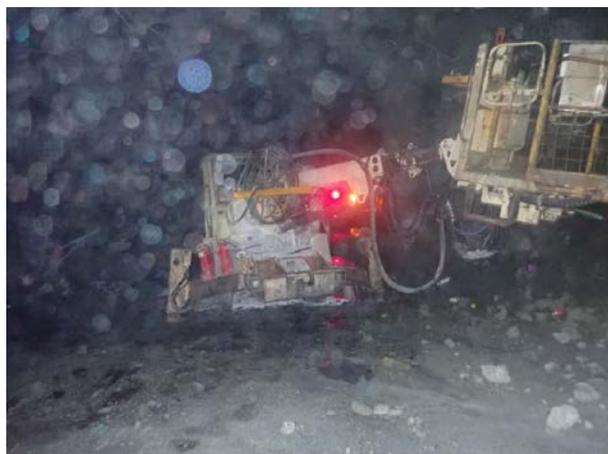
Dangerous incident
IncNot0033495

A fire occurred on a loader in an underground metalliferous mine. A worker was in a work basket when a spotter saw smoke and flames coming from the loader. As the worker went to lower the basket, the fire intensified. The worker jumped from the basket to help extinguish the fire. It was identified that the fire was coming from a hydraulic solenoid.

Mines must consider the methods used for evacuating workers from work baskets when they are elevated. Scenarios must be considered where rapid escape from the work basket is required.

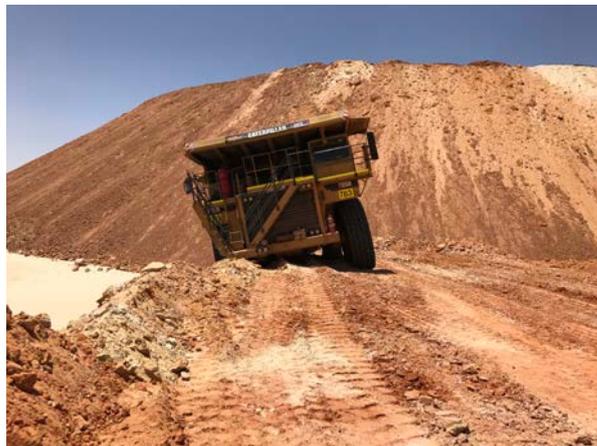
Dangerous incident
IncNot0033494

A haul truck was reversed to a tip head and the rear wheels sank into soft material on the edge of the dump. The incident occurred at night.

Supervisors must monitor and assess worker compliance with dump procedures on an ongoing basis. When changes are made to procedures, workers must be involved and informed.

Bunds must be designed, constructed and maintained to a standard that is suitable to protect workers.

Lighting must be positioned to create a safe work area and shadows must be assessed when determining the position of lighting.

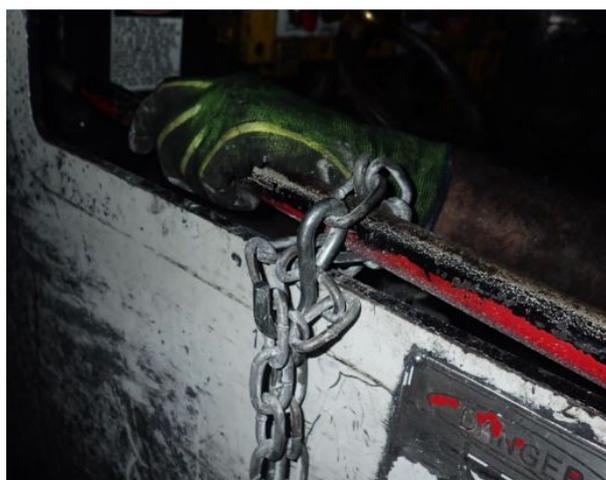
Serious injury
IncNot0033433

A worker suffered two fractured fingers while driving a shuttle car at an underground coal mine. After a shuttle car was used to pull a hose, a vent tube chain was left hanging on the rail next to the cab. The worker had his hand under the rail when the chain was driven over - the rail bent down squashing his fingers.

A vent tube chain should only be used for the intended purpose - not for lifting or towing.

Operator's compartments must be kept clean and free of hazards.

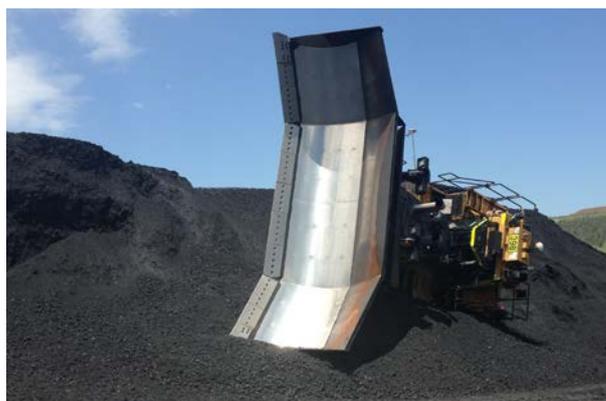
Dangerous incident
IncNot0033387

A dozer rolled onto its side while operating on a coal stockpile, at night, in light rain. The coal was sticky at the time of the incident. The dozer operator was about one metre from the edge of a 6.6 metre drop when coal slumped, rolling the dozer. The worker was not injured.

When working at night, work areas must be inspected, and potential hazards must be identified and communicated to relevant workers.

The nature of wet and sticky material on stockpiles should be considered when establishing work procedures.
