WEEKLY INCIDENT SUMMARY

Week ending Friday 09 August 2019

This incident summary provides information on reportable incidents and safety advice for the NSW mining industry. To report an incident to the NSW Resources Regulator: phone 1300 814 609 24 hours a day, 7 days a week.

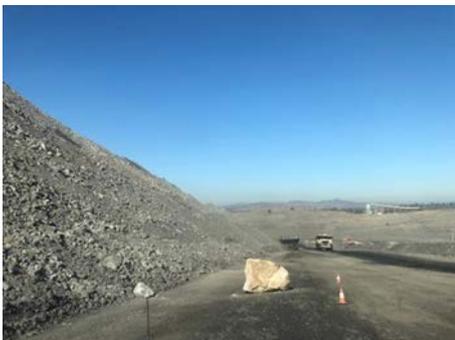
INCIDENT TYPE	SUMMARY	RECOMMENDATIONS TO INDUSTRY
High Potential Incident IncNot0035259

<p>A haul truck reversed onto a waste dump. As it tipped its load, a large rock rolled down over the edge, breaching the catch windrow at the foot of the dump. Another worker notified the dozer operator and other road users of the hazard. After the shift, the area was</p>	<p>Mine operators should have specific procedures detailing correct handling of unevenly sized waste material.</p> <p>The proper design and construction of catch berms and windrows is critical where active roads are positioned at the foot of active dumps.</p>

inspected, preserved and the production superintendent was made aware.
The catch windrow at the foot of the dump was not constructed as per the specified design.

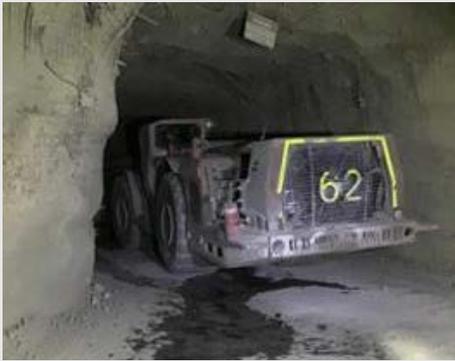
Dangerous Incident
IncNot0035260

A fire occurred on an underground loader.
The fire was in the exhaust area of the loader. The operator of the loader extinguished the fire with a fire extinguisher.
The operator was not injured.

Fires in underground environments present numerous significant risks with potential complexity. Operators need to be highly vigilant regarding standards of maintenance applied to mobile plant, to keep the risk of fire as low as reasonably practicable.

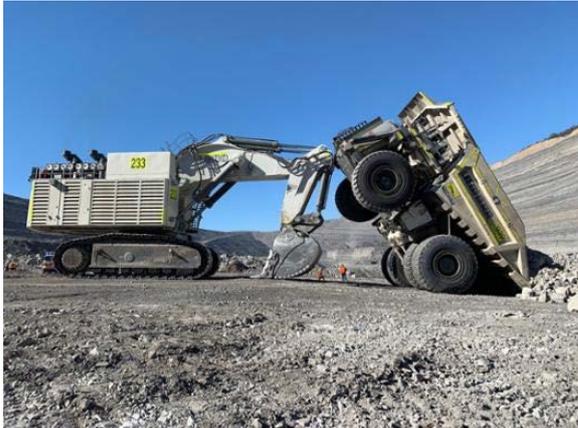
Dangerous Incident
IncNot0035268

An electric-drive dump truck lost propulsion and began rolling backwards, due to the local gradient. The operator applied brakes to stop the rolling. This caused the truck to sit up on its tail, trapping the operator in the cabin.
The operator was removed from the cabin by site emergency responders, with no injuries sustained.

Investigations are continuing, involving mine engineers, the truck manufacturer and Resources Regulator inspectors to establish why the truck lost propulsion.
