# INVESTIGATION INFORMATION RELEASE

## Fatality

**Location:** Bulga Surface Operations, Singleton NSW

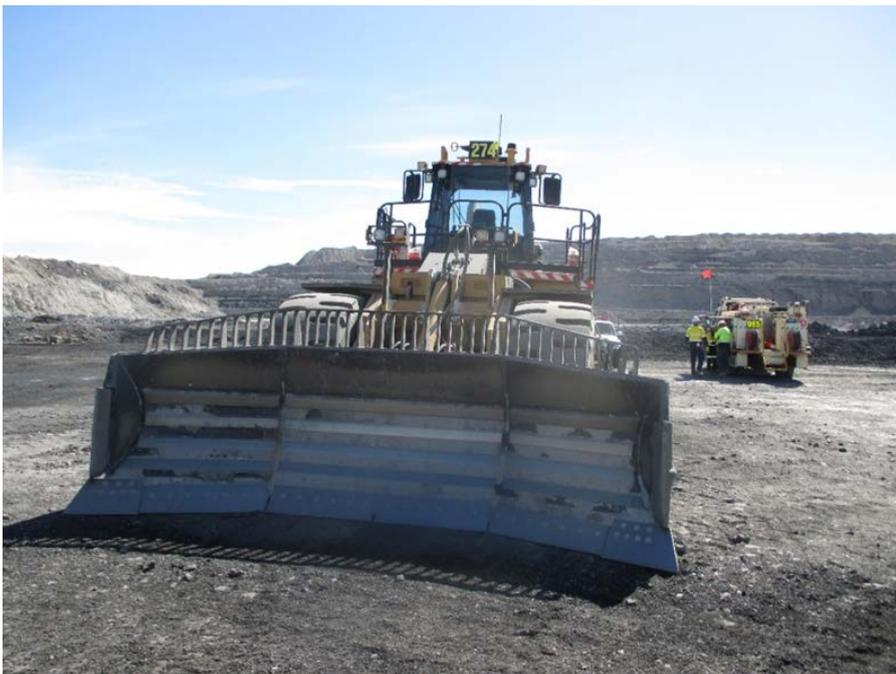
*Figure 1 The rubber-tyred dozer*
