**NSW  
Resources  
Regulator**

**INVESTIGATION REPORT**

# **SERIOUS INJURY**

Springvale Colliery – 5 February 2019

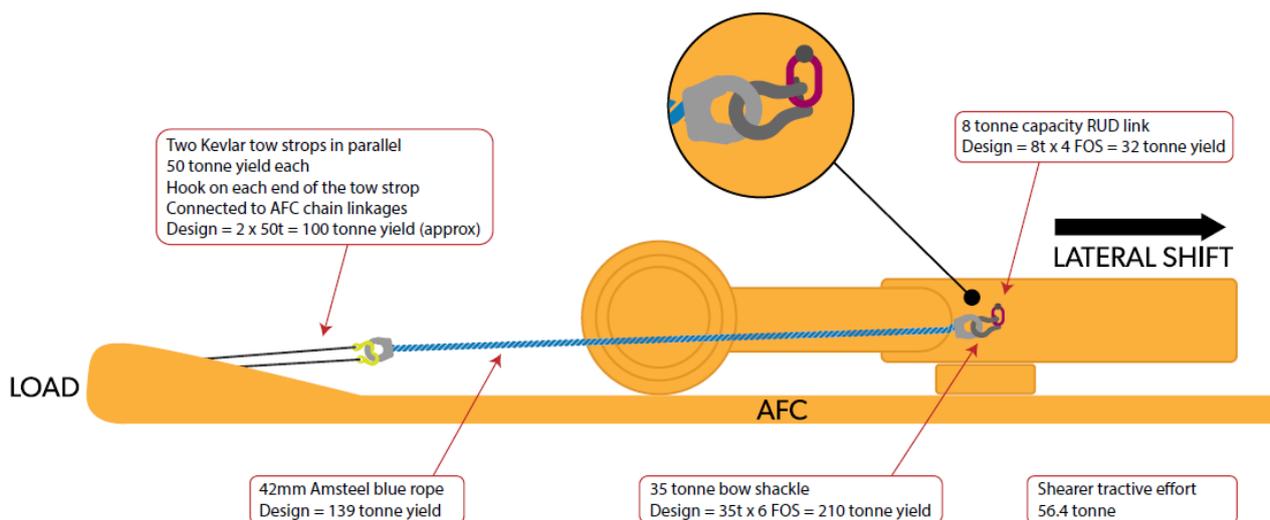
Figure 1 Towing system used at the time of the incident

Workers began to assemble a towing system to move the AFC chain using the shearer. The towing system consisted of a 35-tonne bow shackle, a 42-millimetre nylon rope and two 'Recover Fast' Kevlar 50-tonne tow strops fitted with 16-tonne coupling links and 16-tonne sling hooks at either end. The towing system was attached to the AFC chain, with the sling hooks of the tow strops hooked into the links of the AFC chain. The towing system was attached to the shearer using the 35-tonne bow shackle connected to an 8-tonne RUD link, which was fitted to the shearer.

The workers began to move the AFC chain by simultaneously powering the maingate slow runner and the shearer. Shortly after starting, a loud bang was heard. The 8-tonne RUD link on the shearer failed,

resulting in the nylon rope with the 35-tonne bow shackle attached recoiling towards the maingate. The shackle hit the worker operating the shearer in the lower leg. The impact fractured his tibia and fibula.

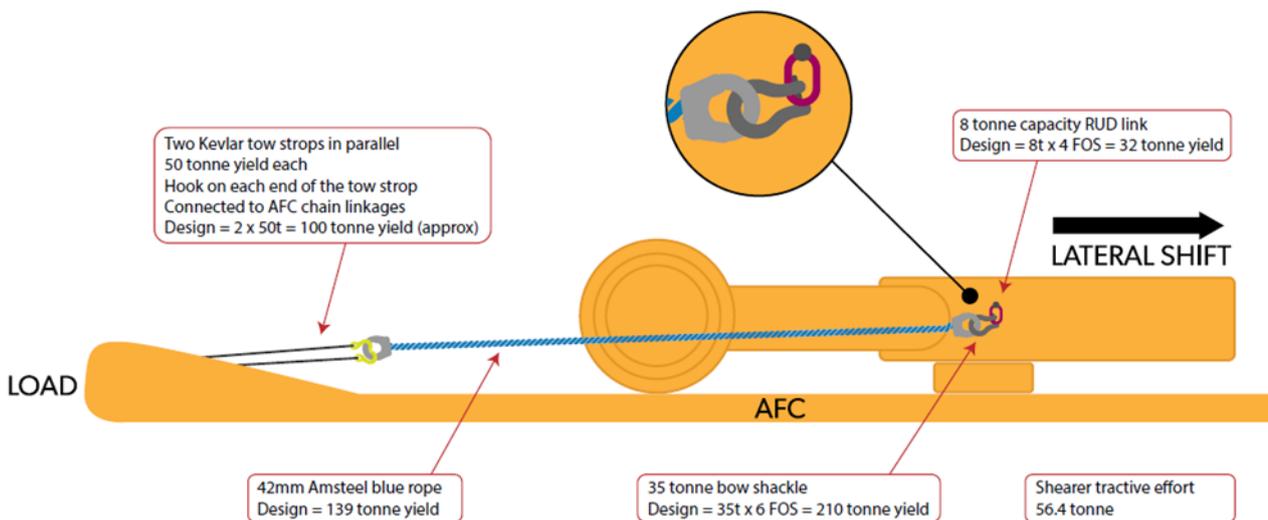
Figure 3 Towing system used at the time of the incident

Workers began to assemble a towing system to move the AFC chain using the shearer. The towing system consisted of a 35-tonne bow shackle, 42-millimetre nylon rope and two 'Recover Fast' Kevlar 50-tonne tow strops fitted with 16-tonne coupling links and 16-tonne sling hooks at either end. The towing system was attached to the AFC chain, with the sling hooks of the tow strops hooked into the links of the AFC chain. The towing system was attached to the shearer using the 35-tonne bow shackle connected to an 8-tonne RUD link, which was already fitted to the shearer.

The workers began to move the AFC chain by simultaneously powering the maingate slow drive runner and the shearer, which was trammed towards the tailgate. Shortly after starting the task, a loud bang was heard. The 8-tonne RUD link on the shearer failed, resulting in the nylon rope with the 35-tonne bow shackle that was attached recoiling towards the maingate. The 35-tonne bow shackle hit the worker operating the shearer in the lower leg.

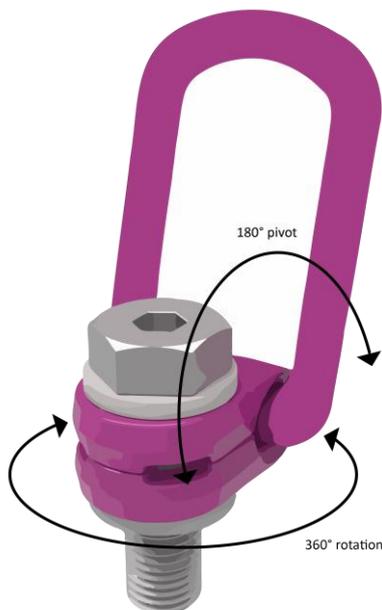
Figure 4 Representation of a RUD link that was fitted to the shearer

The RUD link fitted to the shearer was an 8-tonne swivel load ring. The link had a working load limit of 8-tonne and was normally used for loading in all directions. The link was fitted to the shearer by the OEM at the time of an overhaul of the shearer in July 2018. The purpose of the installation of the link was for lifting the ranging arm of the shearer during transport, installation and removal of the shearer.

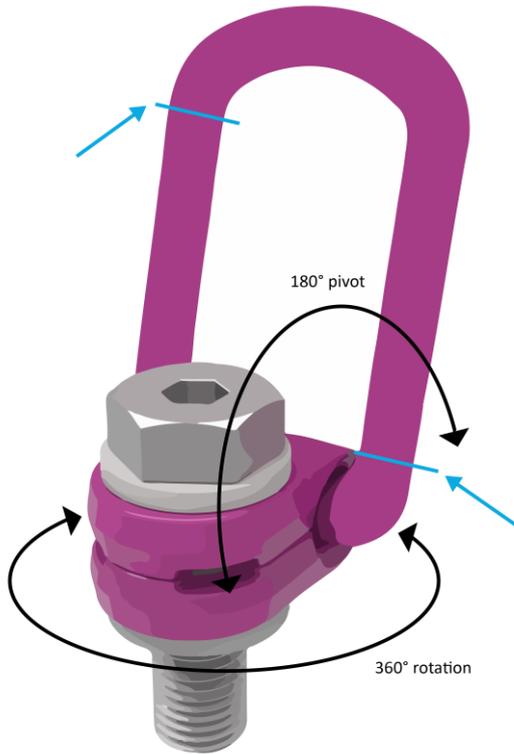
Figure 5 Representation of the RUD link that was fitted to the shearer showing the location of fracture (indicted by blue arrows)

The mine operator arranged for the RUD link to be examined after the incident. Examination of the link found that link failed in a single tensile loading event. The link exhibited twisting and bending deformation indicating off-axis loading. The off-axis loading led to increased, resolved loading and overload failure. There was no evidence of fatigue or other pre-existing cracks.

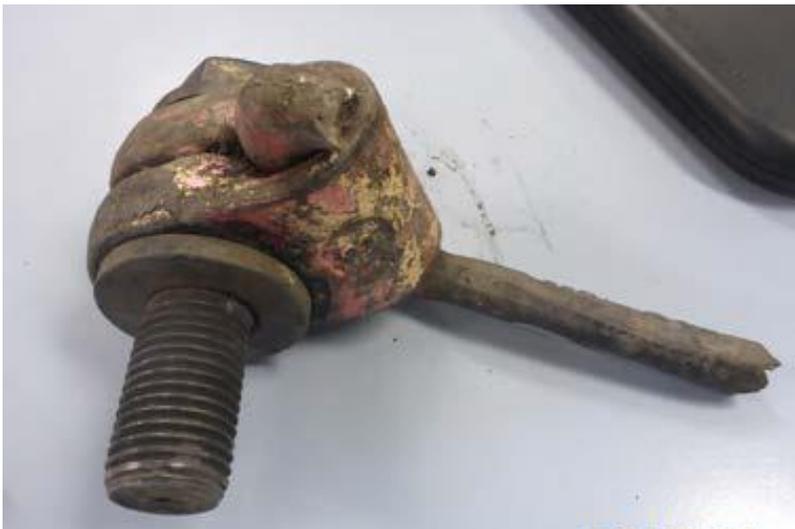
Figure 6 The failed 8 tonne RUD Link

- the failure of the 8-tonne RUD link on the shearer, which was used as a connection point of the towing system, resulting in the uncontrolled release of energy.

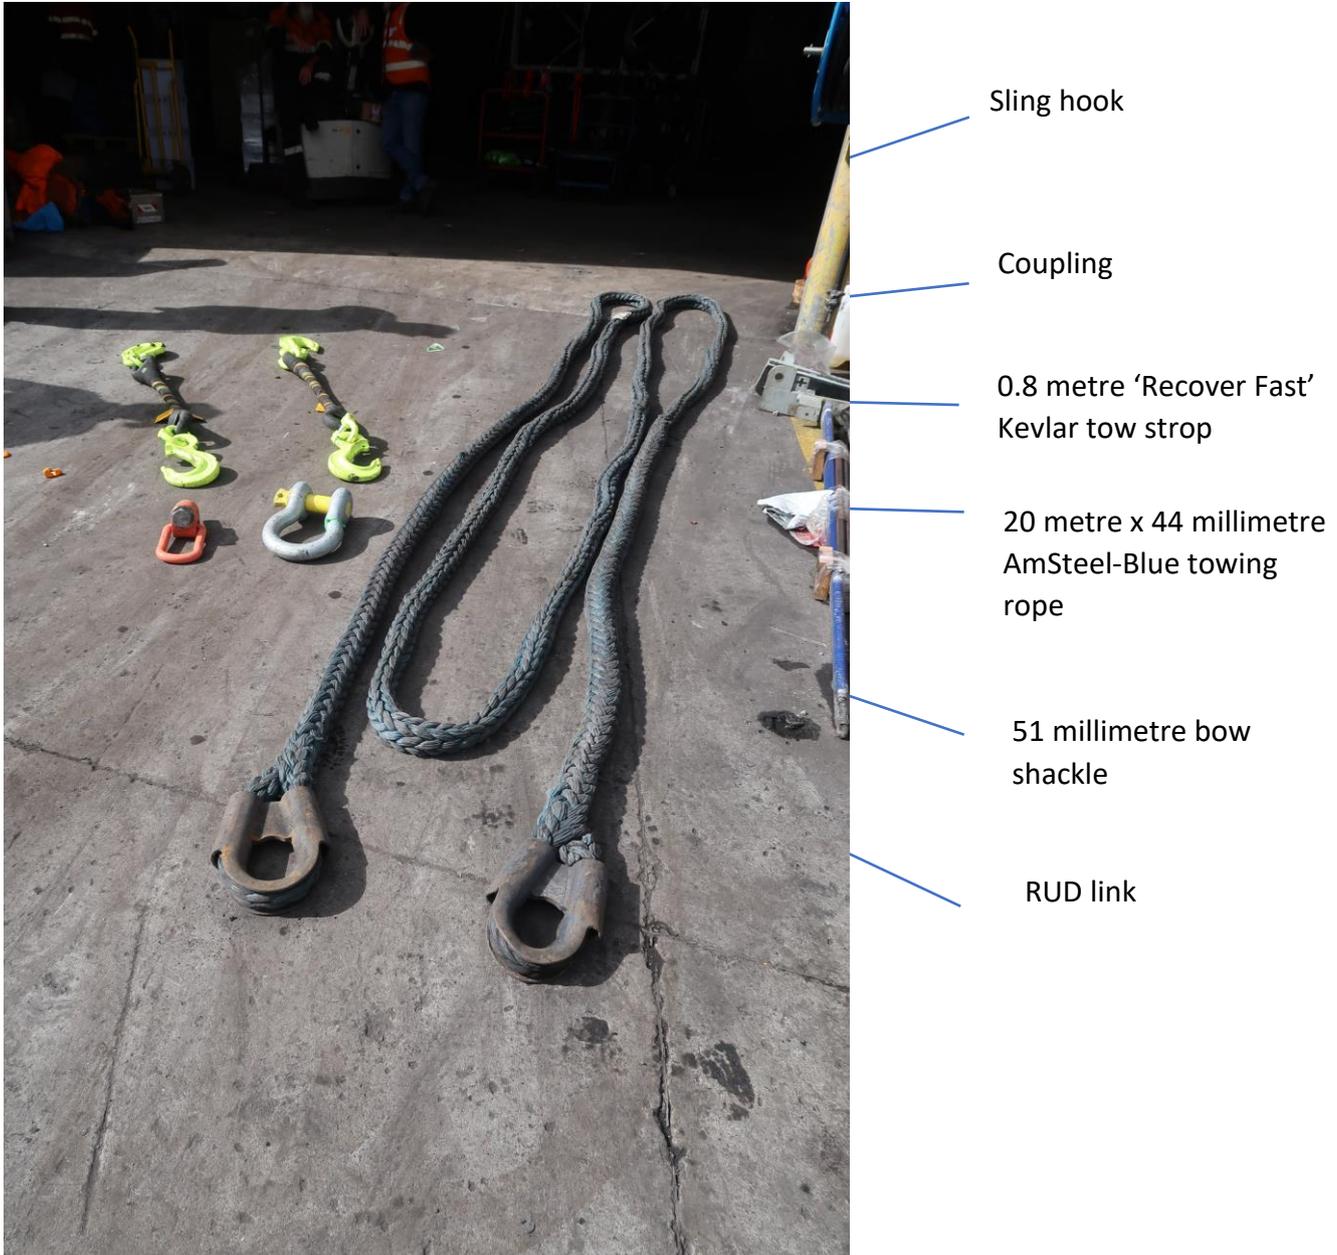
Figure 7 A reproduction of the towing system components as was used in the incident

- RUD link fitted to the shearer with 8-tonne working load limit, connected to a
  - 51-millimetre bow shackle with 35-tonne working load limit, connected to a
  - 20 metre x 44-millimetre AmSteel-Blue towing rope with 62.5-tonne working load limit, connected to
  - 2 x sling hooks each with 16-tonne working load limited, connected to
  - 2 x coupling links each with 16-tonne working load limit, connected to
  - 2 x 0.8 metre 'Recover Fast' Kevlar tow strops each with 50-tonne working load limit, connected to
  - 2 x coupling links each with 16-tonne working load limit, connected to
  - 2 x sling hooks each with 16-tonne working load limited, connected to
  - 2 x links of the armoured face conveyor chain.

The towing system was attached to the shearer by placing the 35-tonne bow shackle through the RUD link attached to the shearer. The towing system was attached to the AFC chain by placing the sling hooks through the links in the two strands of chain.
