# SAFETY BULLETIN

DATE: DECEMBER 2021

## Fires occur after servicing mobile plant

<b>CM9 reference</b>	DOC21/1005934
<b>Mine safety reference</b>	SB21-11
<b>Date published</b>	02 December 2021
<b>Authorised by</b>	Chief Inspector Office of the Chief Inspector

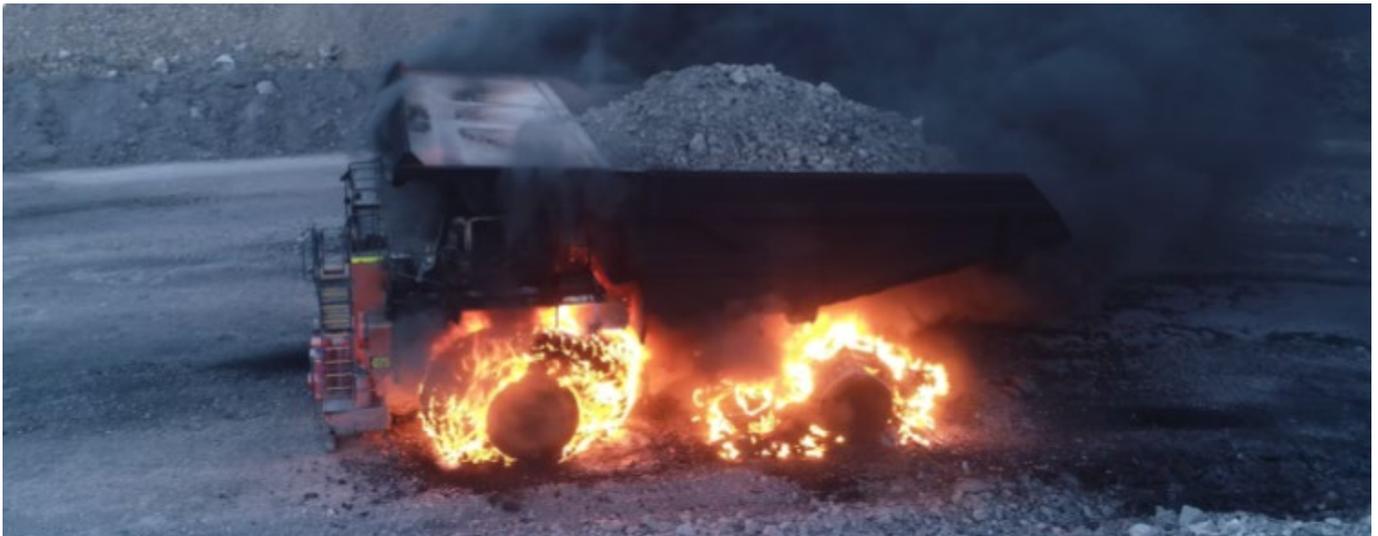
*Figure 1: Cause still under investigation*

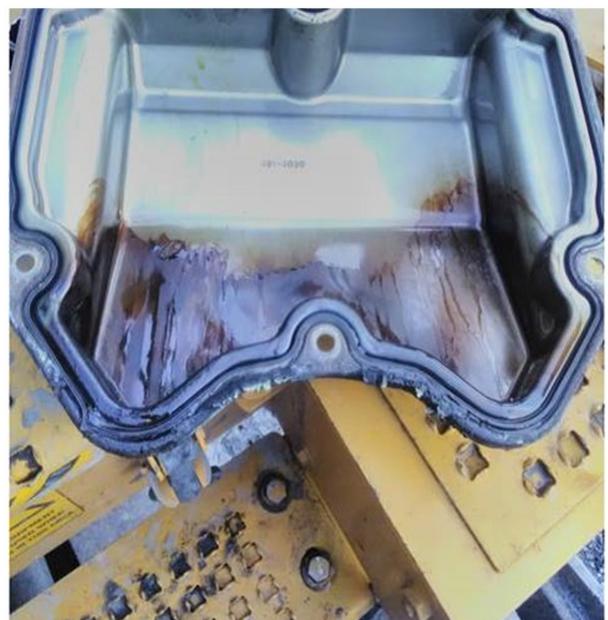
- painted components such as exhaust manifolds and turbochargers released volatile vapours which ignited during initial start-up or commissioning
- oil leaks from valve or rocker cover gaskets caused by:

- failure to install fasteners
  - over-tensioned or under-tensioned fasteners
  - failure to replace gaskets with new gaskets
  - failure to install gaskets correctly (pinched on assembly)

Figure 2: Fire affected rocker cover

- appropriate tools and procedures are available and used for all maintenance and repair activities involving torque critical fasteners
- systematic processes such as 'X' markings are used to account for fasteners being installed and tensioned to the final assembly torque
