INVESTIGATION INFORMATION RELEASE

Collision between dozer and light vehicle

Incident date: 14 September 2019

Event: Collision between dozer and light vehicle at Maules Creek Mine

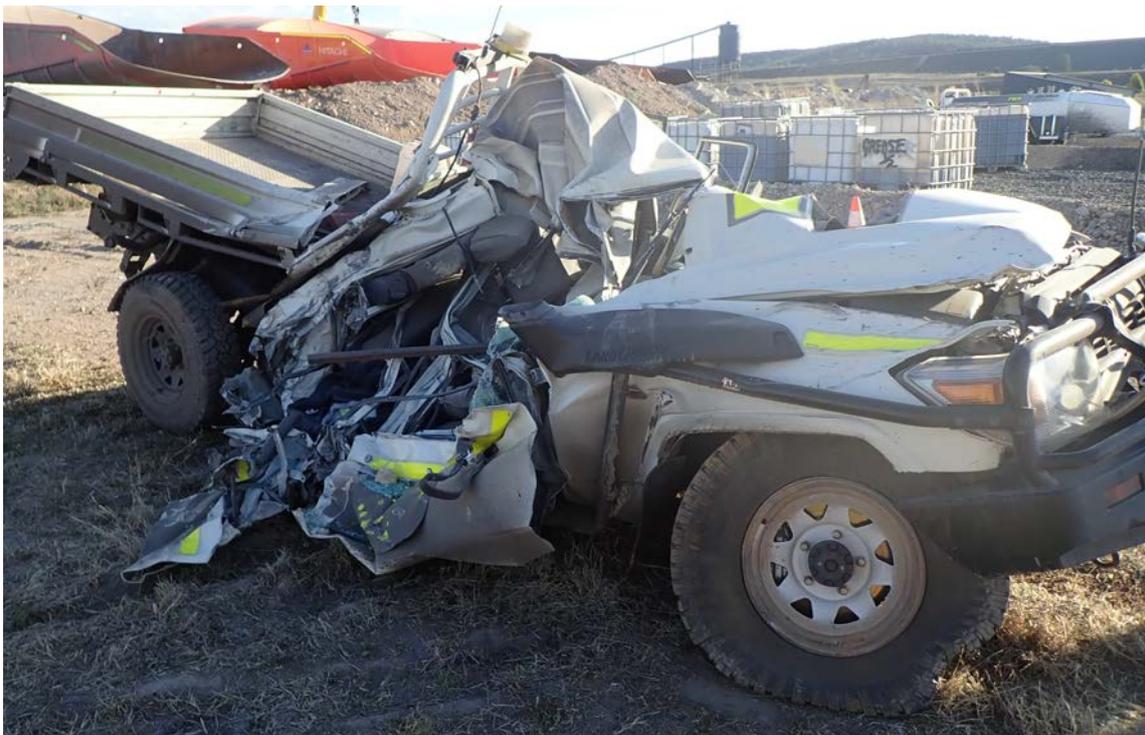
An unoccupied light vehicle was extensively damaged in a collision with a bulldozer on 14 September 2019. The NSW Resources Regulator has completed an investigation into the incident.

Figure 1 Photograph of damaged light vehicle

At about 8pm on 14 September 2019, a worker parked a light vehicle on a bench in a working area of the mine and left it unattended to begin operating an excavator. A dozer was already operating in the area. The dozer reversed some 80 metres before hitting the light vehicle, resulting in extensive damage.

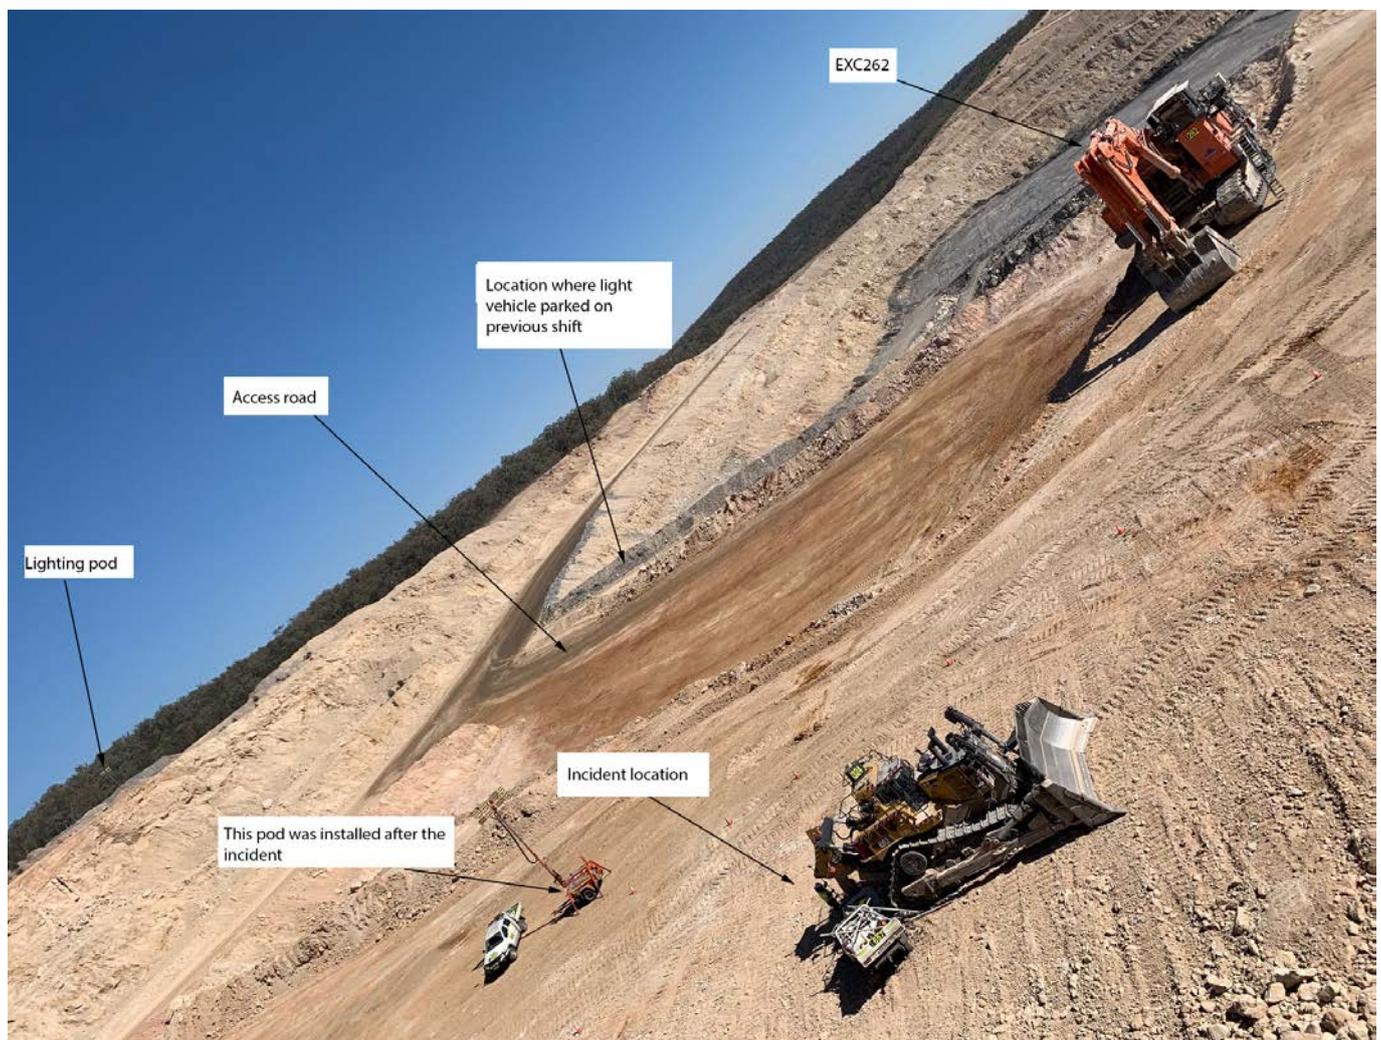
Figure 2 Photograph of work area

- A suitable park up location for light vehicles was not constructed in the work area. During the previous night shift, workers had parked the light vehicle within a bunded area on a light vehicle access road.

- The excavator operator parked the light vehicle on the bench at a location that was a considerable distance from where the dozer was operating. The flashing light was not left on in accordance with site procedures where vehicles were parked outside designated parking areas. The excavator operator advised the dozer operator that he had returned to the work area. He walked across the bench to the excavator which he began operating.

- The dozer operator did initially identify where the light vehicle was parked, however lost situational awareness. At the point in time the collision occurred, the dozer operator thought the light vehicle was in a different location.

- eliminate light and heavy vehicle interactions, by establishing segregated roadways and designated parking locations for light vehicles near working areas
- apply engineering controls such as proximity detection, collision avoidance systems and cameras to assist in managing the risks associated with vehicle and mobile plant interactions,
- review the adequacy of surface transport management plans, including radio and other communications protocols, and the processes detailed within these plans to ensure risk controls are monitored and verified as being effective
- when undertaking risk assessments and implementing operational changes, consider how organisational factors, such as a reduction in supervisory resources, can adversely impact on effective risk management.
