**NSW
Resources
Regulator**

INVESTIGATION REPORT

RIB FAILURE AT CLARENCE COLLIERY

4 July 2018

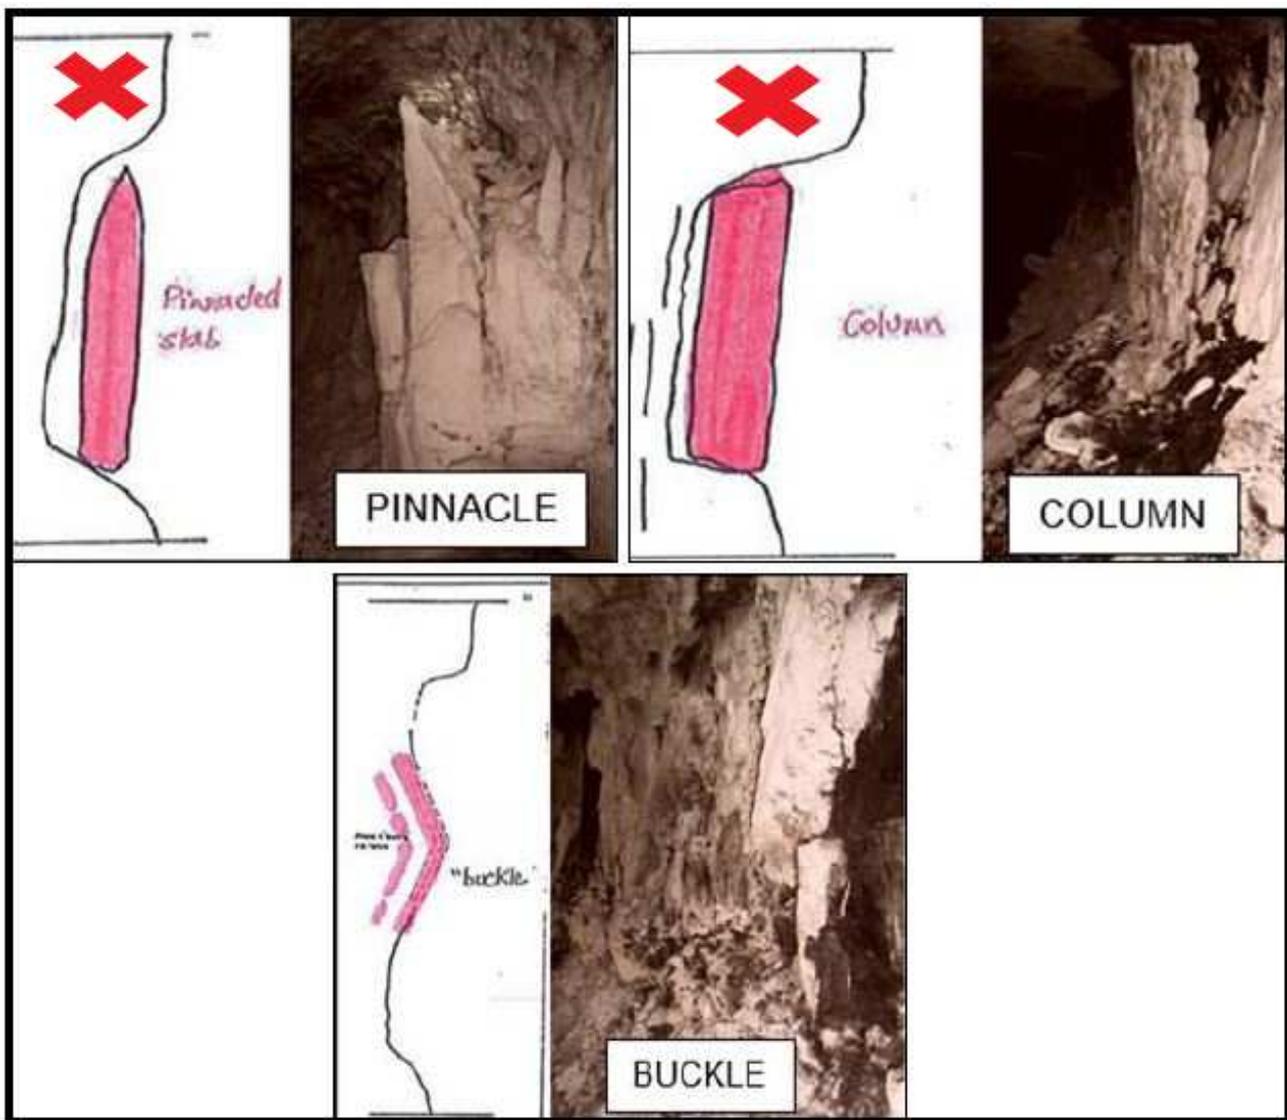
Workers A and B then helped a colleague with an unrelated task before returning to the continuous miner and the location where worker B barred down the portion of rib. Worker A started the continuous miner and began operation via remote control. Worker A was positioned on the continuous miner's driver's side, with his back facing the rib and worker B was located near the continuous miner's rear boom. At this time, a large amount of material comprising of coal and mudstone, collapsed from the upper portion of the rib. The material hit the workers with a large block of coal/mudstone weighing about 600 kilogram hitting worker A. (Refer to Figure 3). Worker B was also knocked to the ground.

Figure 2 Potential overhang of unsupported rib after barring down pinnacles or columns (red crosses)

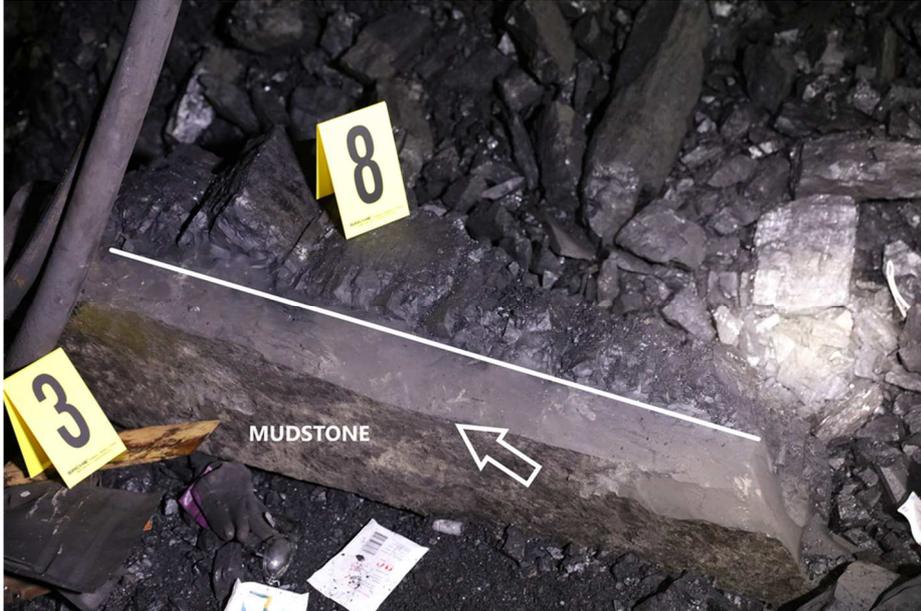
Figure 3 The coal and mudstone block (marked with No.8 'A' frame) which struck worker A

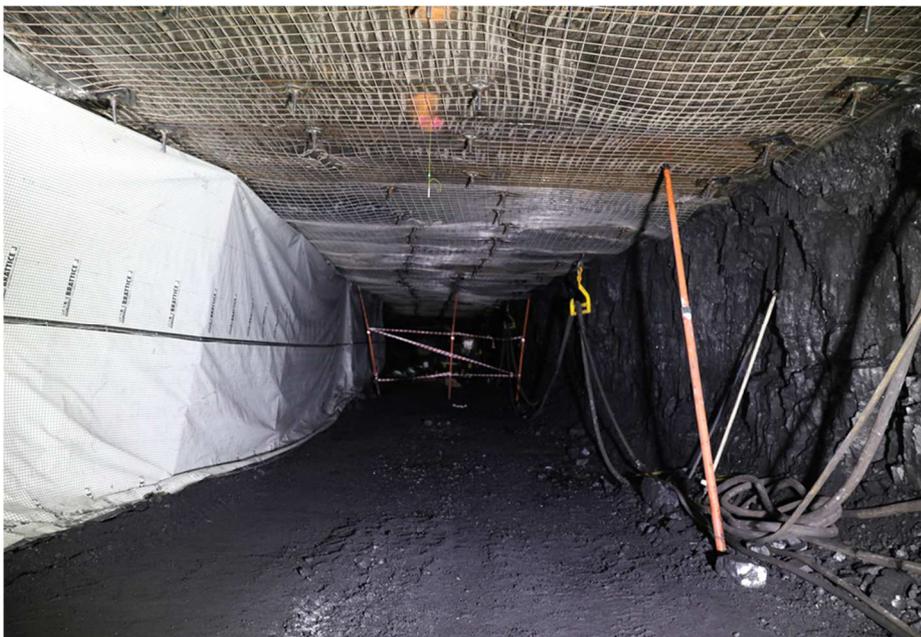
The incident occurred in 'G' heading of the 806A panel within the underground workings of the mine. The panel and heading were about 215 metres underground within the Katoomba coal seam. Only the roof of the incident site was supported with mesh and bolts in an 8 bolts/2 m 4/4 pattern (Refer to Figure 4).

Figure 4 Photo outbye of the incident site

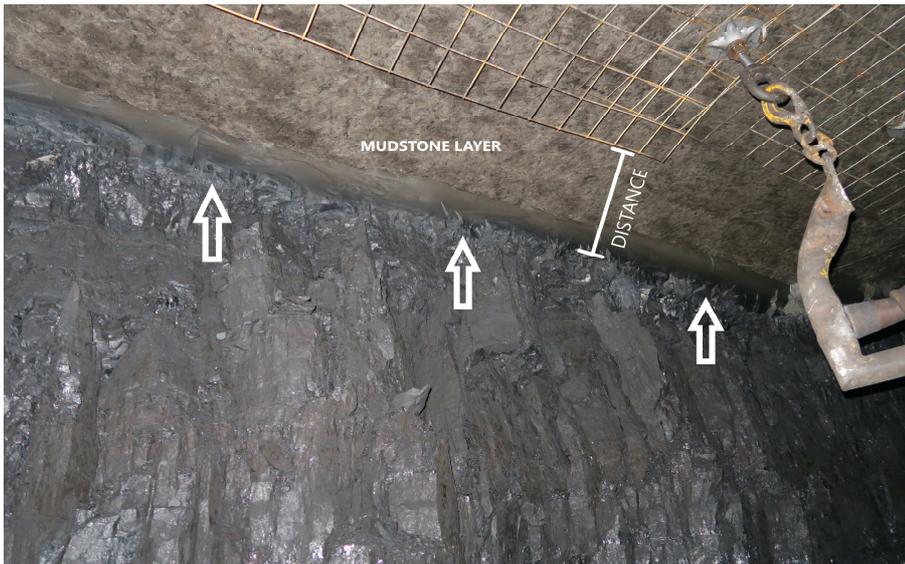
Before the incident, the mine did not routinely install rib support and was aware of the presence of mudstone (Refer to Figure 5), geological faults within the panel and mud stone slabbing (Refer to Figure 6). In a geological report supplied to the mine in 2016, commissioned to review incidents including rib spall, the mine operator's attention was drawn to the presence of mudstone in various thicknesses and poor cohesion qualities.

Figure 5 Mudstone layer between coal and sandstone roof at incident site and mesh sheets

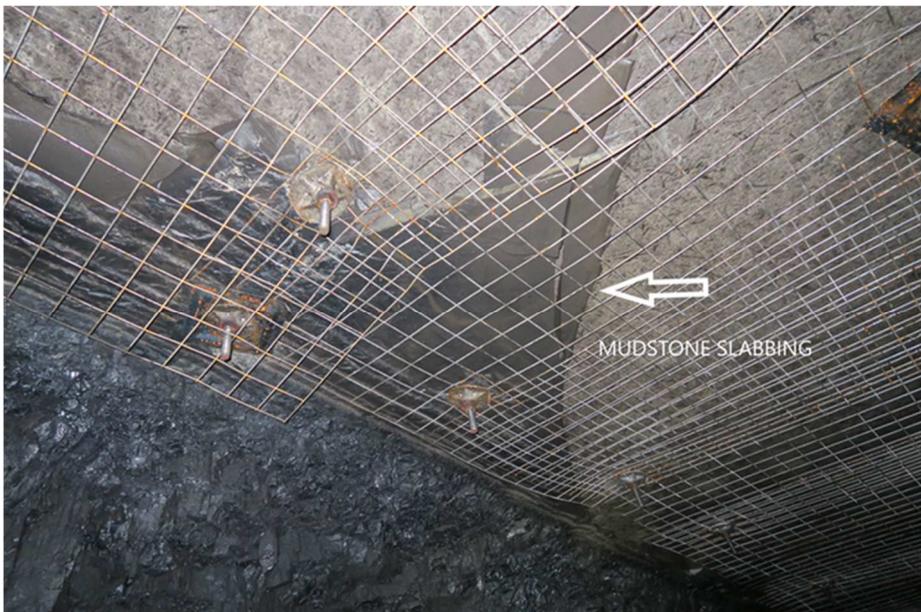
During an examination of the scene, mudstone was identified within the heading outbye of the incident scene, measuring about 50 millimetres thick and increasing in depth towards the incident site up to 190 millimetres.

Figure 6 Mudstone roof slabbing supported by mesh and bolts, outbye of incident site

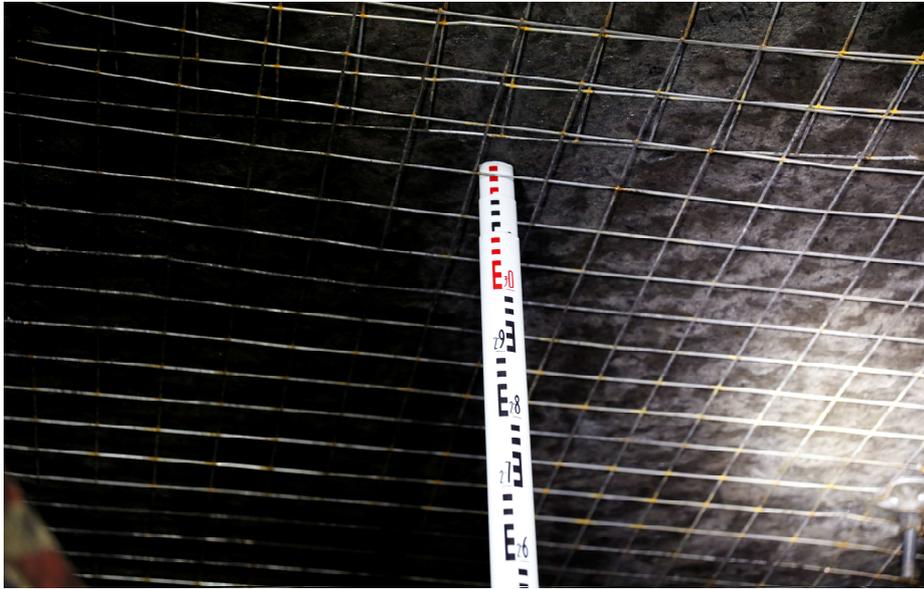
The roof height at the incident scene was measured to be 3.13 metres (Refer to Figure 7).

Figure 7 Roof height measured at rear right of the CM boom to be 3.13 metres

There was no correlation between the depth of mining and the rib incidents, however there was evidence to indicate that the more severe rib incidents occurred in roadways with heights above 2.8 metres. The mine was aware that maintaining road heights between 2.8 metres and 3 metres substantially improved rib stability. The report identified an increase of rib height from 2.8 metres to 3.1 metres (an increase of about 10.7%) increased the risk of rib spall by 35 per cent. An examination of the incident scene by investigators established the height of the roadway, measured alongside the boom or tail of the continuous miner, was 3.13 metres.

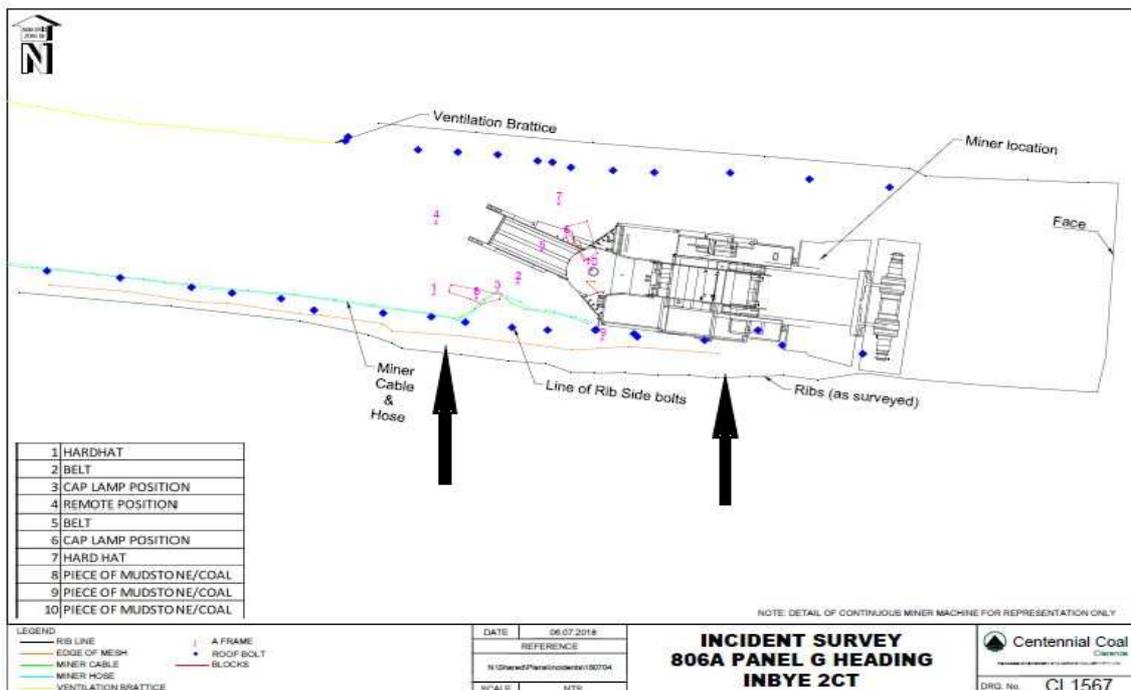
A survey of the right side rib line (looking inbye) completed after the incident, revealed a significant volume of material collapsed from the rib (Refer to Figure 8). As shown in Figures 4, 6 and 7, the installation of roof mesh at the incident site was ordinarily installed to ensure it butted against the rib/roof cornice. Figure 5 shows the distance between the roof mesh and rib post incident.

Figure 8 Survey of the incident site with right side rib (inbye) having collapsed

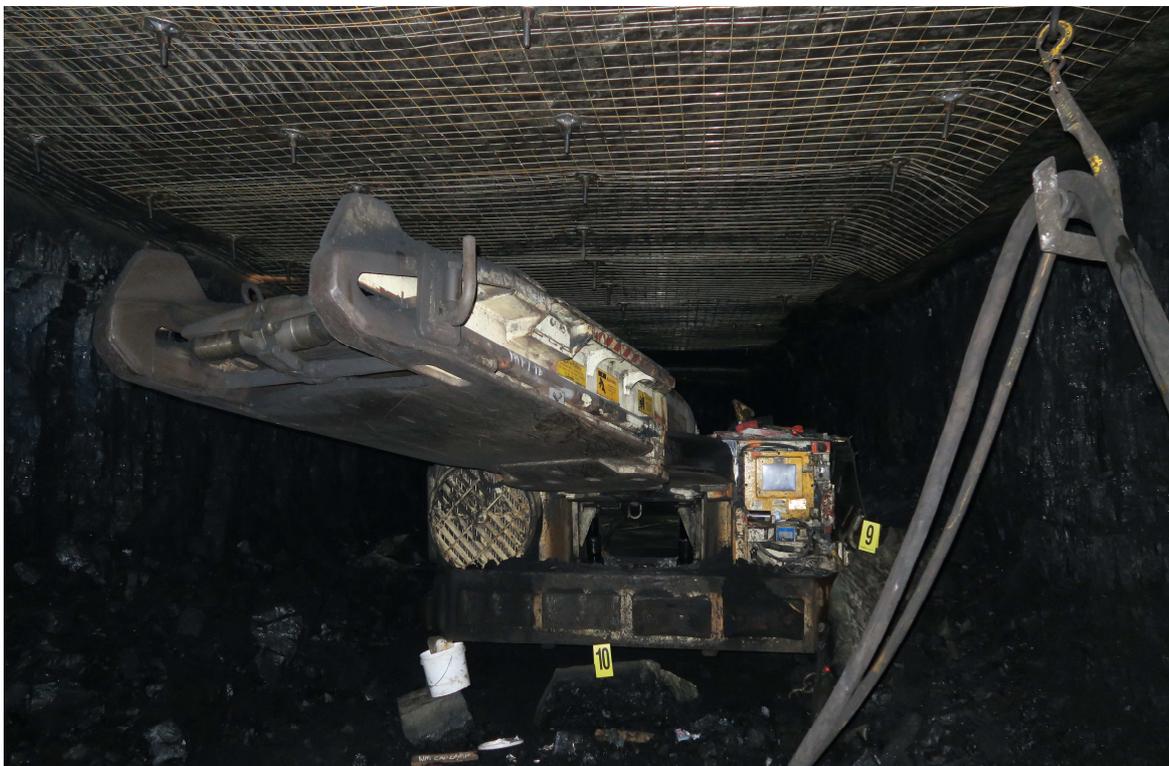
Figure 9 Continuous miner 806A panel ‘G’ heading as found by investigators

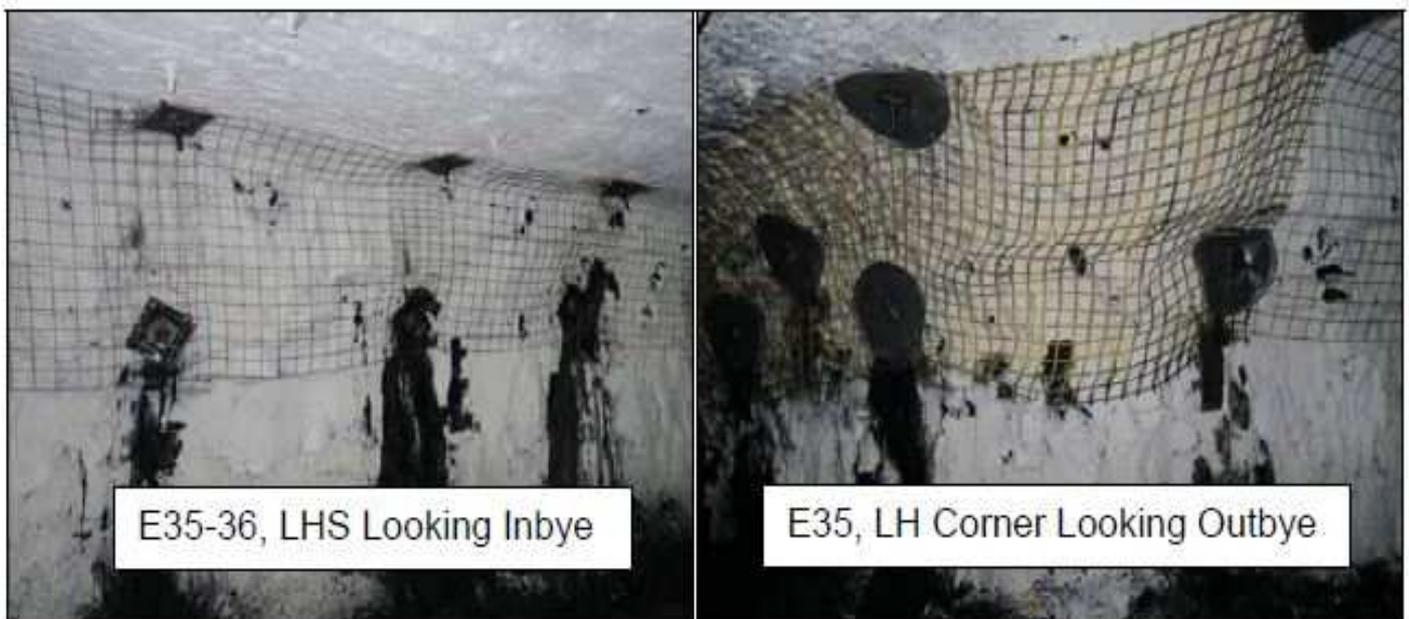
During the investigation, a number of adjacent panels to the incident site were inspected and were found to have 1.2 metre mesh and bolt rib support installed (Refer to Figure 12). The installation of similar support, combined with the roof support installed at the incident location, may have been a reasonably practicable measure to prevent this incident.

Figure 12 Upper rib support observed by investigators in 821 panel

- ribs are adequately supported, especially in areas where workers are required to operate in close proximity to ribs
- mapping of ribs, including the extent and thickness of mudstone roof, to assist with managing risks to the health and safety of workers
- a review of rib related TARPs to ensure they are current and appropriately accessible to workers
- all hazards associated with mining operations are managed in accordance with the hierarchy of controls.
