# WEEKLY INCIDENT SUMMARY

**Week ending Friday 29 May 2020**

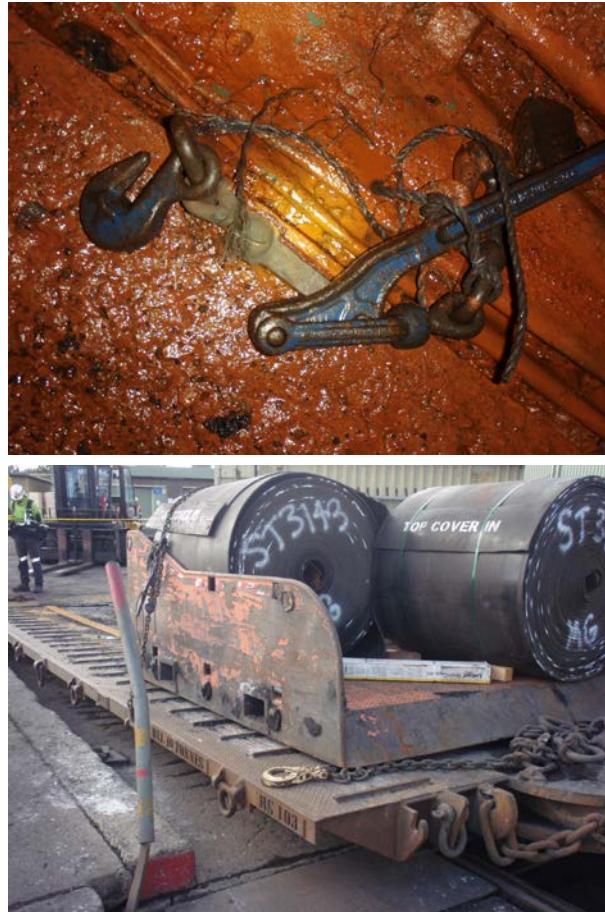
INCIDENT TYPE	SUMMARY	COMMENTS TO INDUSTRY
Dangerous incident IncNot0037446	A dolly car at an underground coal mine was travelling down the drift with three duckbills loaded on a flattop. The front duckbill was secured to the flat top, but detached and slid off. The second duckbill was unsecured and also slipped off the flattop. The dolly car was about 500 metres into the drift at the time of the incident. The first duckbill slid to the bottom of the drift (approx. 1100m) while the second one stopped after about 150 metres. There was no one in the drift at the time of the incident.	Investigation of this incident by the Regulator is ongoing and further information may be published later.
Underground coal

Procedures, relating to transporting loads via a drift conveyance, should be clear about the use of headboards and the proper securing of loads.

Operators should ensure risk assessments for dolly car operations include all known hazards and that

adequate controls have been implemented for identified risks.

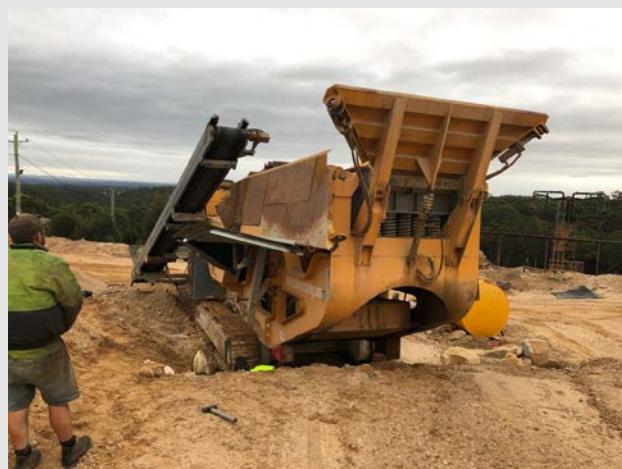
An apprentice was injured by a falling hopper wing on a mobile impact crusher. The crusher was being prepared to float to another location and when a hydraulic cylinder was pressed out, it was noticed that it was broken. The apprentice climbed up to assist in aligning a component, when the wing dropped and hit the apprentice on the back of the head and shoulder. The apprentice sustained a broken scapula and a gash to the back of his head.

No-go zones should be identified during risk assessments for the dismantling of plant.

Under no circumstances should any no climb on plant where securing pins and wedges have been removed during the dismantling process.
