# INVESTIGATION INFORMATION RELEASE

## Worker seriously injured during transit in underground roadway

**Incident date:** 20 May 2021

**Location:** Appin Colliery, Appin NSW

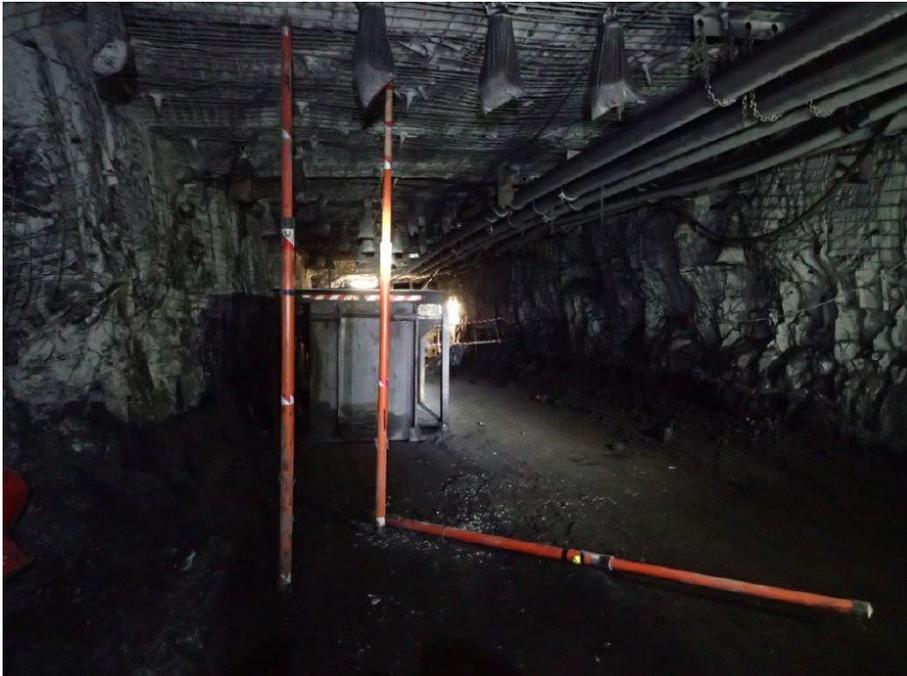
To access the pump site, the workers planned to park their vehicle near the pump. The pump was in another roadway which meant they were required to traverse a cut through. The driver of the vehicle turned left into the cut through and noticed three orange poles (pogo sticks) demarcating a piece of stowed equipment on the passenger side of the vehicle. The driver noticed there was limited clearance and coasted past the piece of equipment. As the vehicle passed the stowed equipment, the driver reported hearing the worker scream. He stopped the vehicle and ran around to the passenger's side to determine what had happened. On observing the workers badly injured arm he returned to the driver's seat and reversed the vehicle clear of the equipment. He then attempted to access the first aid box, however, could not do so as it had a damaged handle. At this point the driver called an emergency over the two-way radio and proceeded to drive the injured worker out of the mine.

Figure 1. The incident scene (after SMV removed) Source Appin Colliery

- Mine operators are expected to ensure that all workers are trained and competent in all aspects of the mine's safety management system where appropriate for the job task.
- Mine operators are expected to ensure foreseeable hazards and risks are mitigated through a sound risk assessment process.
- Mine operators are expected to ensure that rules are in place for stowage and demarcation of materials and equipment, and minimum clearances are specified around mobile equipment in all circumstances
- Equipment design must include a thorough evaluation to ensure the safety of all drivers and passengers.
